Wave Dragon Prototype

Tilstandsvurdering **BILAG**

Energinet.dk projektnummer 6459

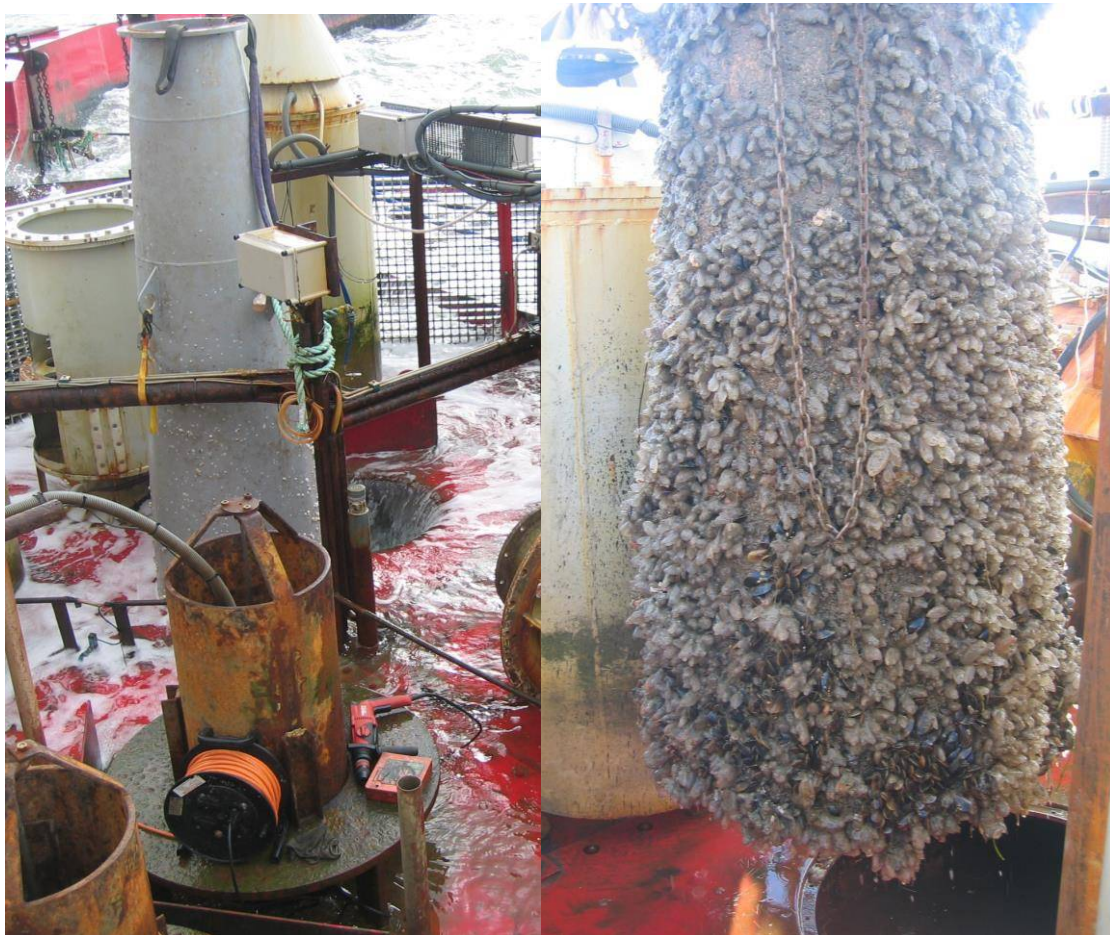
3 af udløbs tragtene fra turbinerne er behandlet med en speciel ”non toxic anti fouling” maling udviklet af Hempel. Disse 3 udløbstragte havde praktisk taget ingen begroning, og den begroning, der var, kunne fjernes med et stykke stift plast.

Figur 10.4 Udløbstragte med og uden begroning.

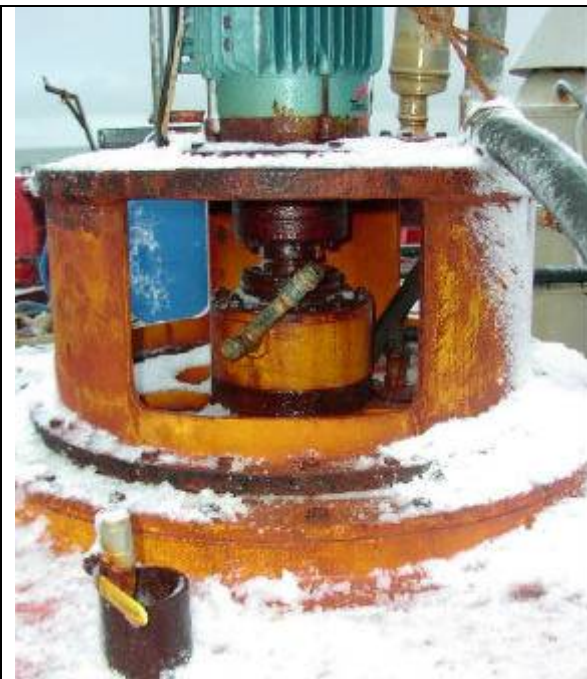
During a visit in January 2004 it had been found that the turbine did not work any longer. A brief analysis revealed corrosion on the whole generator support and heavy corrosion on the bearing and shaft coupling. A very high frictional torque was found when turning the shaft.

generator support 1/2004

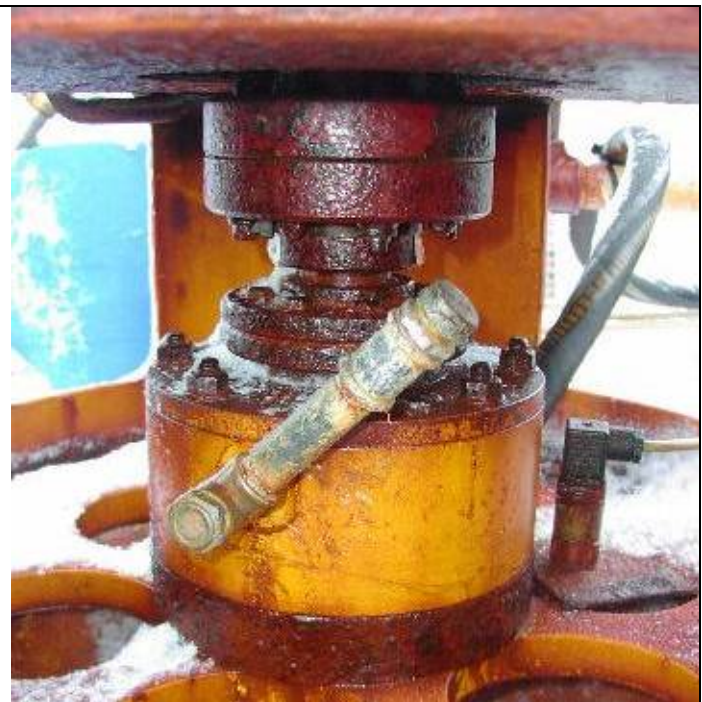
bearing and shaft coupling 1/2004

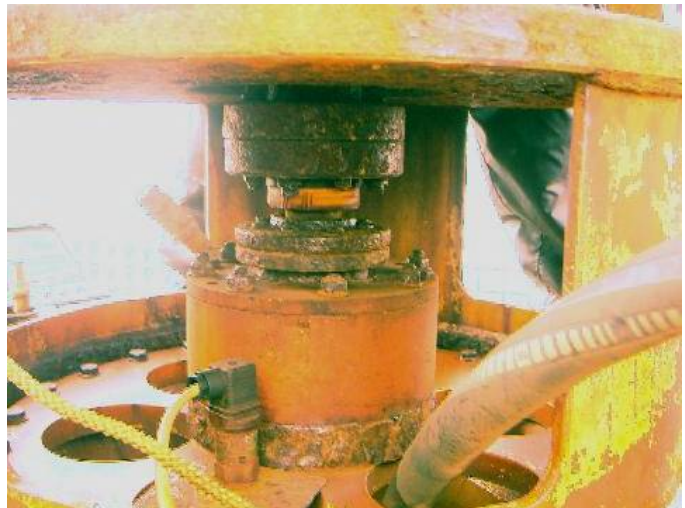
- 1.6. bearing spacer: heavily corroded.
Reason: no paint at all.
- 1.7. turbine shaft:
good condition in view of corrosion, but top end wrongly machined, so that the clamp fit could not be installed properly.
Reason: The analysis has shown that Matti Sorto's drawing for the modification was wrong, and Promecon have executed the machining as per the drawing, not

noticing that about 90% of the clamping area have been machined away. The shaft was obviously fitted without taking notice of this. Probably the loss of the turbine shaft and runner were only prevented by a grub screw in the shaft coupling!

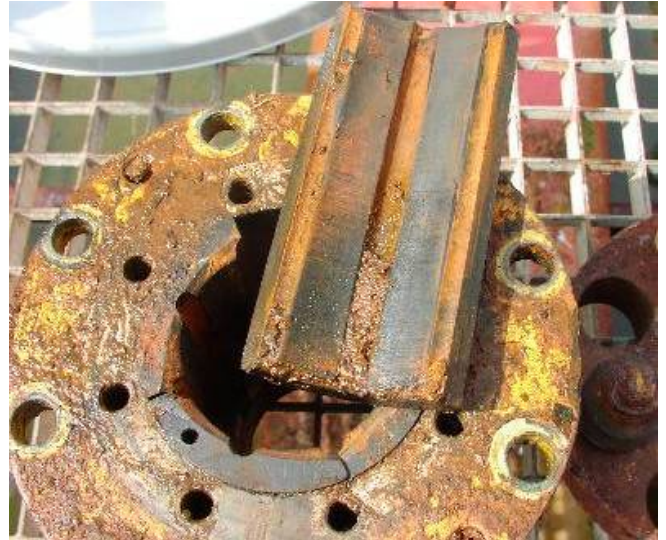
- 1.8. rubber bearing:
good condition, but water grooves approx. 30% filled with rust particles and dirt.
Reason: too much rust and dirt in lubricating water, too close gap of the labyrinth seal underneath the bearing.

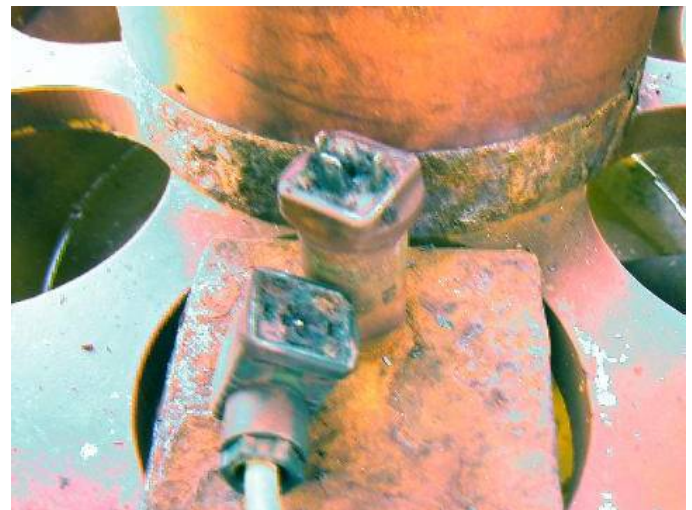
- 1.9. lubricating water level sensor:
sensor and connector destroyed by corrosion, mounting plate heavily corroded.
Reason: unsuitable material of mounting plate, possibly poorly installed sealing on connector, lack of protection.

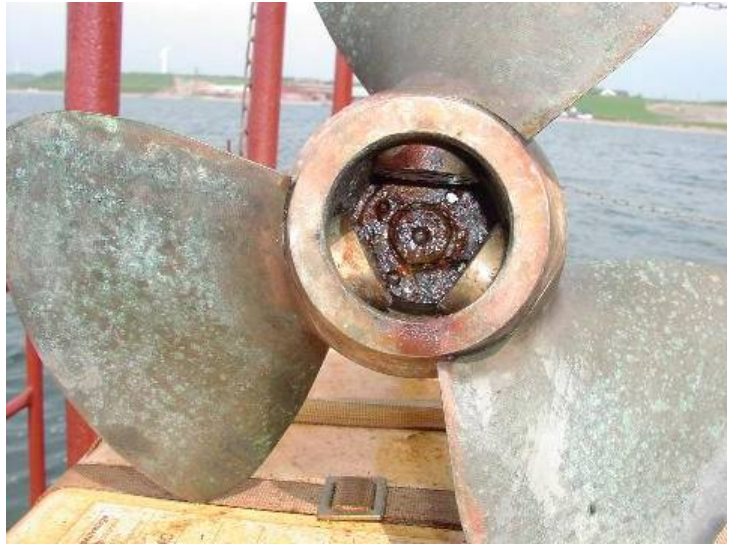
- 1.14. turbine runner:
fair condition, slight corrosion on runner blades. Hub cone missing, thus corrosion inside hub.
A closer analysis revealed that Promecon obviously have not bothered to fit the turbine cone at all. They also fitted a normal steel washer to hold the hub instead of a stainless one, which gave corrosion problems.

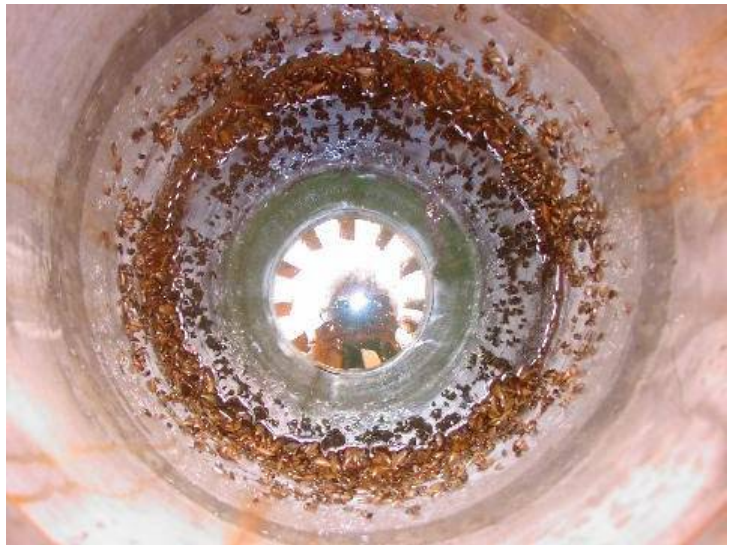
- 1.15. draft tube:
good condition, some marine growth (mussels) that were very easy to remove from the stainless steel surface.

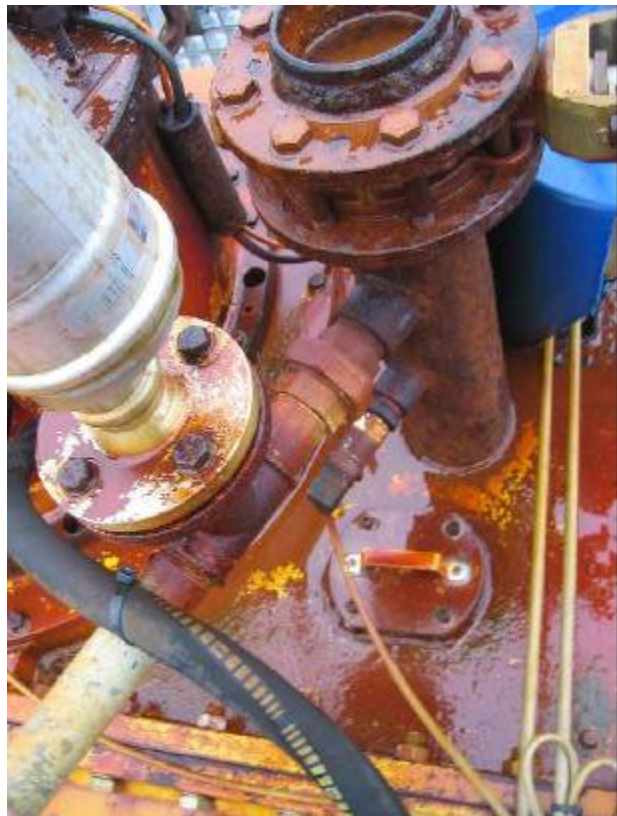
- 1.16. evacuation system:
- butterfly valve o.k.
- operating cylinder: seems defunct (sticking in end positions)
- water separation vessel: crack at top of pipe, loose piping
- evacuation dome (100mm pipe on turbine top): heavily corroded
- level sensor: cable poorly fitted but sensor still o.k.

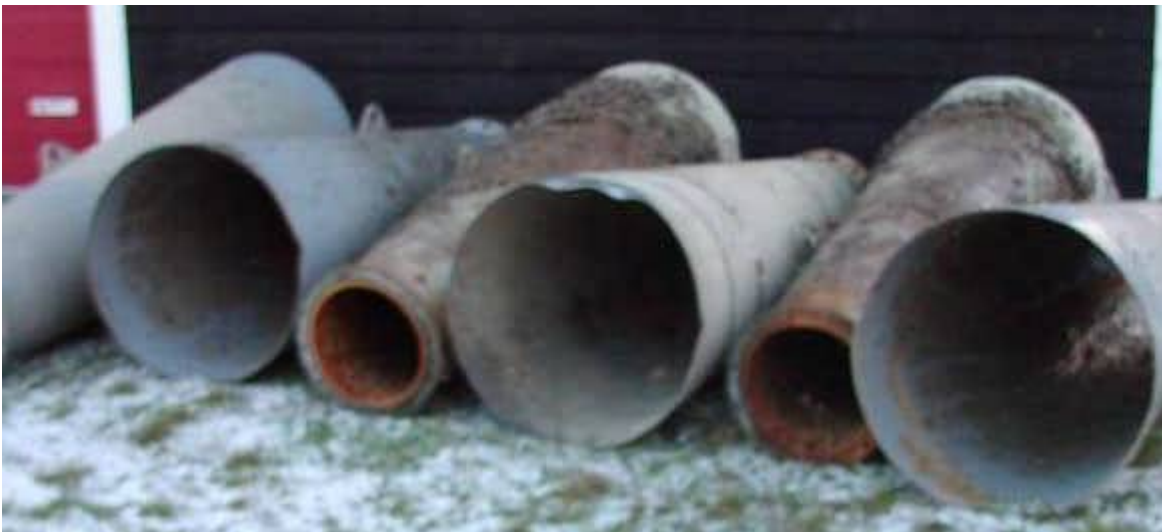
The draft tubes had, obviously due to the soft ground at the location of the stranding, only sustained minor damages, which are given in Tab. 3.1 and the following picture.

The draft tubes painted with the normal epoxy paint system were found heavily overgrown with marine growth; the layer being about 2 cm thick at the upper end and growing to 7 cm at the lower end. The tubes painted with the Hempel anti-fouling paint were found almost clean, with only a few mussels stuck to them that could easily be removed by hand. Interestingly this applies also to turbine No. 3, which had not been run at all up to now. The pictures below show an epoxy painted and a Hempel painted draft tube in comparison. The growth has already collapsed a bit as the pictures were taken after leaving the tubes out in the winter weather for one day.

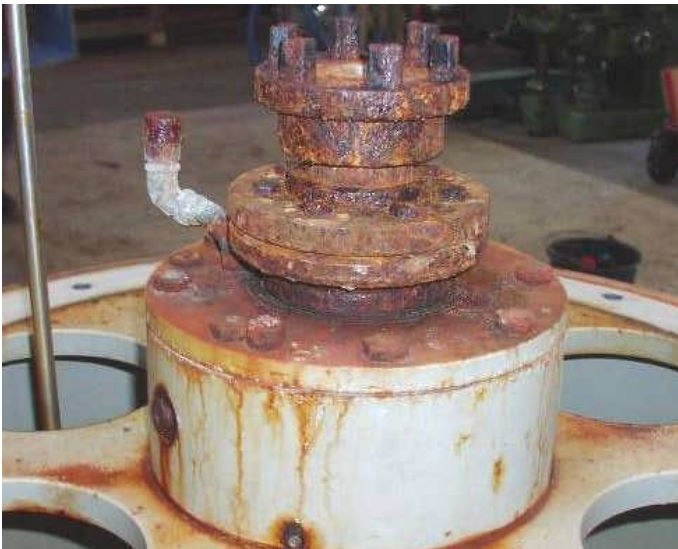
In dismantling, no damages due to the stranding have been found, but the corrosion damages to the thrust bearings and generator and sand filling to the radial bearing were as expected.

thrust bearing assembly turbine no. 3

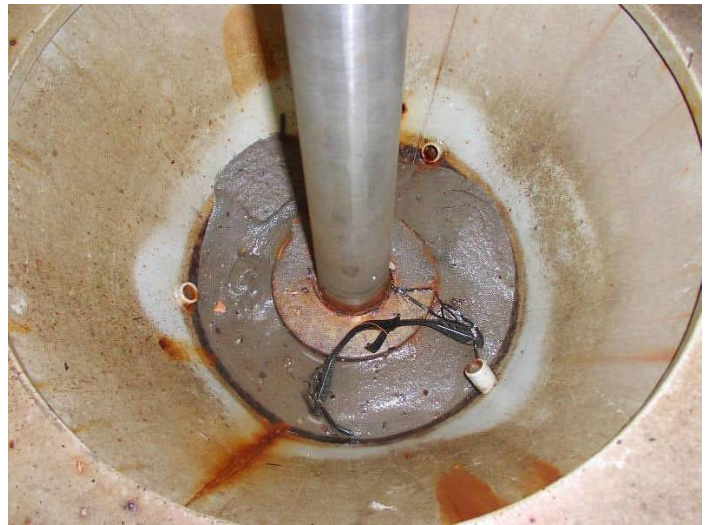
rubber bearing assembly turbine no. 3

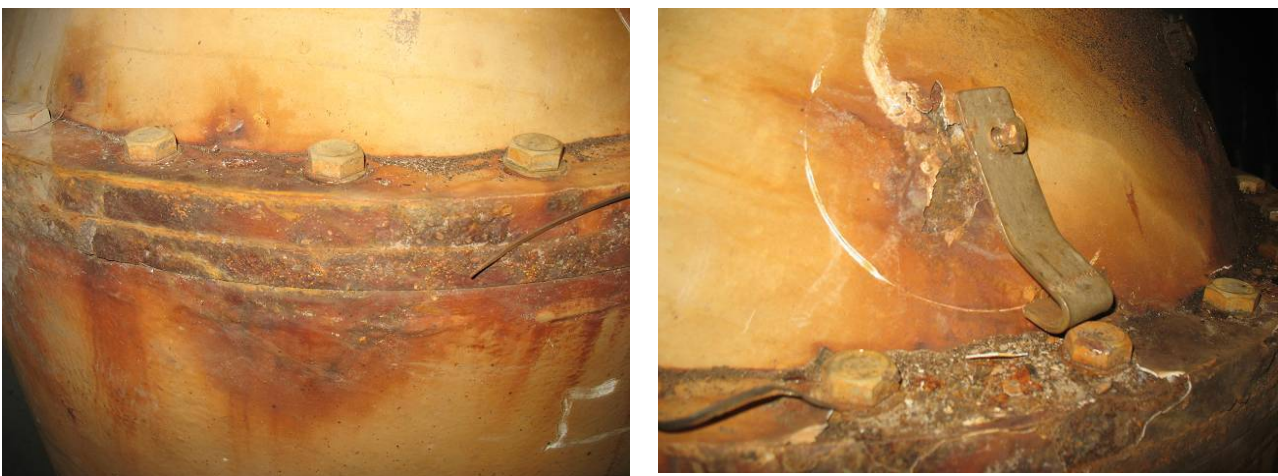
fig. 7: cylinder gate - corrosion on edges and connection bolts

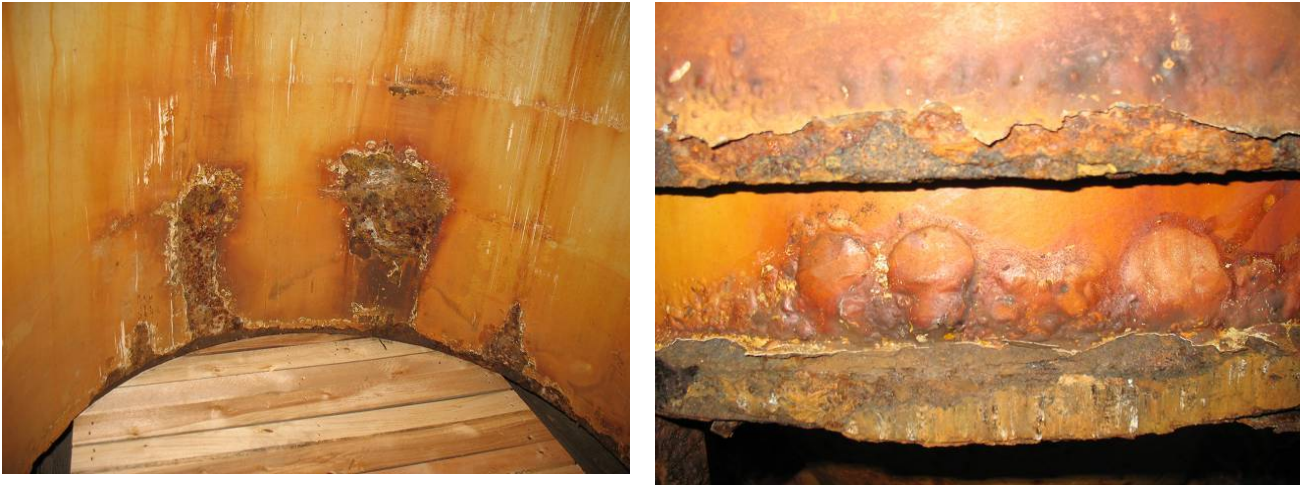
fig. 8: cylinder gate – corrosion on lower edge

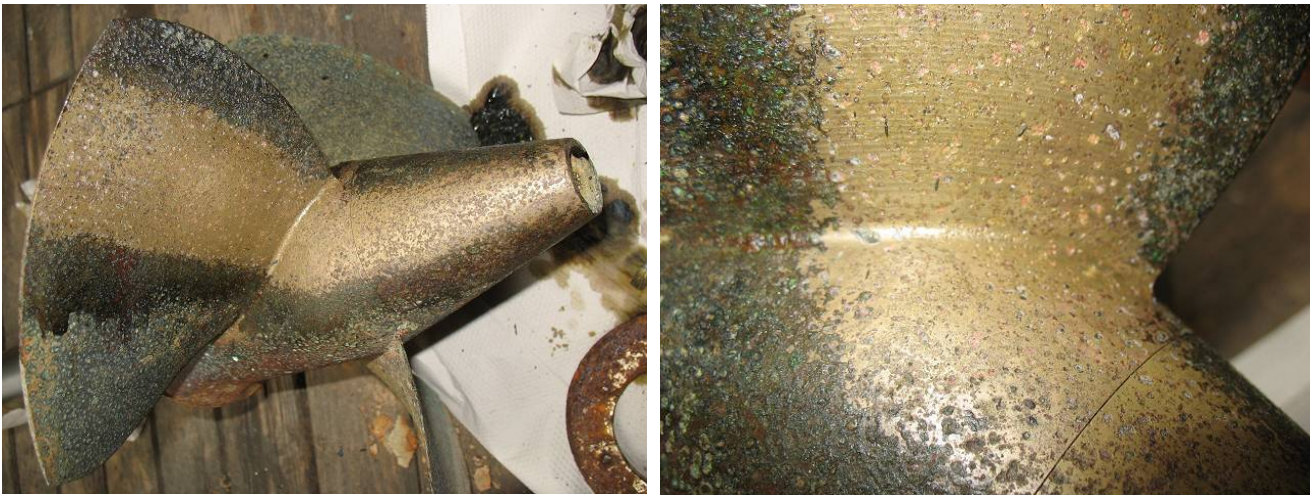
fig. 34: corrosion on turbine runner

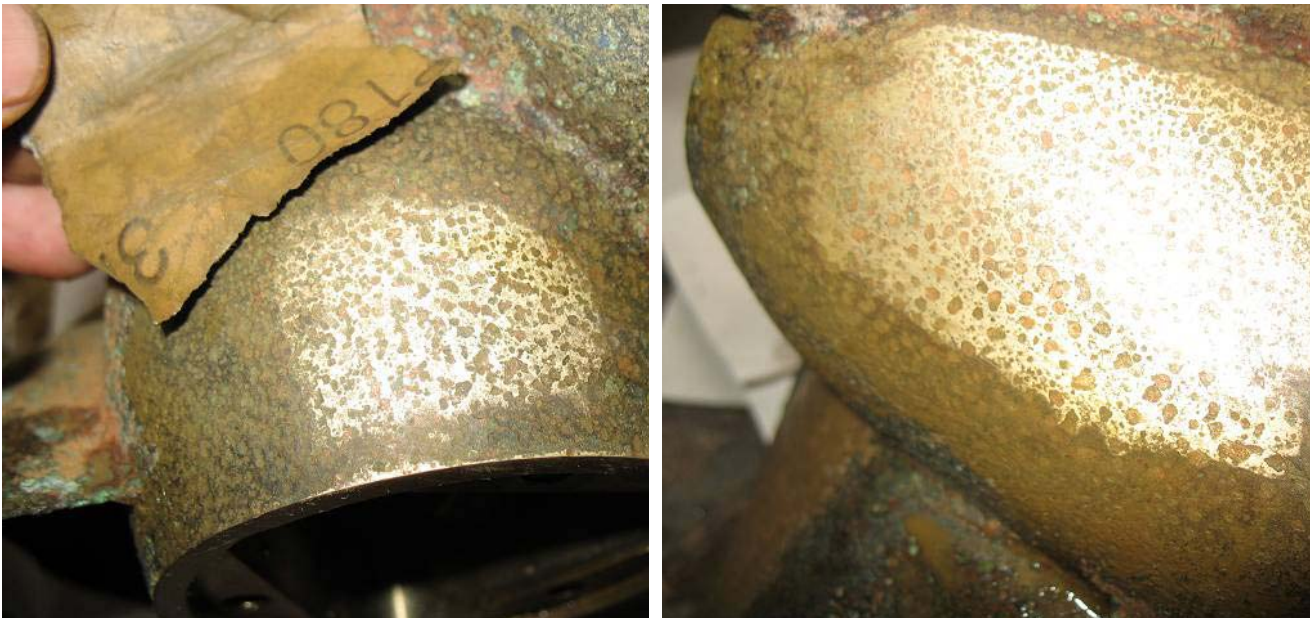
fig. 35: corrosion on turbine runner

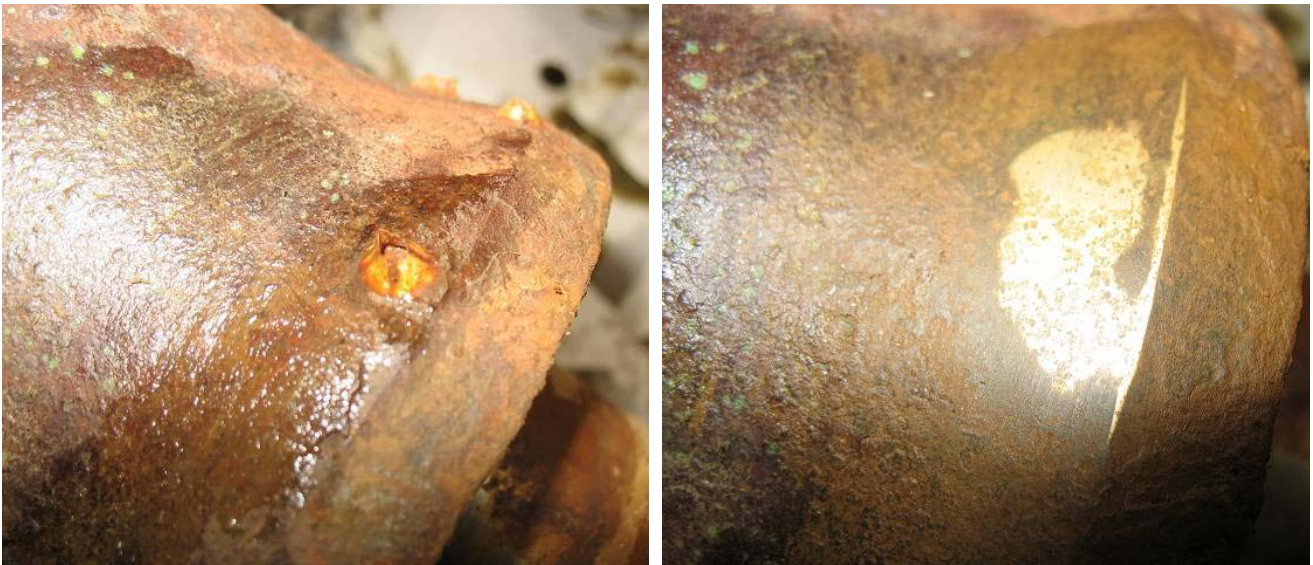
fig. 36: corrosion on turbine runner

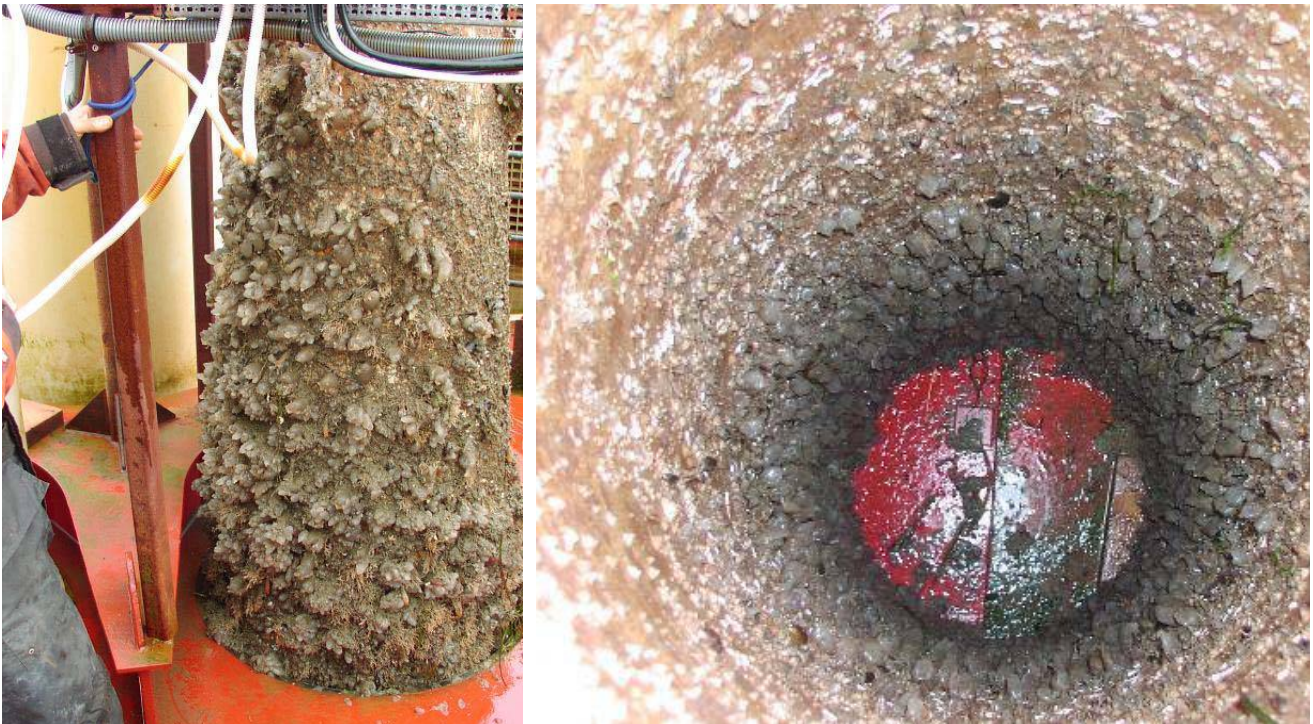
fig. 39: growth on epoxy painted draft tubes, outside and inside

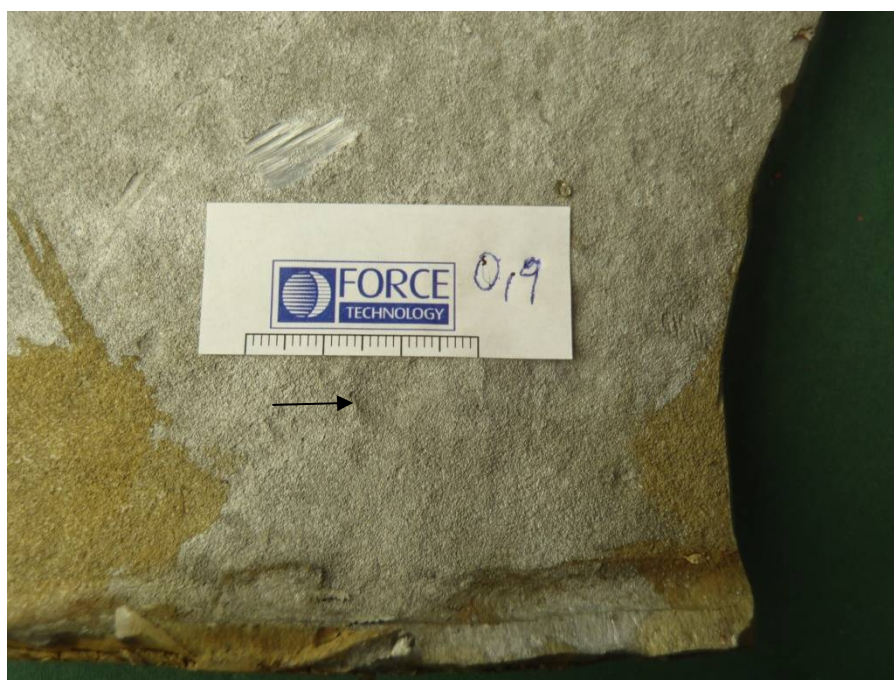
Figure 15 Pitting/localised corrosion 0.9 mm deep in sample ? after acid cleaning.
