Root Area Transition Zone – RATZ and Reduction O&M cost of WT blades

EUDP project 64015-0602 – Final Report

Date: 01-02-2019

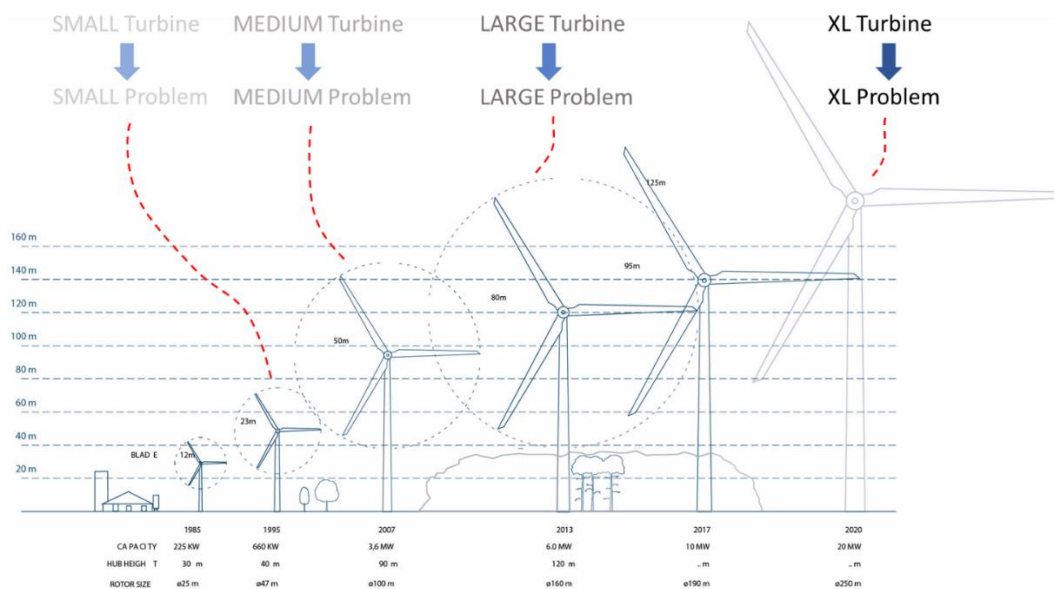
Figure 1: As blades grow in size the structural failure modes become rapidly more critical.

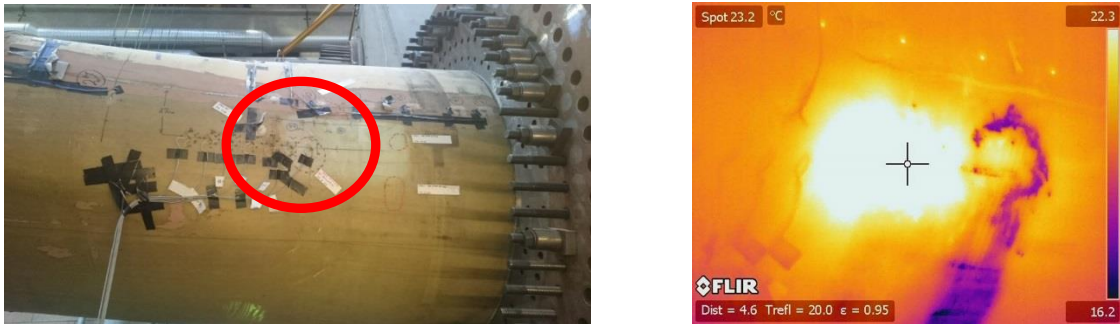
Figure 4: Left: Damage on the SSP34 blade, observed by visual inspection. Right: Thermographic photo of the same damage. The temperature at the damage location has been greatly increased.

Together with LM Wind Power and Blaest (Blade test center in Aalborg, Denmark) Bladena has carried out a full-scale test on an SSP34m blade and an LM58.7m blade with edgewise fatigue loads [4] [6]. The first blade to be tested was the SSP34m blade and in Figure 4 the damage developed during test in the Root-Transition zone can be seen.

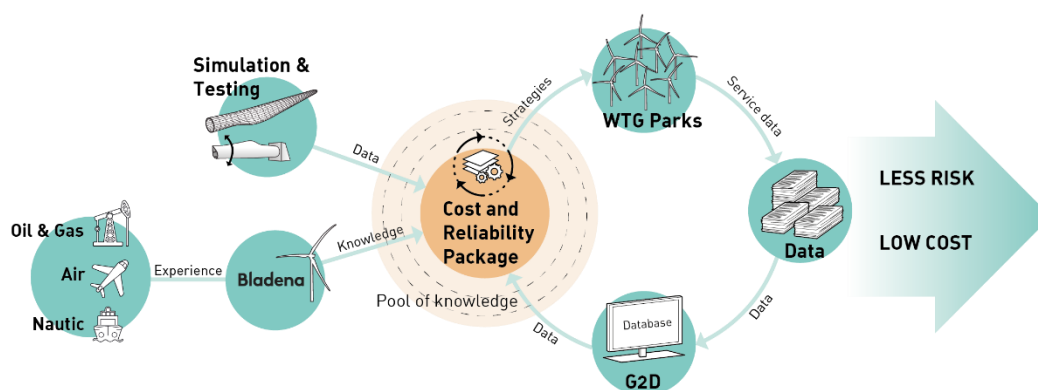
Figure 8: The motivation behind the Cost and Reliability package. A specific issue can have different solutions and strategies to obtain the best outcome in terms of technical but also cost efficiency. The development of the package aims to process an issue with respect to technical assessment and cost and risk performance, in order to offer the user an optimized strategy both in technical terms but also in cost and risk.

Defects and damages in the transition zone may during operation develop and ultimately result in failures requiring exchange of the blade. Proactive and preventive inspections and maintenance can be a cost-effective approach to mitigate defects and damages. With the aim to develop methods and tools to minimize the costs for inspections, maintenance, repairs and replacement of wind turbine blades, the work in the Cost and Reliability work package has mainly been related to the package 'Optimized cost and risk solution' as illustrated in Figure 8.

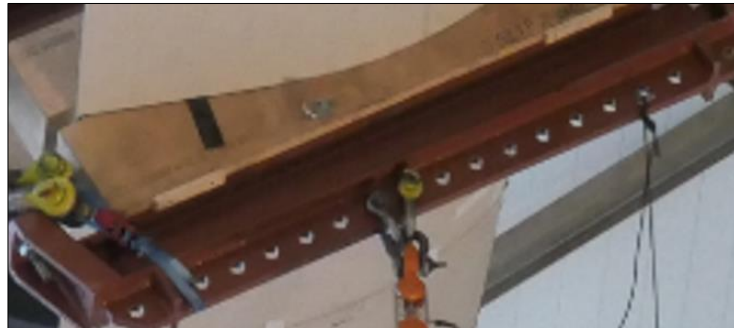
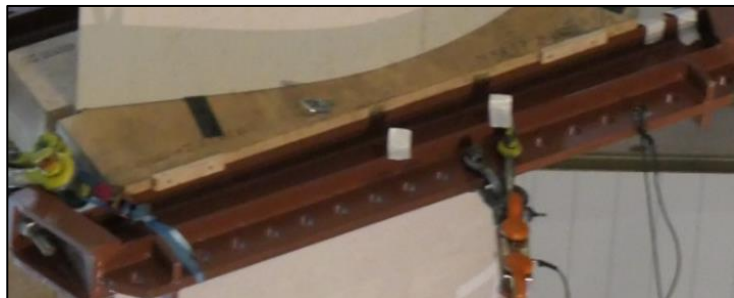
Offset load application:

Figure 29: The same test was performed with and without and offset of the load application point towards trailing edge. In the figure is shown the wooden clamp at 49m from blade root with the two different load applications.

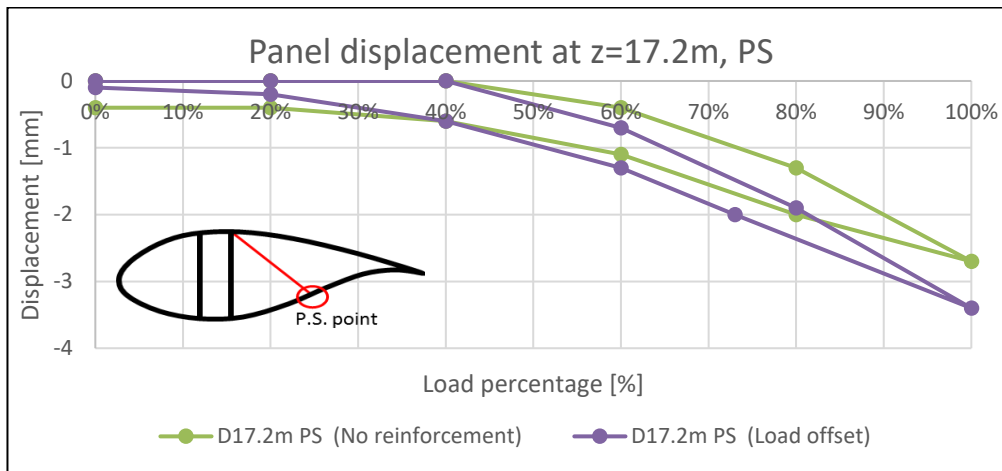
Figure 30: Effect of the load offset on the resulted deformation of the pressure side panel.

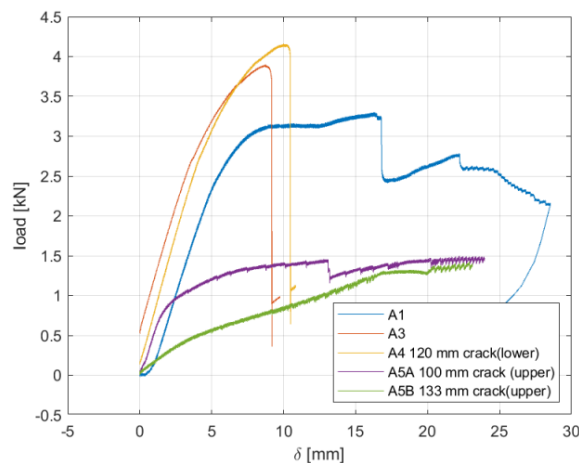
Figure 36: Static load four-point bending tests on SSP34 specimens, highlighting the loss in bending stiffness due to increase in the debonded area at the upper face having a net compressive load. Note that a crack in the lower face loaded in tension (A4) does not influence the behaviour of the beam and is equivalent to the pristine condition (A3).

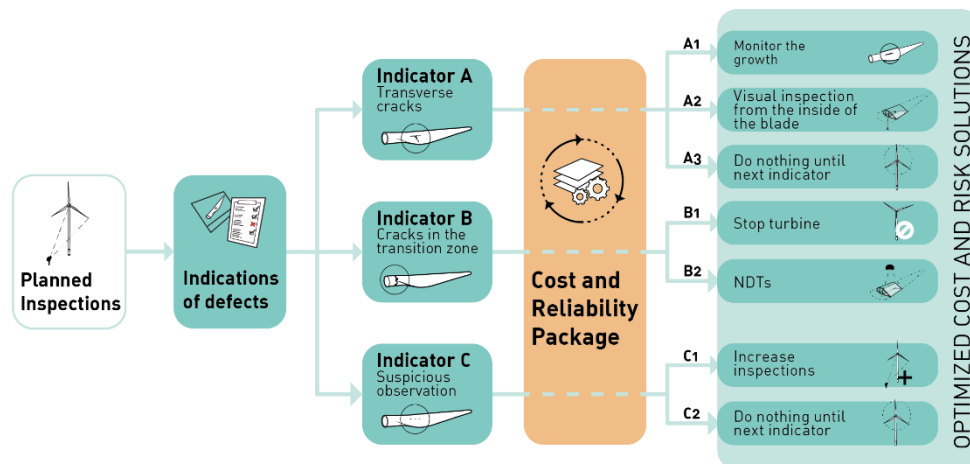
Figure 43: Data obtained through planned inspections lead to different defect indicators. However, a defect indication does not contain information regarding how severe the specific damage is. The cost and reliability package, through the different technical modules and probabilistic models, “filters” the various indicators and different actions are obtained depended on the severity of the damage.

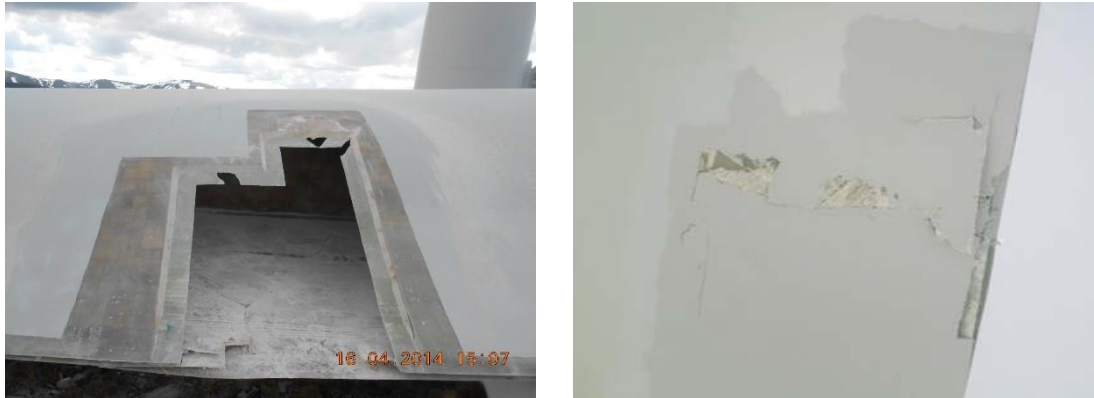
Figure 55: Extract of a blade inspection report showing transverse cracks in the max chord region on an infield wind turbine blade.
