Final report

Project title	Methane emission from Danish biogas plants
Project identification (program abbrev. and file)	2013-1-12093
Name of the programme which has funded the project	ForskEL
Project managing company/institution (name and address)	AgroTech A/S Agro Food Park 15, 8200 Aarhus N
Project partners	Dansk Gasteknisk Center
CVR (central business register)	30589335
Date for submission	24.06 2015

1.2 Short description of project objective and results

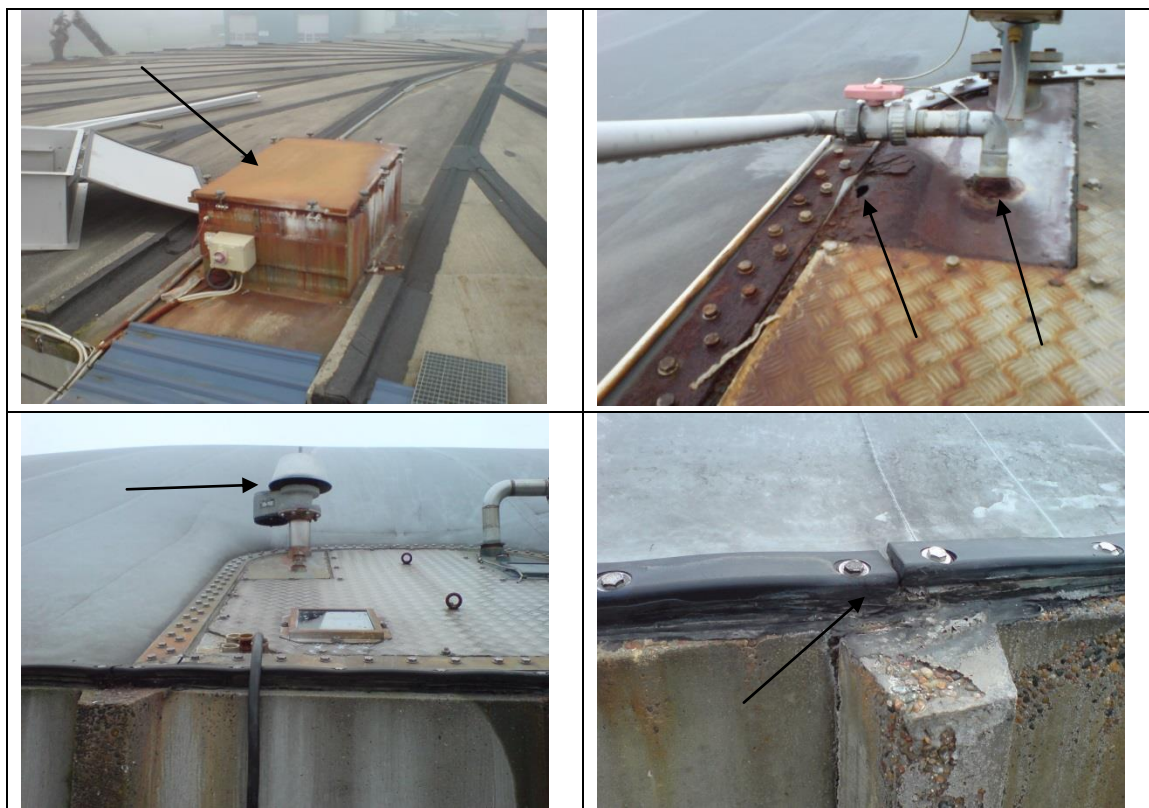
In total more than 50 leaks were identified at 9 of the 10 biogas plants inspected (Table 2). One biogas plant owner decided to withdraw the plant from the project after the initial leak detection and results from this biogas plant are therefore not integrated in the project. The leakages were found to vary considerable in type, design and location. See examples in Figure 2.

Figure 2. Examples of detected leaks. Top, left: Leakage through a box covering a mixer on the roof of a covered digestate storage tank. Top, right: Leakage through a hole in a covered digestate storage tank. Bottom, left: Leakage through a pressure safety valve. Bottom, right: Leakage through the assembly between the concrete wall and the membrane roof at a digestate storage tank.

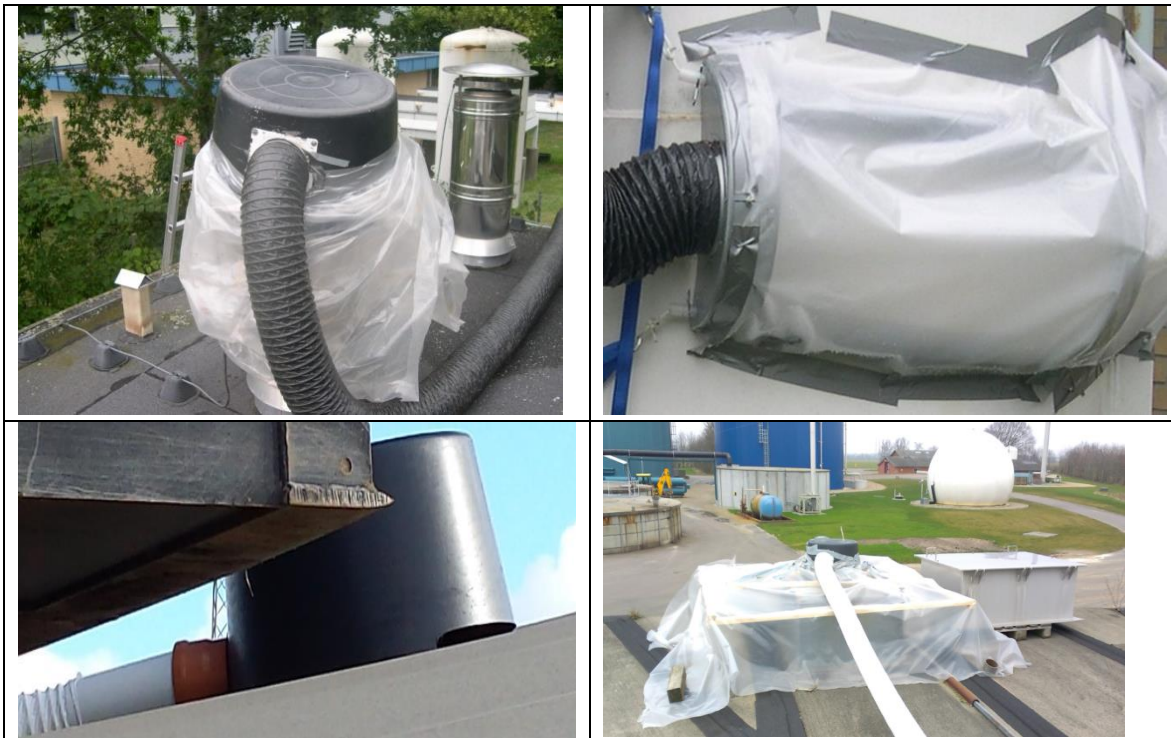
The sampling devices used in the study were partly open to the surroundings to prevent that a pressure drop inside the sampling device affected the leakage of methane from the methane source. The sampling devices were designed for the different type and designs of the leakages and its surroundings. Various types of sampling devices were therefore developed and taken into use (Figure 4)

Figure 4. Examples of sampling devices suited for measuring methane leakages. Top left: Sampling device suited for leakages from pressure relief safety valves. Top right: sampling device for measurement of a leakage on a curved surface. Bottom left: sampling device for sampling a leakage in biogas digester cover. Bottom right: Sampling device designed for measurement of methane emission from a mixing pump cover box situated above a digestion tank.

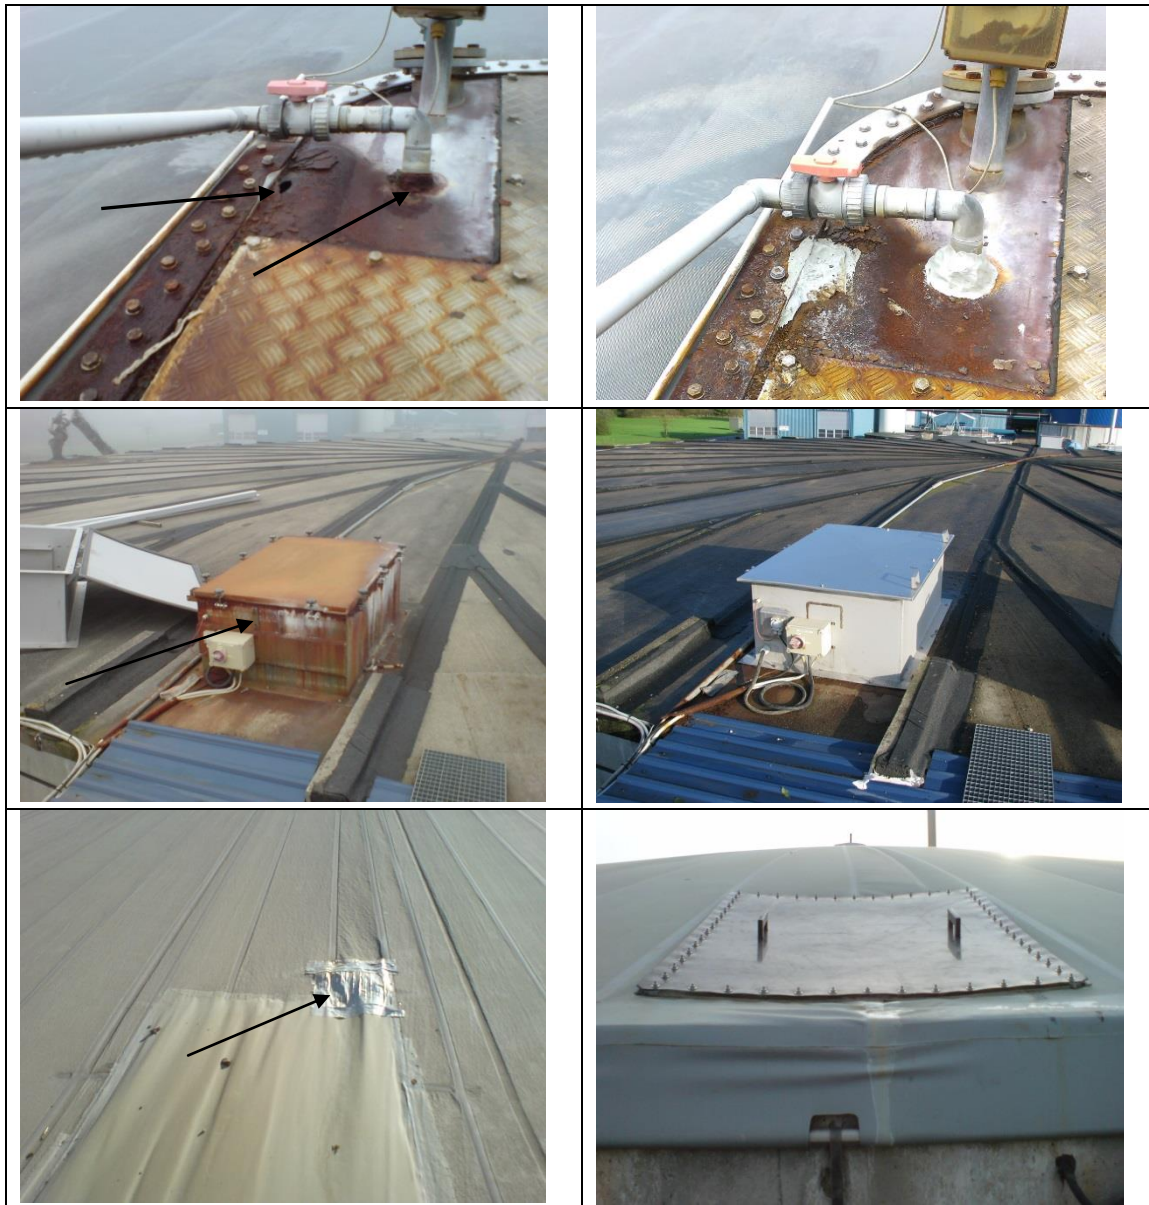
The repair of identified leakages were conducted differently ranging from very quick and cheap to more expensive and time consuming solutions (Figure 5). Most leaks that were considered relatively easy and cheap to repair were repaired. Only a few leaks were not repaired, primarily leaks through assemblies.

Figure 5. Examples of leakages repair. Top (left): Leakages identified at the cover of a digestate storage tank. Top (right): The identified leakages after being repaired with sealants. Middel (left): A leaking box covering a mixer situated on the roof of a covered digestate storage tank. Middel (right): The covering box was later replaced by a new box. Bottom (left): Leakage in a membrane covering a digestate stor- age tank. Bottom (right): The membrane was later replaced by a new membrane.

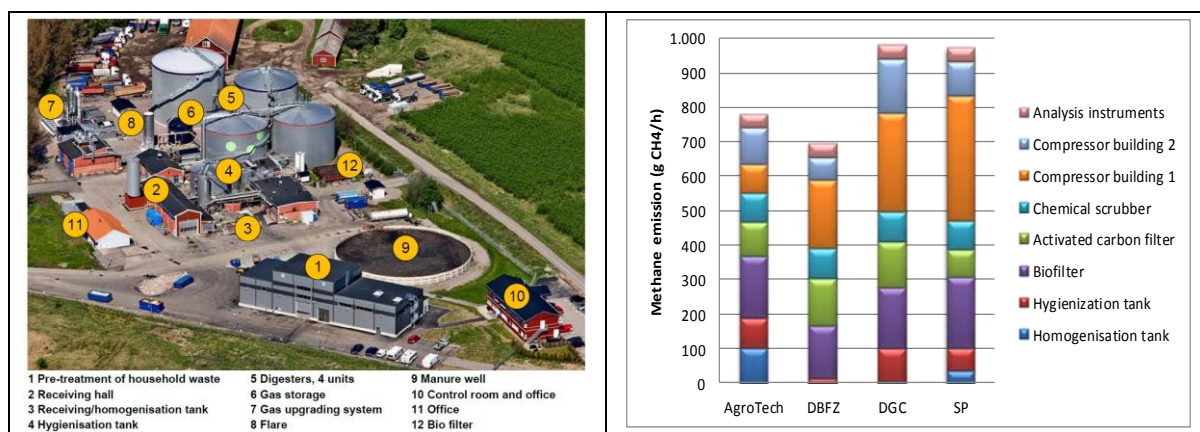
The conclusion of the comparison measurements in Linköping was that the general results from different methods and approaches involved in the comparative study are comparable (Figure 6). The total methane loss reported by the on-site measurement teams range between 0.6 – 1.1 % of the total methane production at the studied biogas plant. There were many and unknown uncertainties in all measurement results and they were due to both analytical uncertainties and time variation in emission sources.

Figure 6. Methane emission sources at Linköping biogas plant, and comparison of estimated/hypothetic emission levels measured by the four different institutes measuring on-site at the different methane emission sources.
