# Final report

<b>Project title</b>	Energy efficient comfort in older apartment blocks
<b>Project identification (program abbrev. and file)</b>	64013-0574
<b>Name of the programme which has funded the project</b>	EUDP
<b>Project managing company/institution (name and address)</b>	DTU Byg, Brovej Building 118
<b>Project partners</b>	Dresden University, Rönby.dk, Ekolab, E&P service, Kingspan, Introflex, Airmaster, Nilan
<b>CVR</b> (central business register)	30 06 09 46
<b>Date for submission</b>	08. September 2016

## 1.2 Short description of project objective and results

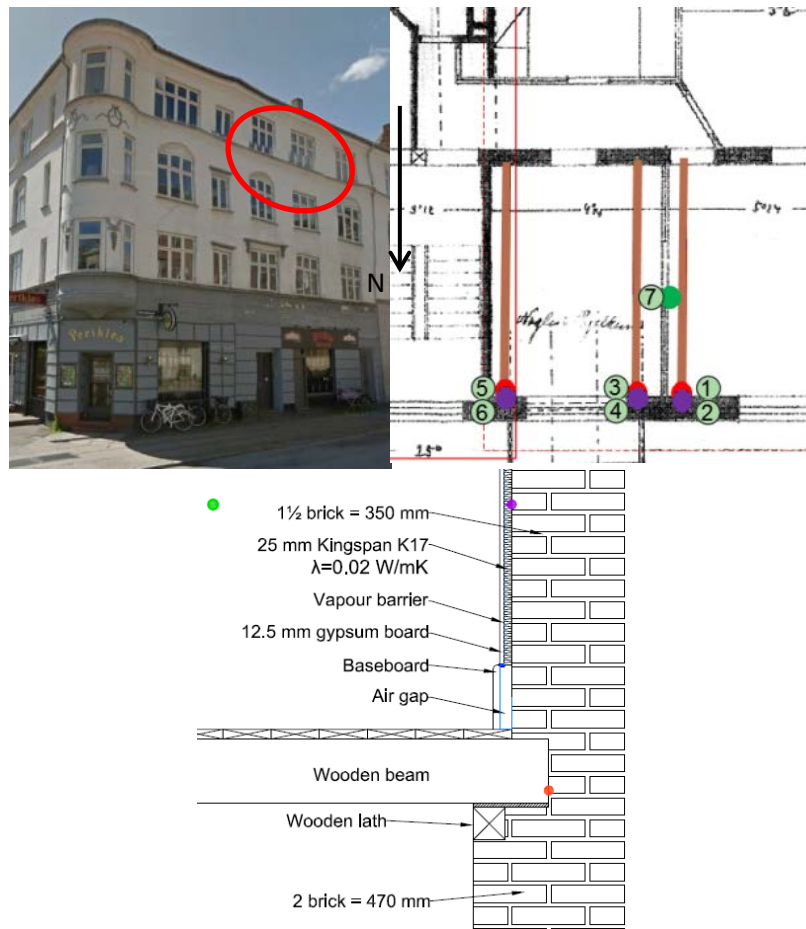
Kildevældsgade 69, Copenhagen, seen in Figure 4, is a residential building from 1905, with embedded wooden beams, and a rendered façade. In March 2015 internal insulation, 25mm Kingspan K17 (20 mm for infill walls), and a vapour barrier was installed on the northern façade on the 3rd floor. A 20 cm air gap was left above the beam in order to achieve higher temperatures at the beam end. The sensor placements and the structure are seen in Figure 4. Sensor 7 represents interior conditions, while sensors 2, 4 and 6 represent conditions at the interface between insulation and the existing wall, and sensors 1, 3 and 5 represent conditions at the beam ends. Only the upper apartment was insulated, hence higher temperature in the beam ends are expected compared to if both upper and lower apartment was insulated.

Figure 4: Kildevældsgade and indication of wall placement (left), sensor placement on floor plan (middle) and construction with sensor placement (right)

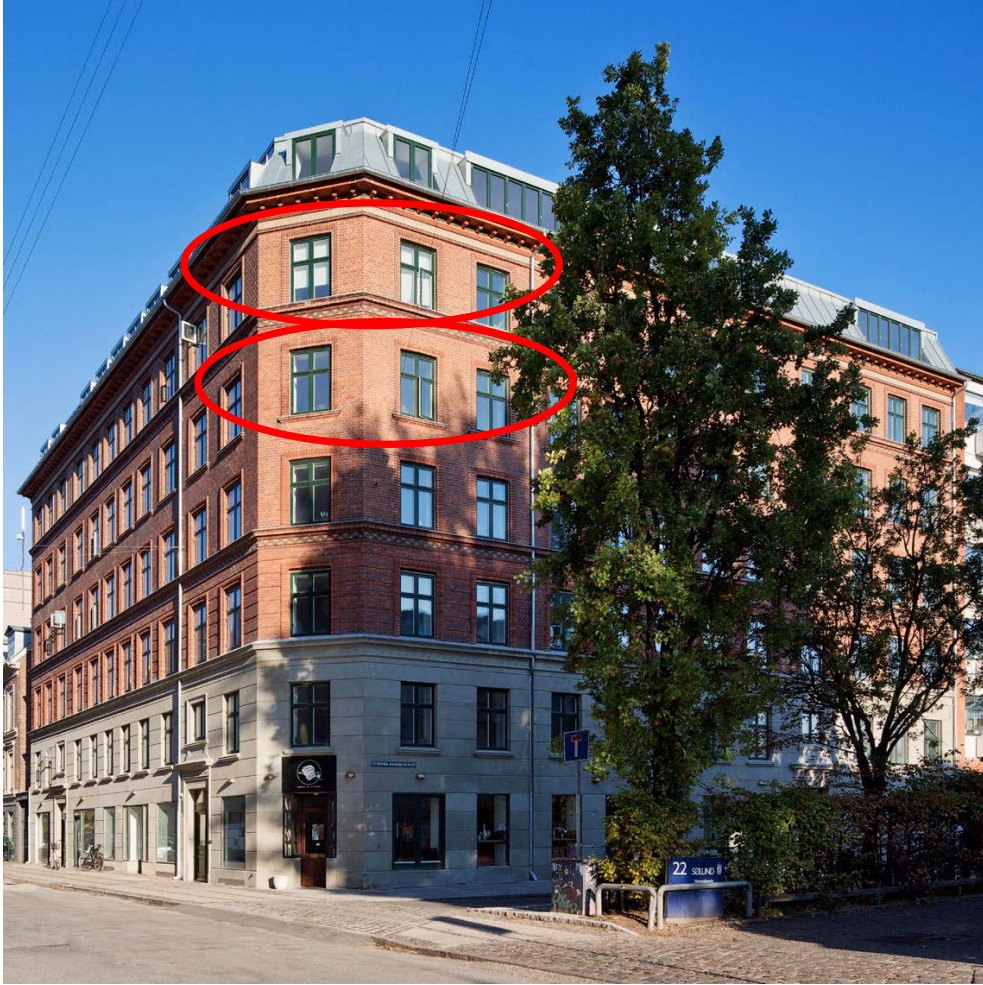
From the previous EUDP project: “1:1 demonstration af koncepter til renovering af ældre etagebygninger til lavenergiklasse 1”, measurements were carried out in Ryesgade on the 4th and the 5th floor in the corner apartments with orientation as seen in Figure 9. Also from Figure 9 the measuring points in both apartments can be seen. As seen the insulation is stopped 200mm above the floor construction in order to create a thermal bridge so that the beam ends have higher temperatures and thereby lower relative humidities. More details about the building can be found in the final report of the EUDP project: “1:1 demonstration af koncepter til renovering af ældre etagebygninger til lavenergiklasse 1”.

Figure 9: Measuring points from Ryesgade 30.

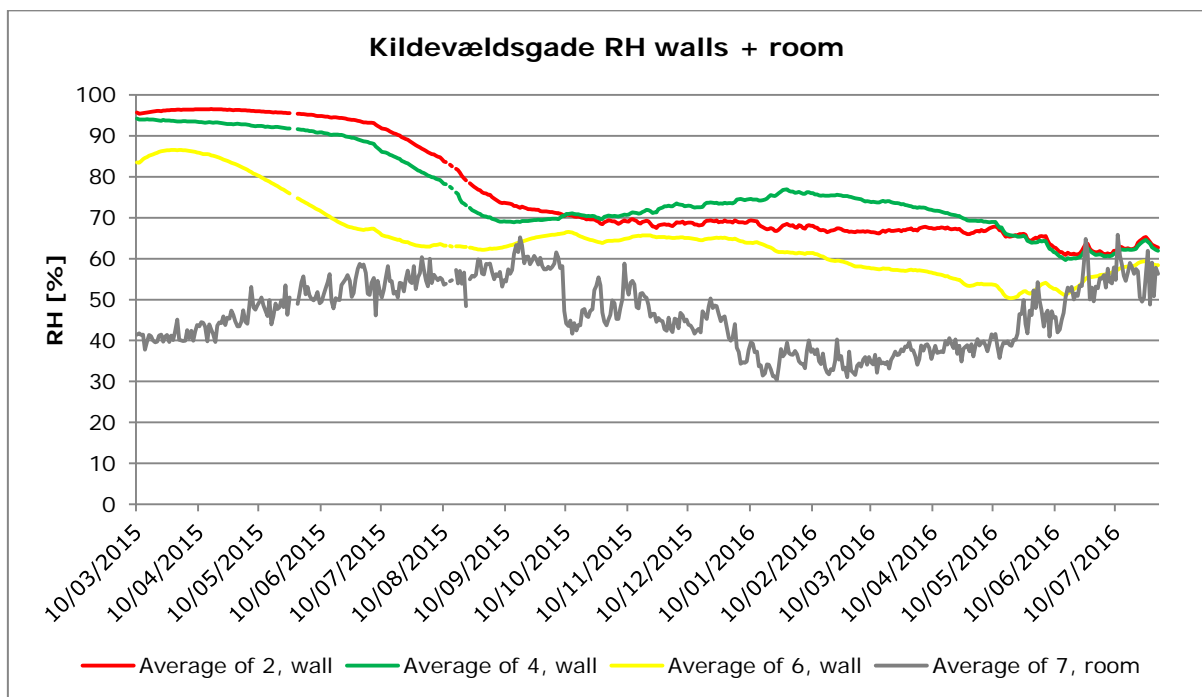
Figure 16: Relative humidity measurements in Kildevældsgade, at interface between internal insulation and existing wall, as well as room conditions

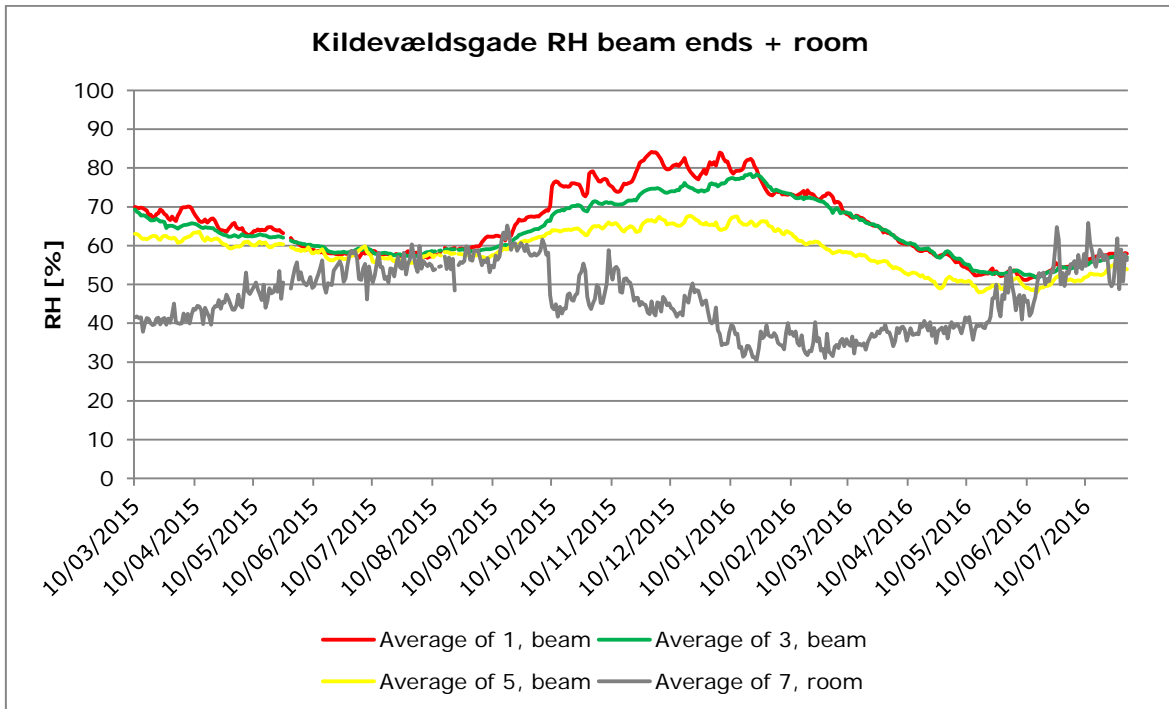
The relative humidity measured in beam ends at Kildevældsgade, seen in Figure 18, appear to be at acceptable levels during the measuring period from March 2015 - April 2016. The values generally vary seasonally between 50-80% - only sensor 1 exceeds 80 % slightly for short periods during winter. It is seen, that sensor 5 has the lowest relative humidity, and highest temperature, Figure 19, which again could be assumed to be caused by the hot water pipes. In this case, the temperatures in the beam appear to be slightly higher when compared to the wall-insulation interface. Despite the lower story not being insulated, the air gap installed may have the desired effect in this case.

Figure 18: Relative humidity measurements in Kildevældsgade, at beam ends, as well as room conditions

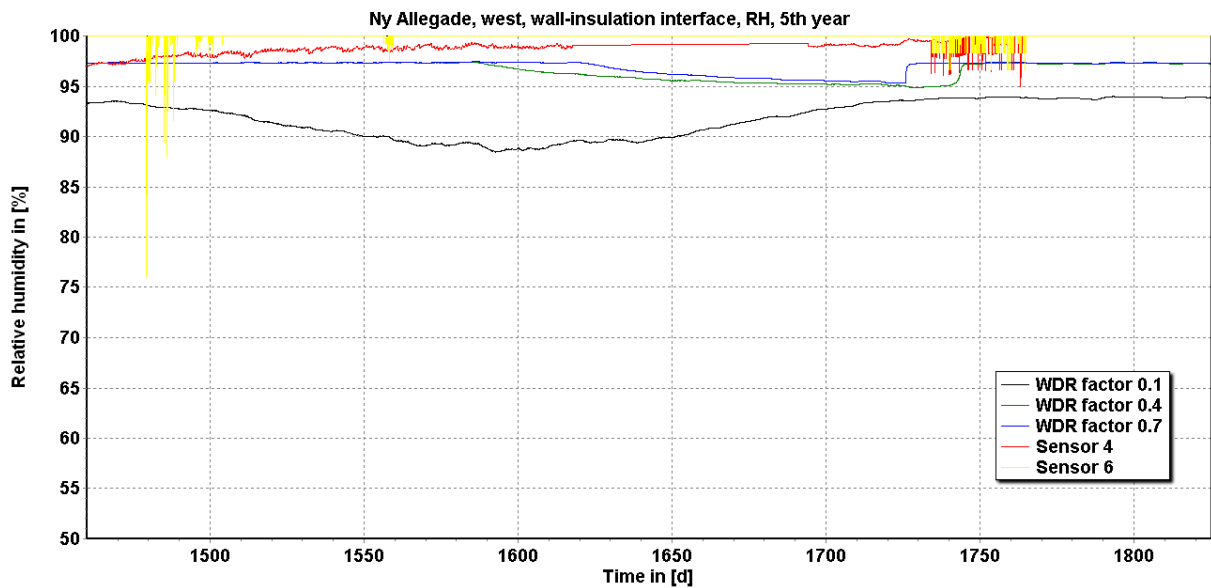
Figure 51: Relative humidity measurements and simulation results for west wall-insulation interface in Ny Allegade

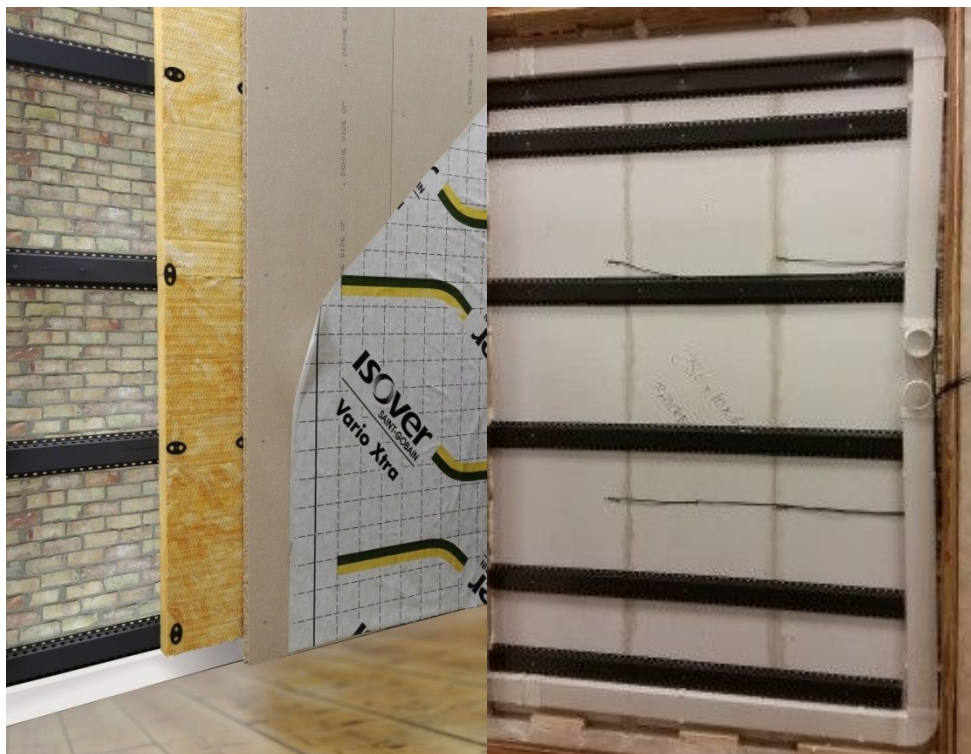
**Figure 19: Isover RetroWall, left) showing all layers and right) the ducting**

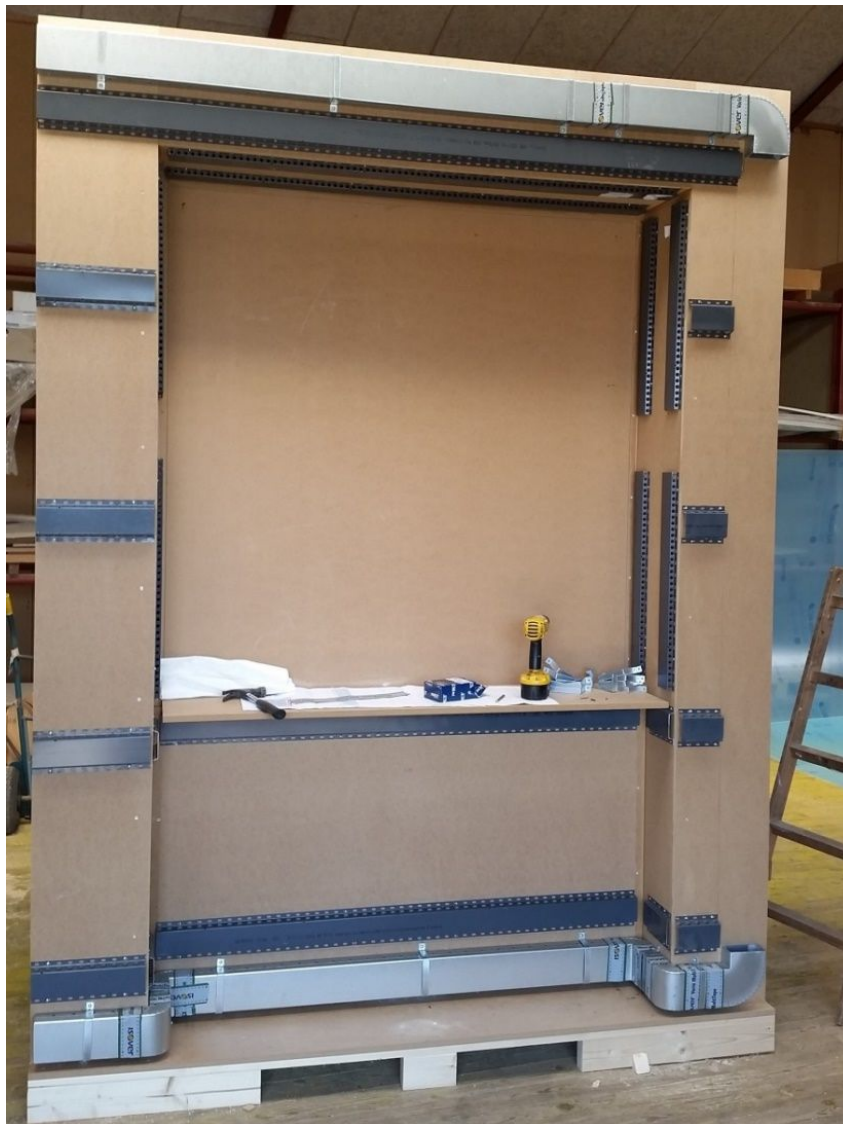
**Figure 42: Mock-up test constructed by Isover**

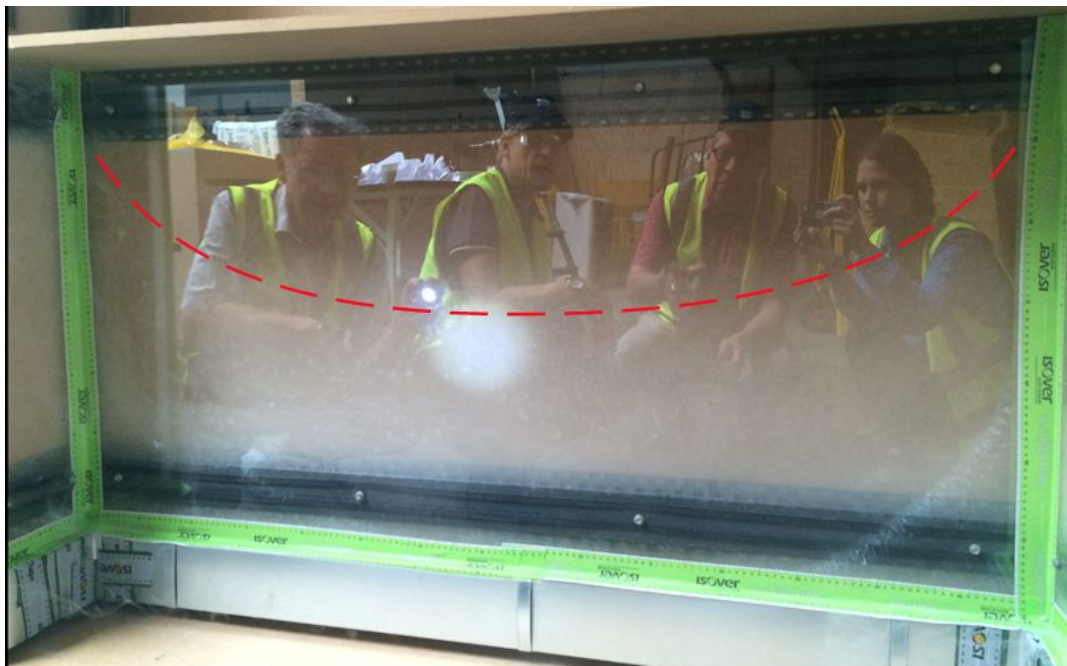
**Figure 48: Movement of air beneath window visualized with smoke test**
