Wave Dragon Prototype

Tilstandsvurdering **BILAG**

Energinet.dk projektnummer 6459

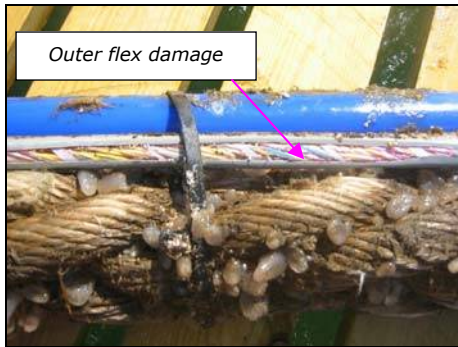
Fig. 2.1 Damaged original signal cable

A new signal cable from the main body of WD to the mooring pile was installed (06.08.03) in light of the excessive damage to the original cable as can be seen in Fig. 2.1. The complete cable under water has been mounted in a PEL pipe for extra protection.

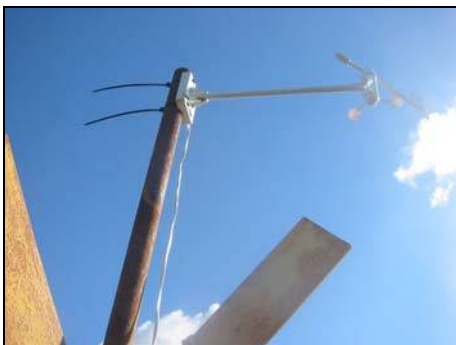
Fig. 2.3 Wind vane mounted on mooring pile

Some problems, however, were met in installing the weather station. Turbulence from the mooring pile was found to influence wind direction measurements. This was remedied by raising the height of the wind vane using some steel piping. Realignment of the wind vane followed with care being taken to minimize the influence of the high voltage cable and steel pipe on compass readings.

Additionally, wind vane alignment should be validated in terms of known direction (fixed point on the horizon) or possibly the use of GPS.

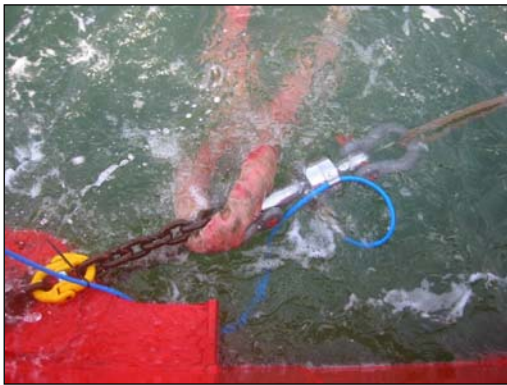
Fig. 2.7 Force transducer as originally installed

A force transducer was installed in the wire between the reflectors at the time of re-installation of the same (see Fig. 2.7). However, despite efforts to protect the force transducer wiring with a tube, the wire was broken within two months of installation (see Fig's 2.8 & 2.9). The transducer has since been repaired.

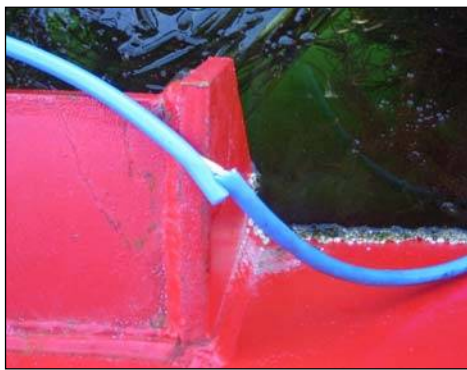
Fig. 2.8 Force transducer tube damage

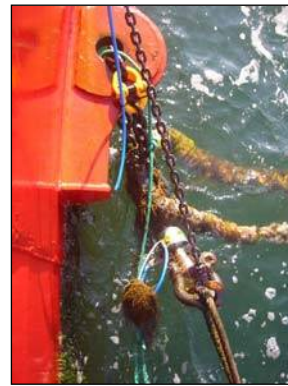
Fig. 2.9 Force transducer wire failure

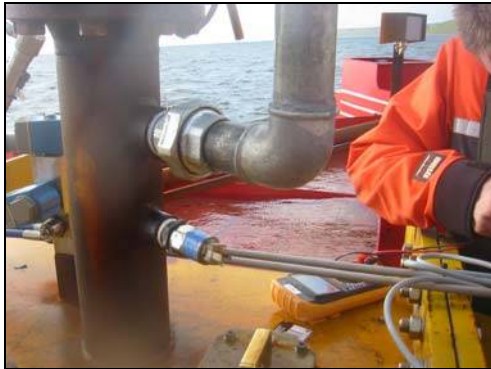
- Water level switches required for identifying water in aeration tube (see Fig. 3.1) and lubricating water in siphon turbine (See Fig. 3.2).

Fig. 3.1 Aeration tube water level switch installation

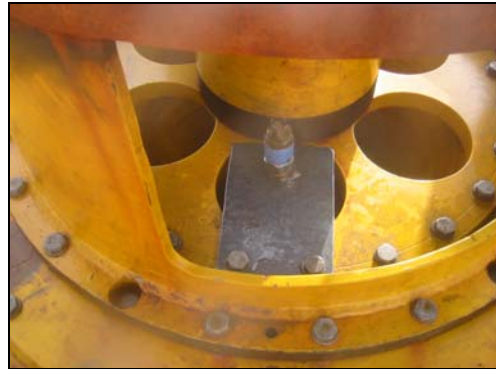
Fig. 3.2 Siphon turbine water level switch

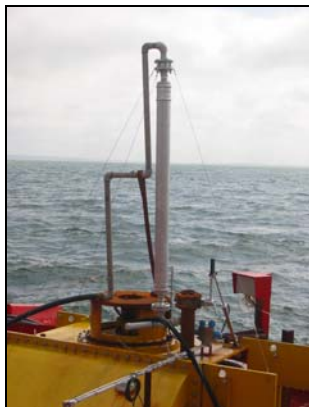
- Large diameter pipe in aeration tube to avoid water in the vacuum pump (See Fig. 3.3).
- Debris collecting at the dummy turbines in cases of heavy overtopping, preventing operation of same. This problem will be eliminated with the planned inclusion of mesh fence to be placed all around the turbine area prior to the start of operation of the cylinder gate turbines.

Fig. 3.3 Large diameter pipe installed in aeration tube

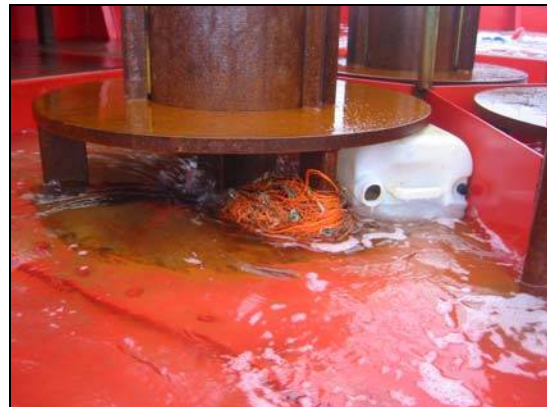
Fig. 3.4 Debris collecting at the dummy turbine cylinder gate

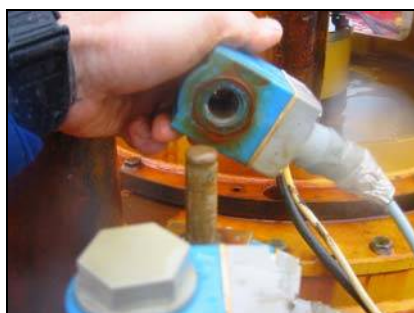
- Intrusion of saltwater in solenoids controlling the hydraulic pistons in the turbines. This has on more than one occasion lead to malfunction of the pistons. Some kind of shielding of these units is necessary.
- Corrosion of black steel dummy turbines. More on that below.

Fig. 3.5 Saltwater corrosion of solenoid (23.06.03)

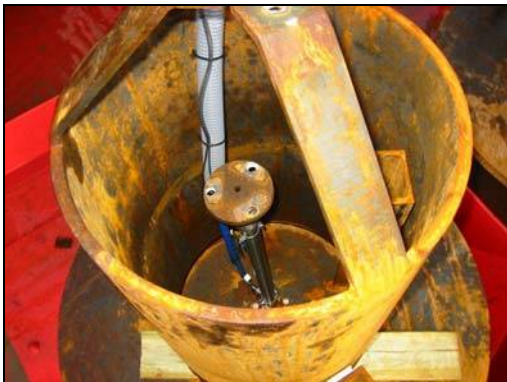
The adverse effects of sea conditions on the operational integrity of WD has nowhere been more noticeable than in the functioning of the dummy turbines. It is interesting to compare the depreciation of the turbine gate material (black steel) over the five month period at sea. Fig. 3.6 shows the dummy turbine shell after deployment in late March. In contrast, the severe erosion of the annular ring of the turbine gate through which the shell slides is clearly evident four ½ months later.

Fig. 3.6 Dummy turbine condition (31.03.03)

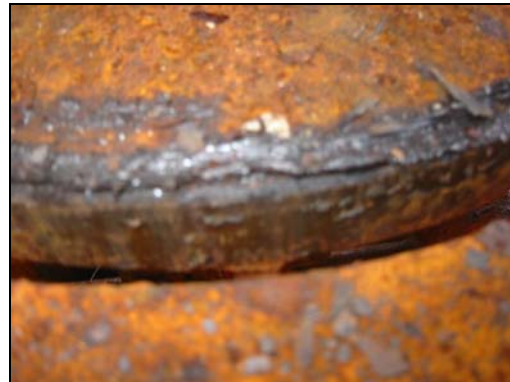
Fig. 3.7 Severe erosion of dummy turbine gate (11.08.03)

As a result of this erosion, two of the three dummy turbines jammed. In addition, the hydraulic cylinder in one of the turbines was damaged (bent) in the process of attempting to move it. The cylinder was removed and has since been repaired at the workshop.

In light of these operational problems, dummy turbine re-conditioning work was carried out (15.09.03). All three turbine shells were extracted individually using the hoist shown in Fig. 3.8 before rust removal and treatment was carried out (Galvafruid and greased). The result is shown in Fig. 3.9.

This allowed the shells to open and close effectively. In addition, the re-conditioned hydraulic cylinder was installed in the appropriate turbine. All three turbines now operate satisfactorily. Doubts remain, however, as to the long term operating ability of same. Efforts need to be concentrated on improving the vertical guidance of the shells with a self-centering system preferred.

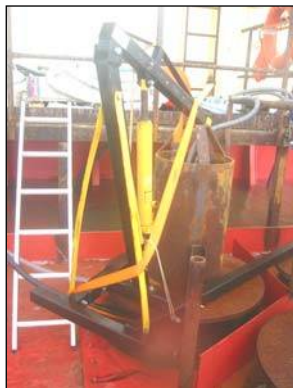
Fig. 3.8 Hoist used for dummy turbine removal

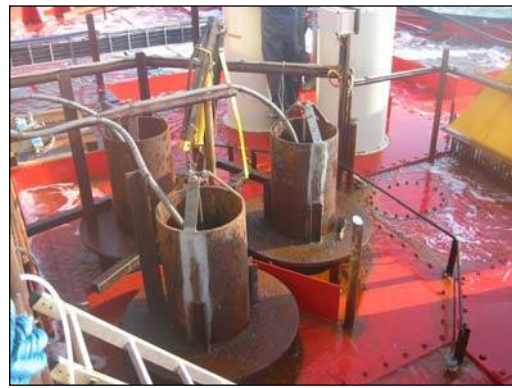
Fig. 3.9 Dummy turbines following maintenance

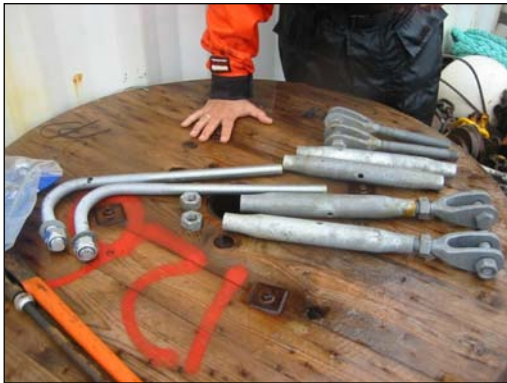
Another area of concern involves the wear of certain mooring lines due to contact with edges of the WD structure. A case in point is the wear of the mooring lines from the rear of WD to both reflectors on rubbing against the base reinforcement gusset's. This problem has been remedied by attaching some guide brackets to the main structure to deflect the ropes from the gusset's as can be seen in Fig's 4.1 and 4.2.

Fig. 4.1 Mooring equipment for deflecting lines from rear of WD

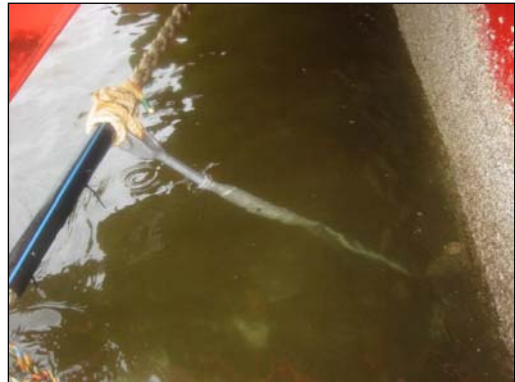
Fig. 4.2 Installed mooring attachments

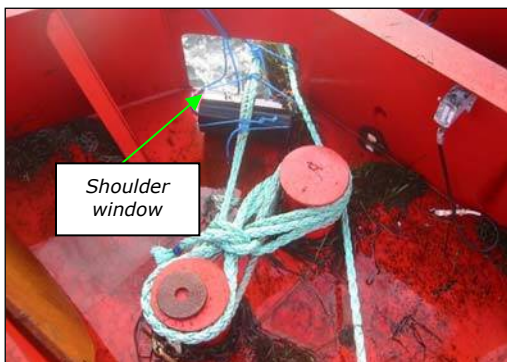
It is clear that, in the absence of appropriate mooring maintenance procedures, the stability of WD is severely jeopardised. Evidence of this has presented itself on more than one occasion. For example, it was noticed (19.08.03) that one of the ropes connecting to the main body (starboard side) had completely failed due to rubbing contact with the shoulder window on the main body.

Fig. 4.3 Rubbing at shoulder window

Chain has now been used for the section, on both port and starboard shoulders, near the bollards, to prevent this type of failure again (see Fig. 4.5). Note: Rounded edges are to be installed on the lower edge of the shoulder window to prevent steel-steel wear.

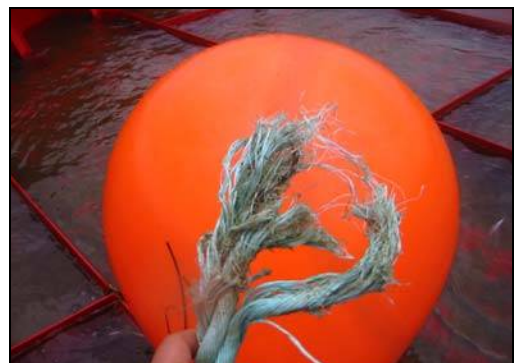
Fig. 4.4 Cut mooring rope with resulting stability problems

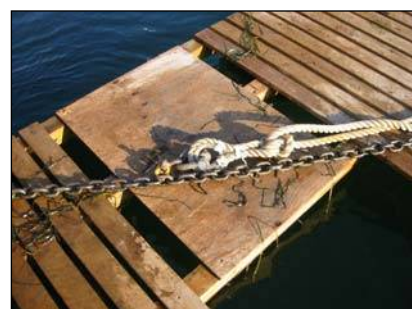
Fig. 4.5 Chain section near shoulder

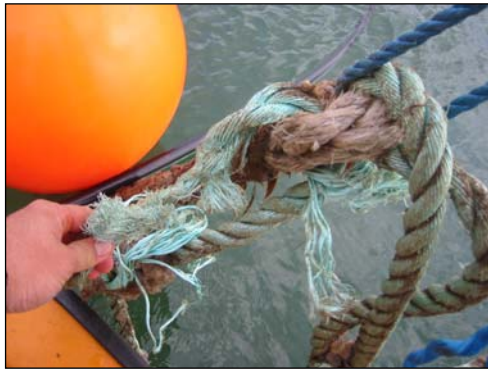
In addition, the mooring lines from the reflector tips to the mooring pile were shown to possess significant wear (29.08.03). This was especially true of the mooring line to the starboard reflector at the mooring pile end (See Fig.4.6).

Fig. 4.6 Significant wear on starboard reflector mooring line

This was remedied by placing a shackle and thimble on the main rope from the body to the mooring pile (See Fig. 4.7). The shackle accommodates the thimbles on the ends of the mooring lines from the reflector (which were reversed). For completion and extra protection, thimbles have been placed on the opposite end of the reflector mooring lines. Both the fore mentioned mooring lines had their lengths modified to comply with the designated 42m.

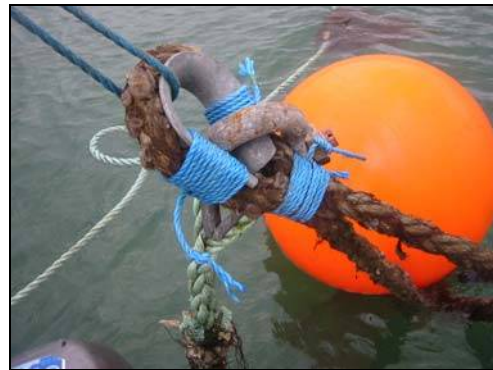
Fig. 4.7 Improved mooring line protection

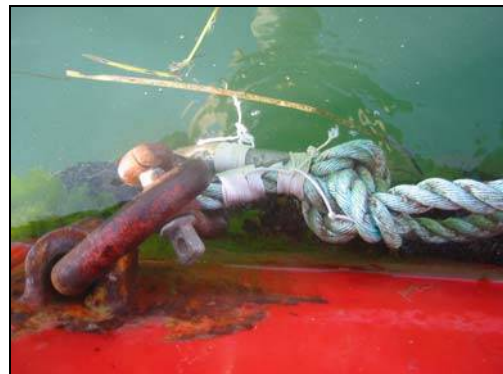
Fig. 4.9 Improved thimble/shackle mooring arrangement

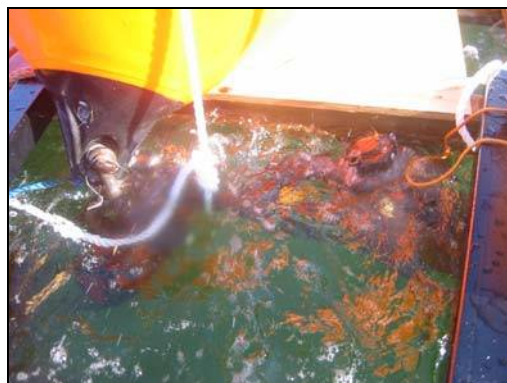
Fig. 4.10 Mounting of buoy using shackles (10.07.03)

Buoy mounting had also proved difficult. Rope attachment of same at mooring junctions has been insufficient with the ropes being cut. Instead shackles have been used as per Fig. 4.10.

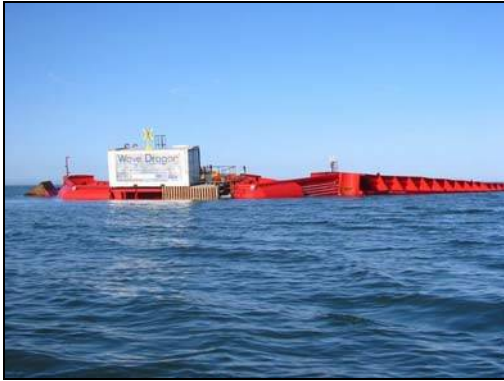
The first attempt to deploy the completed (reflectors attached) Wave Dragon at test site 1 in Nissum Bredning (27-28.03.2003) partly failed, as the reflectors were dislocated from the main platform during harsh wind conditions in the days (30.03.2003) after installation. Refer to Appendix B for details while pictures in the aftermath of the incident are provided below. In addition, Appendix C outlines details for reflector re-installation.

Fig. 5.1 Extreme heel of WD after reflector disaster

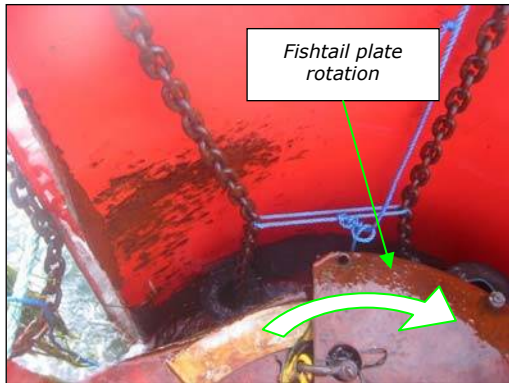
On the starboard shoulder, one of the nuts (inner most, see Fig. 5.7) securing the fender chains to the top fishtail plate had loosened completely allowing the fender and chain to fall out of the shoulder/reflector joint.

Fig. 5.7 Fender chain loosened and misplaced

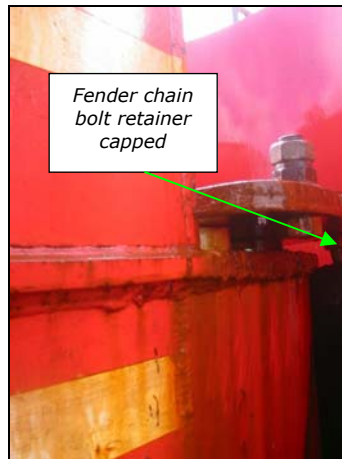
Fig. 5.8 (a) & (b)- Complete capping of outer fender retaining bolt

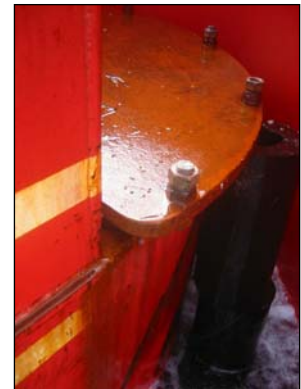
Fig. 5.9 Insufficient retaining of fish-tail plates

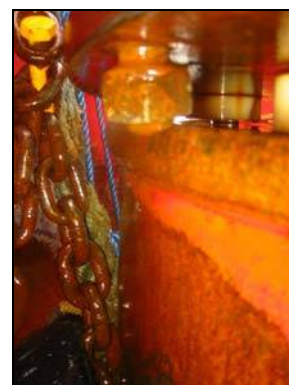
Fig. 5.10 Capping of port fender chain bolt retainer

On the port side, the three innermost fender chain retainer bolts had completely sheared, again on the threads at the lower side of the upper fishtail plate (see Fig. 5.10). It is assumed that the chains were "pinched" by the misalignment of the floating level of the main body.

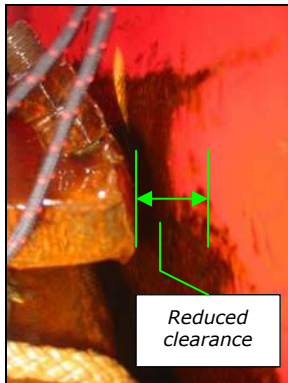
This misalignment, which may have, in part, occurred due the transfer of air from cells, especially with the high floating level of the main body, or, alternatively, due to improper operation of valves (not closing fully), caused the main body to pitch forward and reduce the gap between the upper fishtail plate and the reflector (see Fig. 5.11).

Fig. 5.11 Reduced distance between fishtail plate & reflector

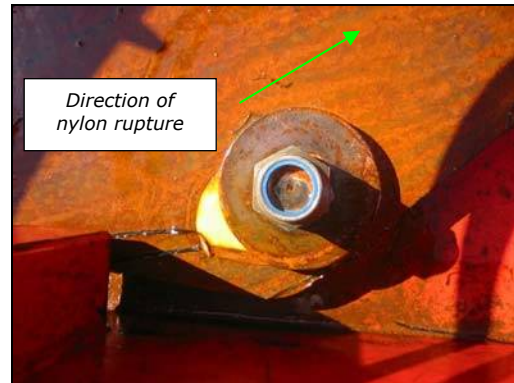
Fig. 5.12 Failure of nylon insert on fishtail plate

The natural movement of both the main body and reflector is likely to have generated enough impact force to cause failure of the nylon insert on the fishtail plate (see Fig. 5.12).

A similar course of action to that on the right hand side was employed here to prevent metal-metal contact.

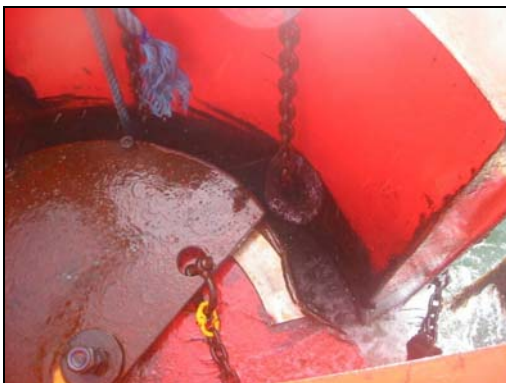
The severity of the damage is well illustrated by examining the port shoulder as per Fig. 5.13.

Fig. 5.13 Damage to port shoulder

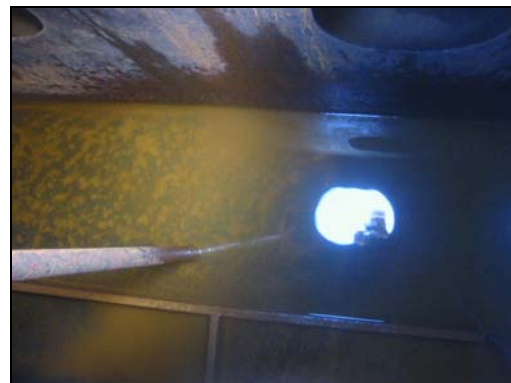
Fig. 5.14 Flooding of port shoulder

It is widely regarded that unexpected tilt in WD (port side) was in some way responsible for the capping of the fender chains on that side from the obvious reduction in clearance between fishtail plate and reflector. This tilt, which was present before the storm damage, was later identified to result mainly from water in one of the closed chambers in the port shoulder, not discounting the possible contribution from the earlier theories. As a result, this water was removed from the chamber using a submersible pump with depths of 1 meter reported in extreme sections (see Fig. 5.14) Submersible pumps have now been installed in both port and starboard shoulders.

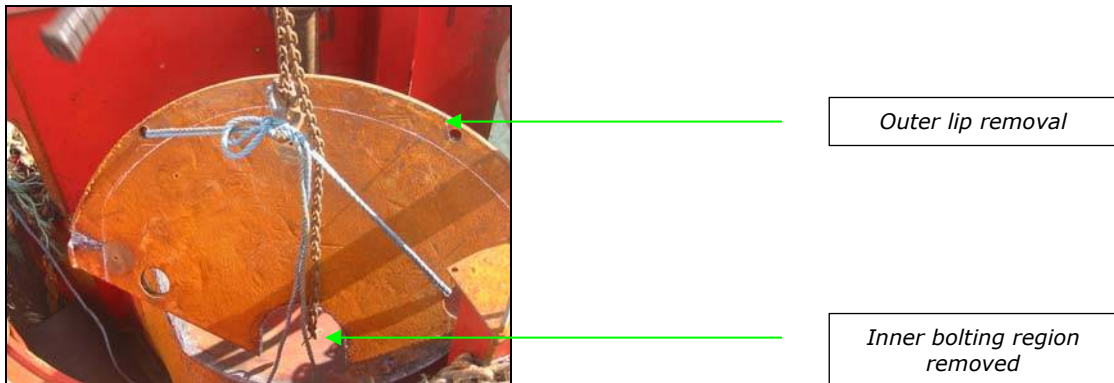
Fig. 5.15 Fishtail plate modification

In an effort to combat the previous problems experienced at the shoulder connections, it was decided to permanently weld the upper fishtail plates to the shoulder.

This involved removing the outer lip of the fishtail plate (thus also preventing any further opportunity to “pinch” the fender chain bolts should the clearance between the plate and reflector be substantially reduced again). The inner bolting region of the fishtail plate was also surplus to requirements and likewise removed. (See Fig. 5.15)

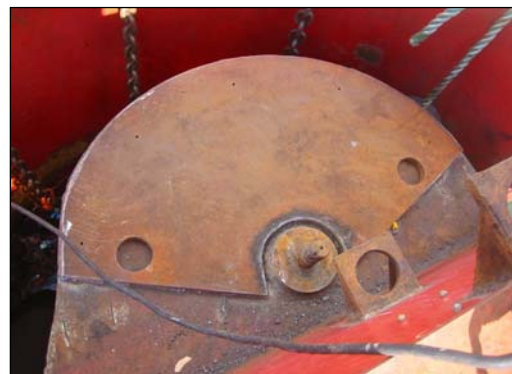
Fig. 5.16 Modified fishtail plate

The resulting welded fishtail plate is shown in Fig. 5.16. Note also that brackets (into which fits a support frame) have been added in the shoulder region to aid in the deployment of the rubber fenders at the interface.

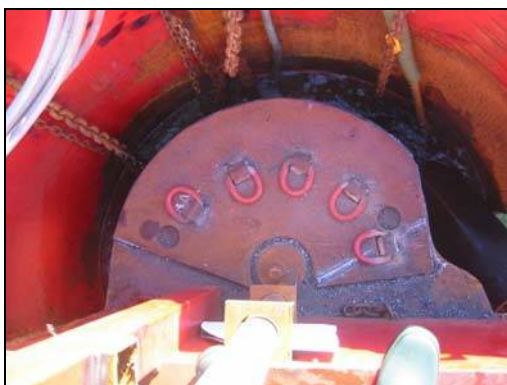
Fig. 5.17 Fishtail plate with chain rings welded

In place of threaded chain tensioners, rings have been welded to the fixed fishtail plate (See Fig. 5.17). These rings will suspend the vertical fender chains while being secured using chain-locks.

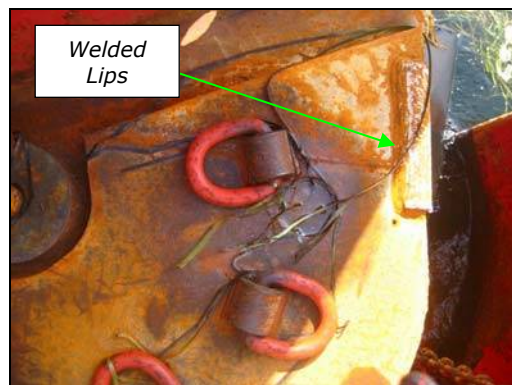
Fig. 5.18 Fishtail plate lips

Note also that five lips have been welded (See Fig. 5.18) at the shoulder edge to provide a smooth overhang for the vertical chains. Extra security is also being afforded at the shoulder connection with the inclusion of horizontal chains connecting the vertical fender chains, which will keep the latter equally spaced. Lost fenders have also been recovered from the sea bed while the chains have been located by attaching ropes to WD.

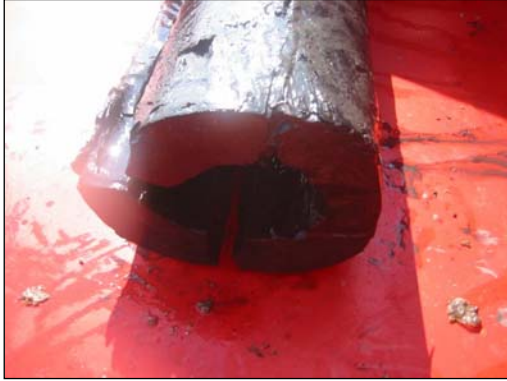
Fig. 5.19 clearly illustrates the severity of the forces at the reflector/shoulder interface.

Fig. 5.19 Rubber fender damage

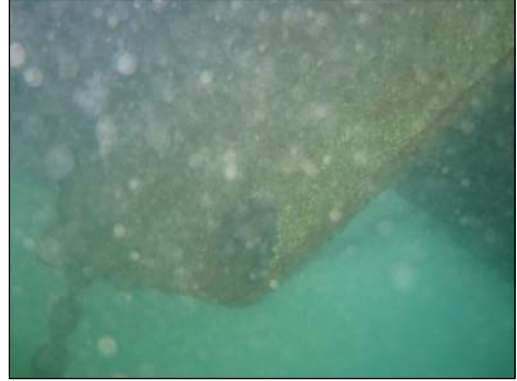
Fig. 5.20 Lower fishtail plate (starboard) misplaced

During fender retrieval, it was noticed by the diver that the lower fishtail plate on the starboard side had the bolt and retaining nut capped off. The resulting overhang of the fishtail plate is clearly seen in Fig. 5.20. This problem, which has since been found to have also occurred on the port side, has been remedied by modifying (see Figs. 5.21 & 5.22) and restraining (see Fig. 5.23) the fishtail plate to the rear of the shoulder.

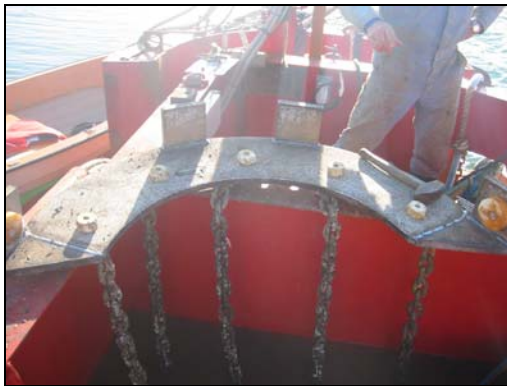
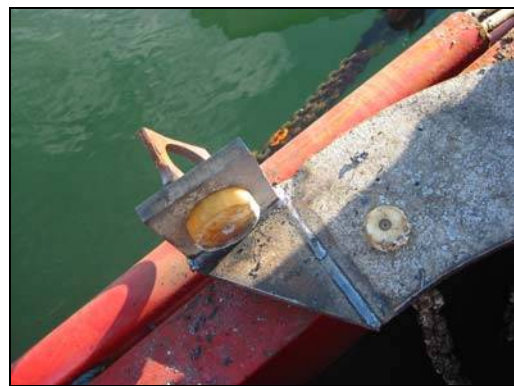
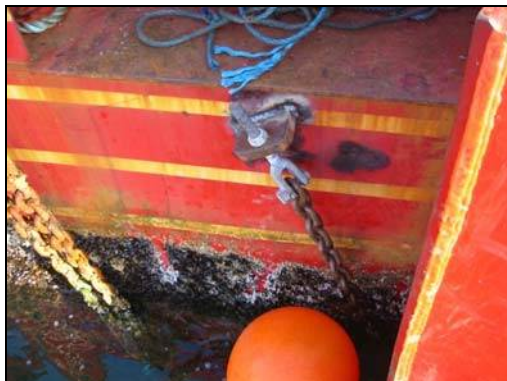
Fig. 5.21 Modified lower fishtail plate

Fig. 5.22 Point of restraint of modified fishtail plate

Fig. 5.23 Tensioning of fishtail plate

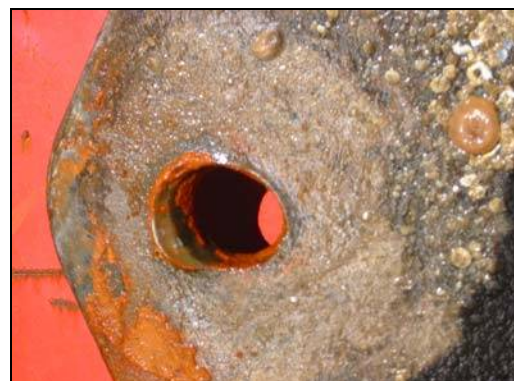
Fig. 5.24 Original damage caused by fishtail plate bolt

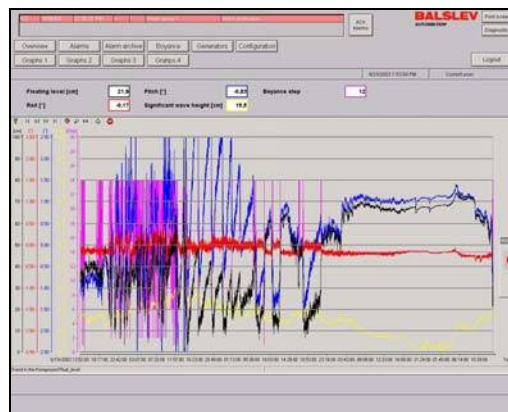
With a high floating level and in the case of larger waves, it has been observed that there is a tendency for air to escape from the foremost air compartments with the result being a heeling forward of the main body.

In addition, there has been greater instability in heel and trim movements with high floating levels.

Fig. 6.1, which depicts WD movements for given floating levels, is evidence of these instabilities.

Fig. 6.1 Floating conditions in harsh wave climate

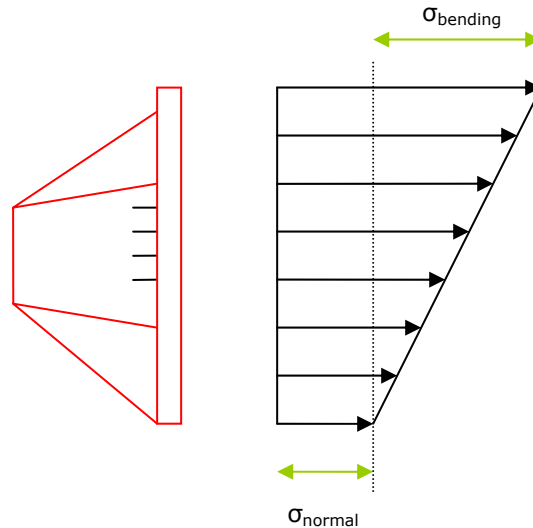
Fig. 7.3 Stress distribution across gauges

The four stress results can be extrapolated. The extrapolation to the lower part of the reflector gives the Normal stress equal to (Normal force/Normal area).

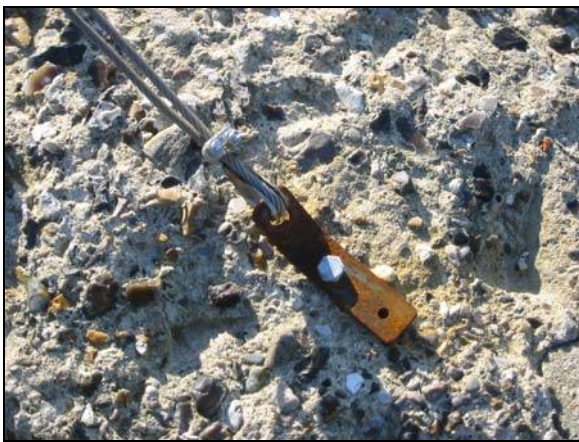
- It was established (26.08.03), on consulting with Torsten Bach (Siemens technical representative), that a signal for Fixed Wireless Access (FWA) for Internet connection could be established via Lemvig – thus avoiding the need to erect a tall, specialised mast, in the event of using a signal from Hurup, as was originally thought. In light of this, the existing roadside wooden pole, which supports the network cable interface as well as other electrical transmission features, has been made more secure with the addition of some wire-rope stabilisers to ground level as seen in Fig. 8.1.

Fig. 8.1 Wooden pole stabilised using wire rope

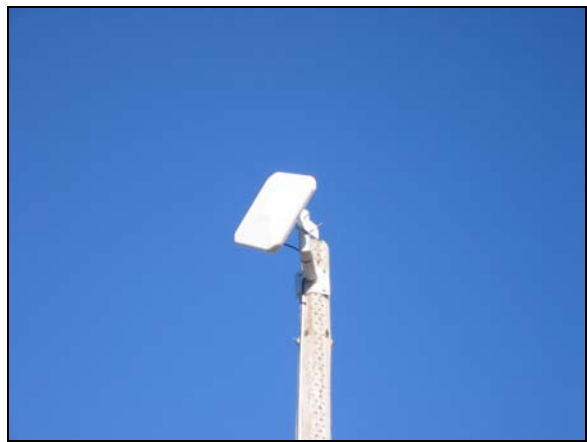
Fig. 8.2 Wooden pole with transmitter attached

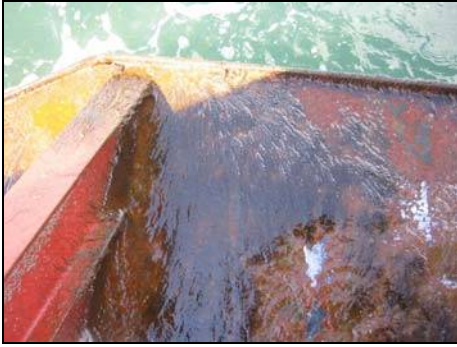
Fig. 8.1 Early moss growth on damper plate

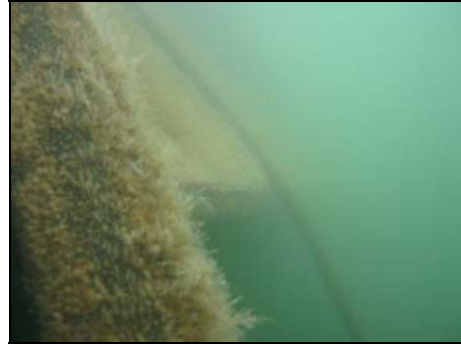
Fig. 8.2 Recent view of marine growth underneath the structure

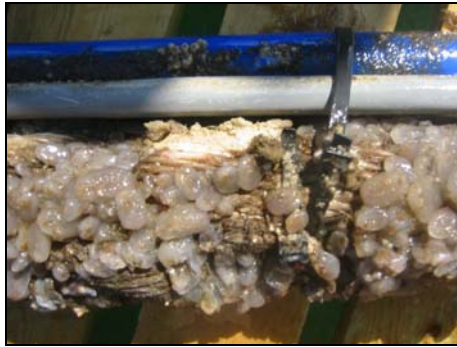
Fig. 8.3 Ascideans on rope to mooring pile

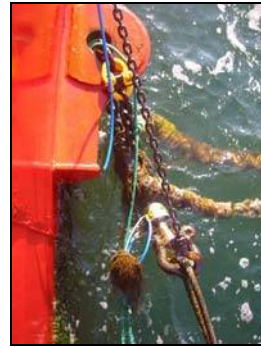
Fig. 8.4 Marine reeds growing near the force transducer

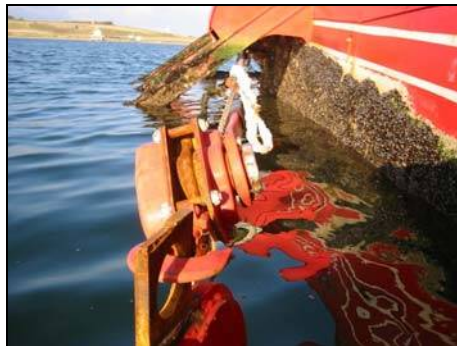
Fig. 8.5 Blue mussels seen growing around the structure

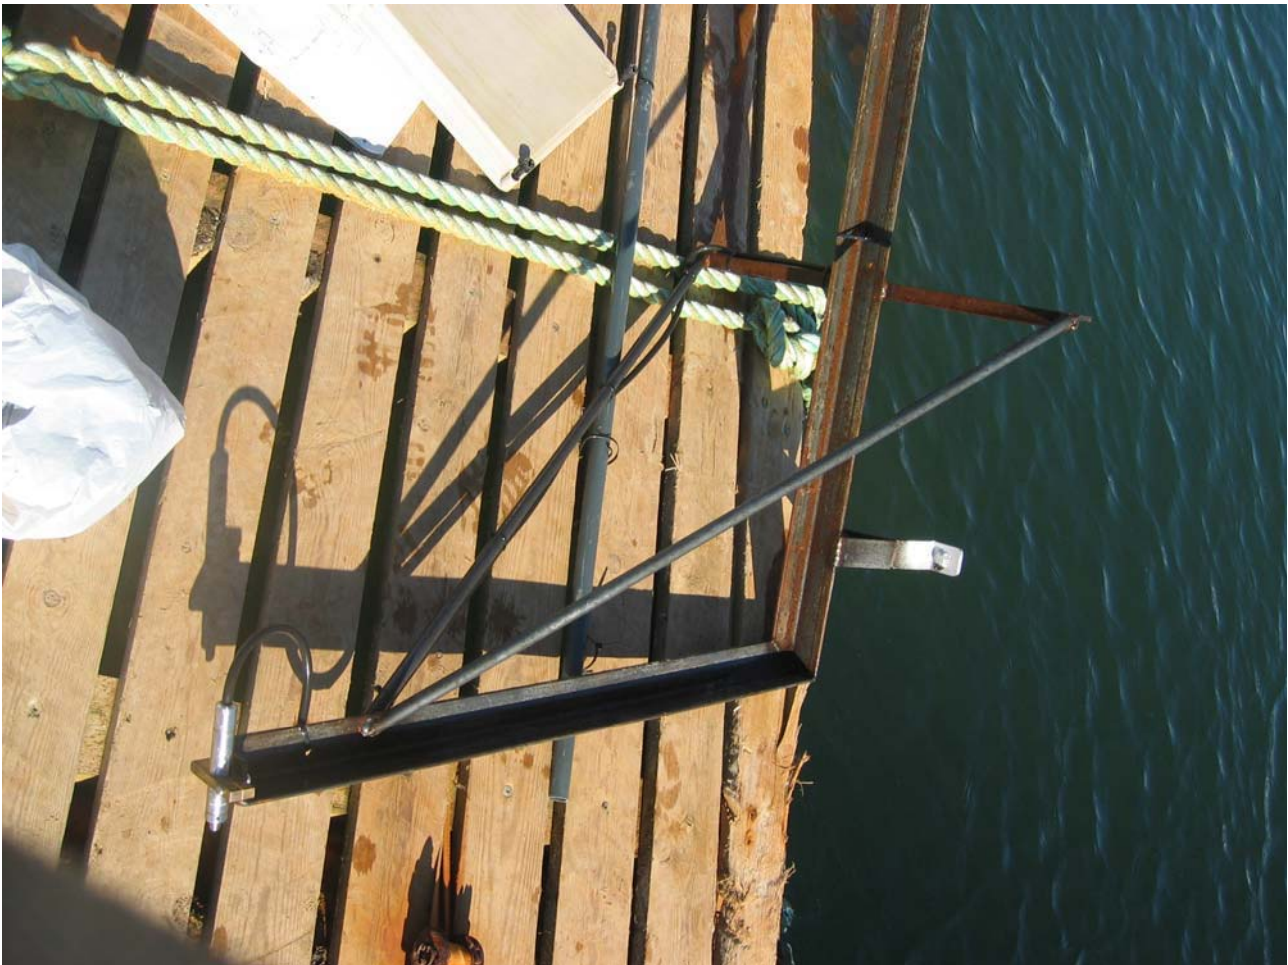
Figure 2.1: New pressure gauge on frame prior to installation on mooring pile.

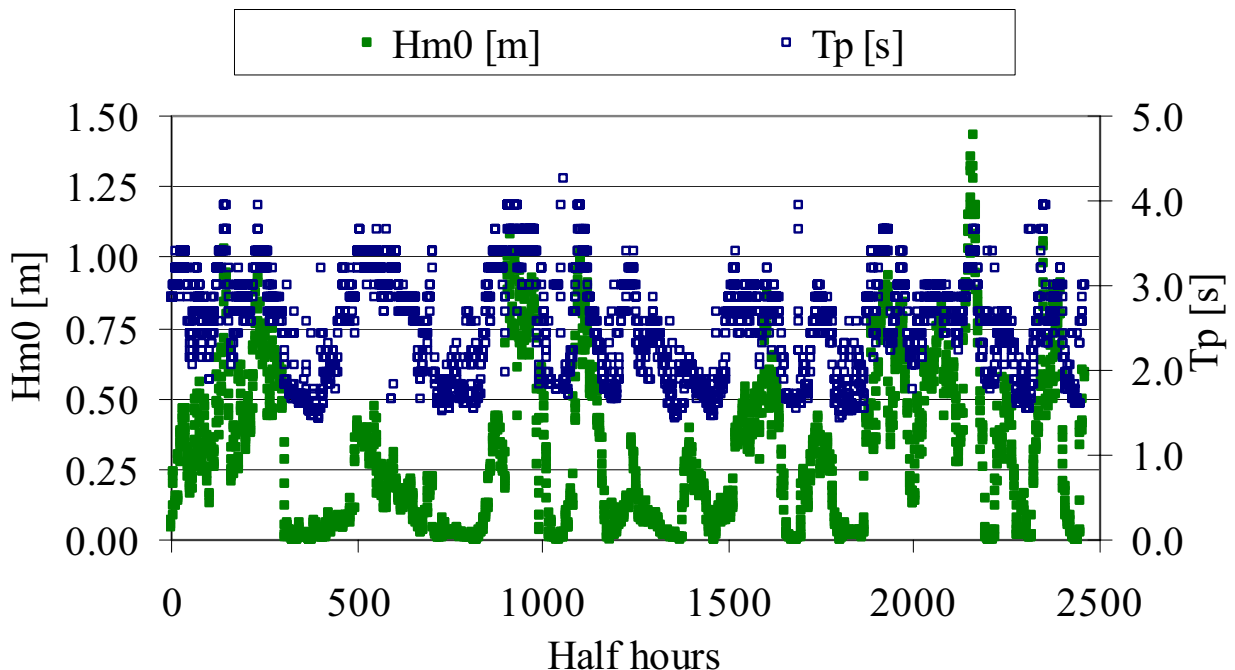
Figure 2.2. Results of the frequency domain analysis in terms of the frequency domain estimate of the significant wave height H_{m0} and the peak period T_p .

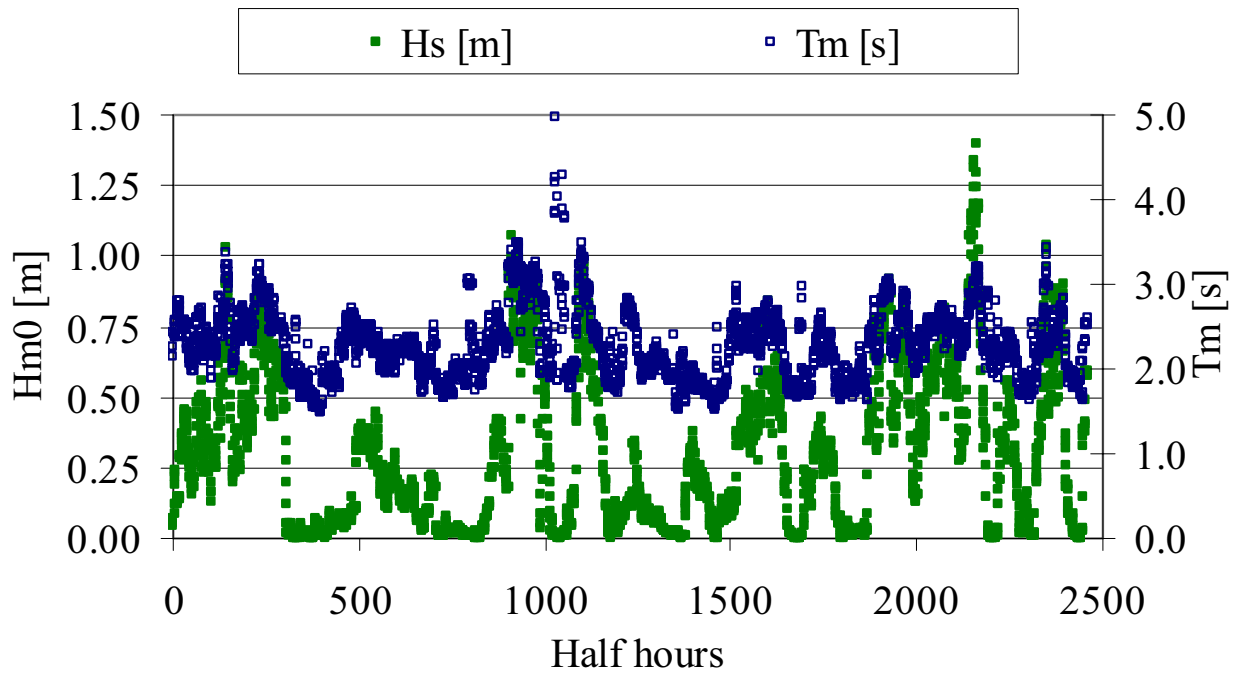
Figure 2.3. Results of the time domain analysis in terms of the significant wave height H_s and the mean period T_m .

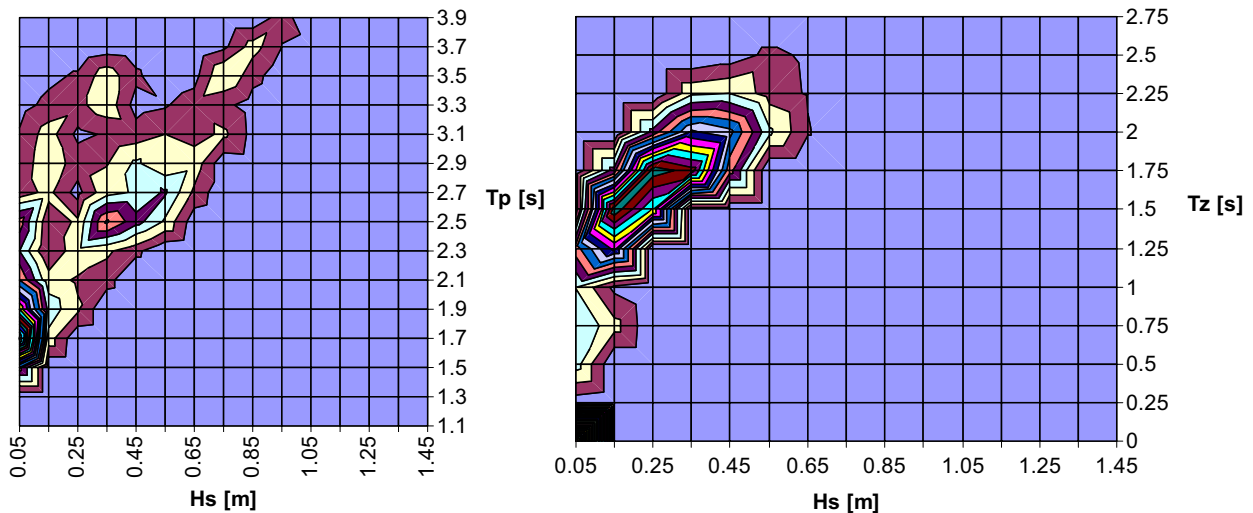
Figure 2.4. Left: Contour plot of the data given in table 2.1. Right: Results of calculation of wave conditions at 5 m water depth at Helligsø Teglværk, Kerper and Jacobsen, 1998 (T_z is the average time domain wave period, typical T_p/T_z ratio is ~ 1.25 for inner waters like Nissum Bredning).

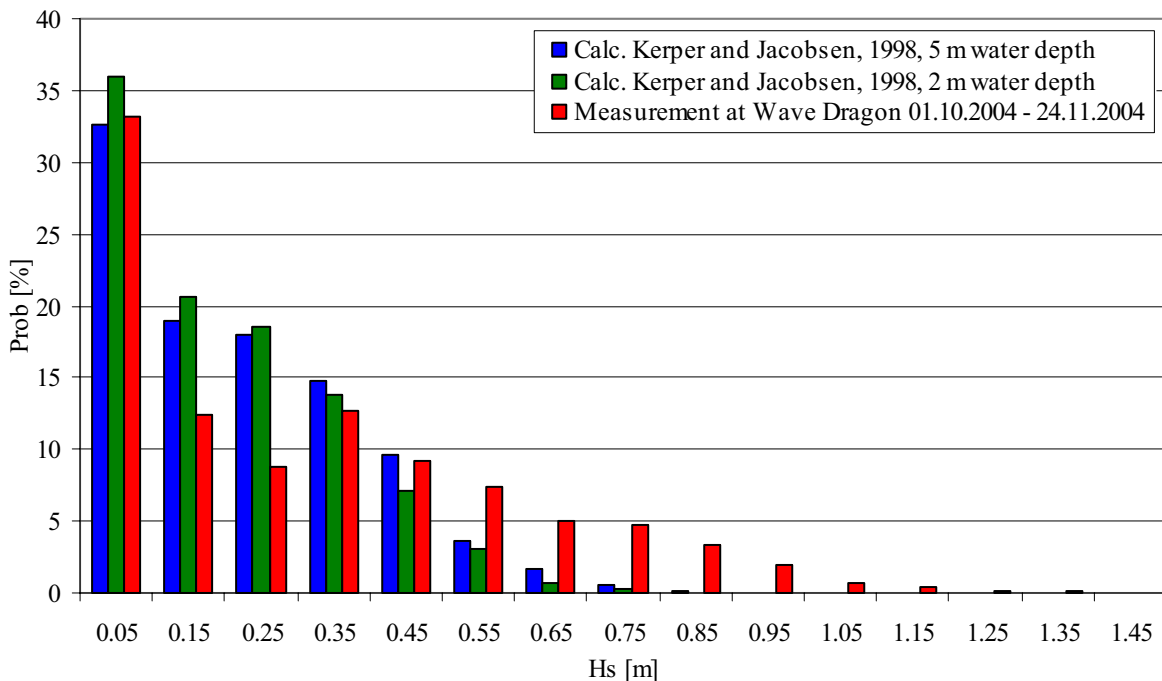
From this comparison it is seen that the WD data covers wave conditions exceeding the wave conditions calculated by Kerper and Jacobsen, 1998. One reason for this is that the WD covers a limited period during one autumn, while the data by Kerper and Jacobsen, 1998, are overall average data. Since autumns generally are more windy than all year round averages it is not surprising the larger wave conditions are overrepresented in the WD data. However, the data by Kerper and Jacobsen, 1998, suggests that at a water depth of 5 m $H_s > 0.9$ m has almost zero probability, while the WD data shows that $H_s > 0.9$ m is almost frequently exceeded ($> 3\%$). As seen in figure 2.8 the water depths for the WD data are roughly 5 to 6 m.

Figure 2.5. The wave height distribution for the wave conditions measured at WD and the calculated wave conditions at 5 and 2 m water depth at Helligsø Teglværk by Kerper and Jacobsen, 1998.

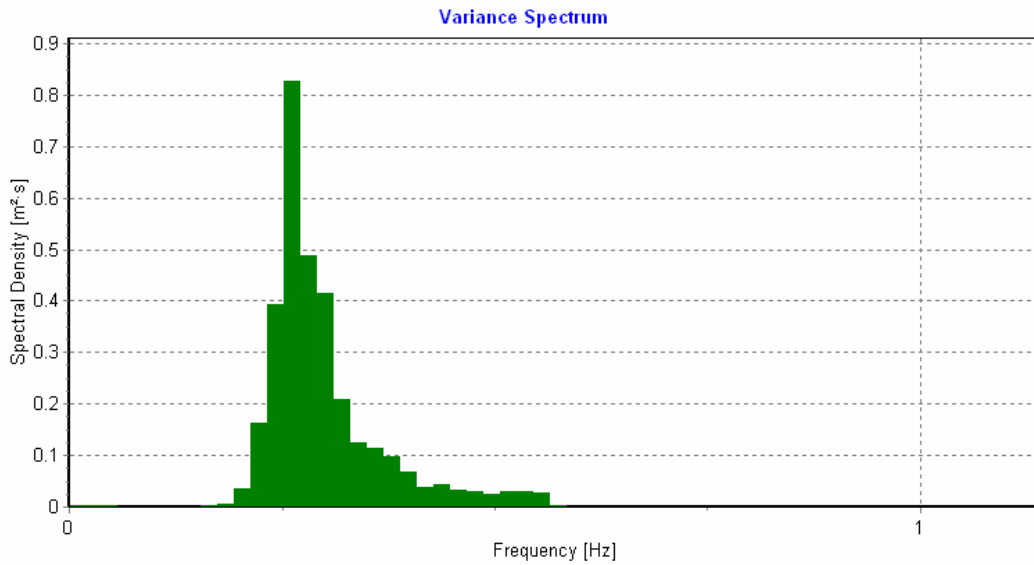
In figure 2.6 and 2.7 examples of measured wave spectra and wave height distributions are given. These shows reasonably shaped spectre and wave height distribution for a significant wave height of 1 m (no signs of significant wave breaking or higher order effects).

Figure 2.6. Variance spectrum for the measured waves from 25.10.2004 14.18-14.48. $H_{m0} = 1.001$ m, $T_p = 3.94$ s.

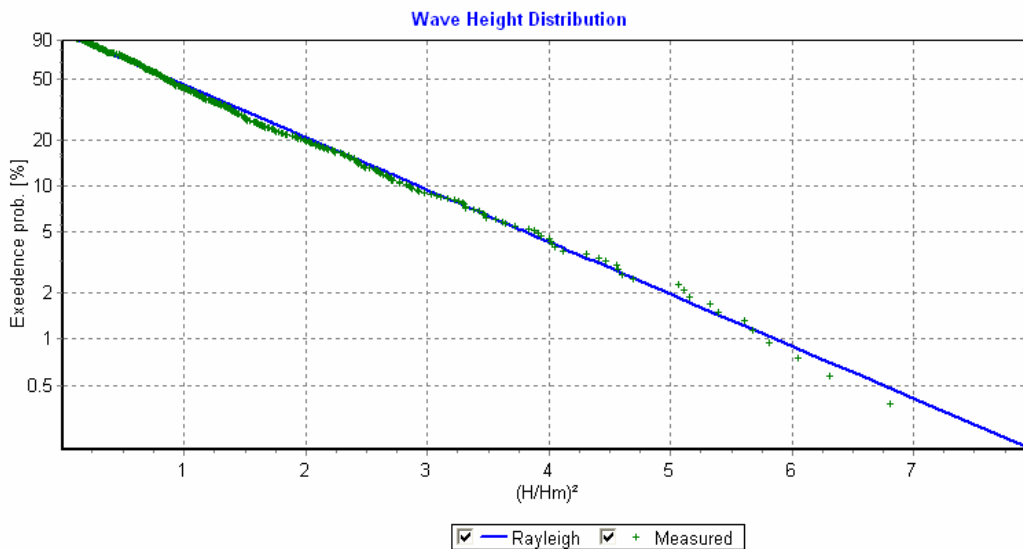
Figure 2.7. Wave height distribution for the measured waves from 25.10.2004 14.18-14.48. $H_s = 0.992$ m, $T_m = 3.38$ s.

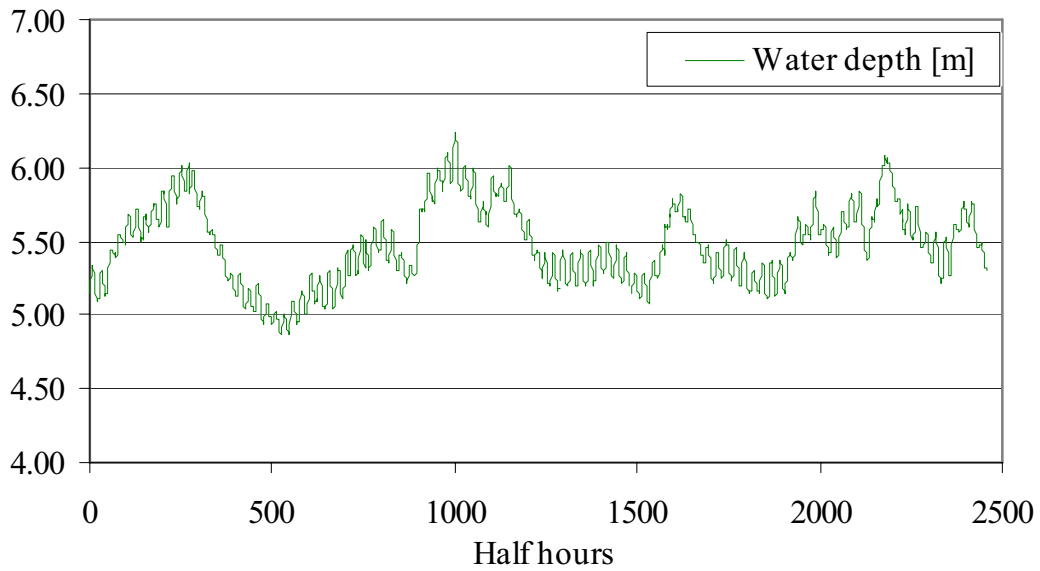
Figure 2.8. Water level variations at the location of the mooring pile during the period 01.10.2004 to 24.11.2004.

From these water level variations it is seen that the tide variation typically is up to 25 cm, while the larger variations (up to a little more than one meter) mainly is due to wind driven setup at the west coast, which enters into Nissum Bredning at Thyborøn.

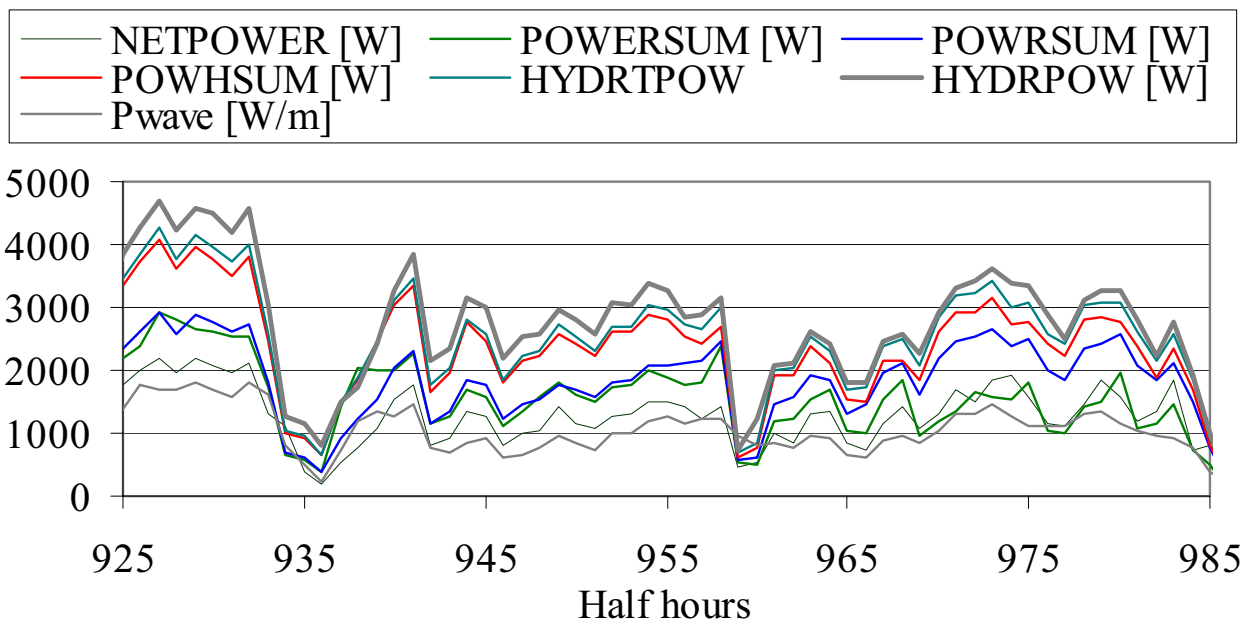
Figure 3.1. Power produced on board calculated in various manners.

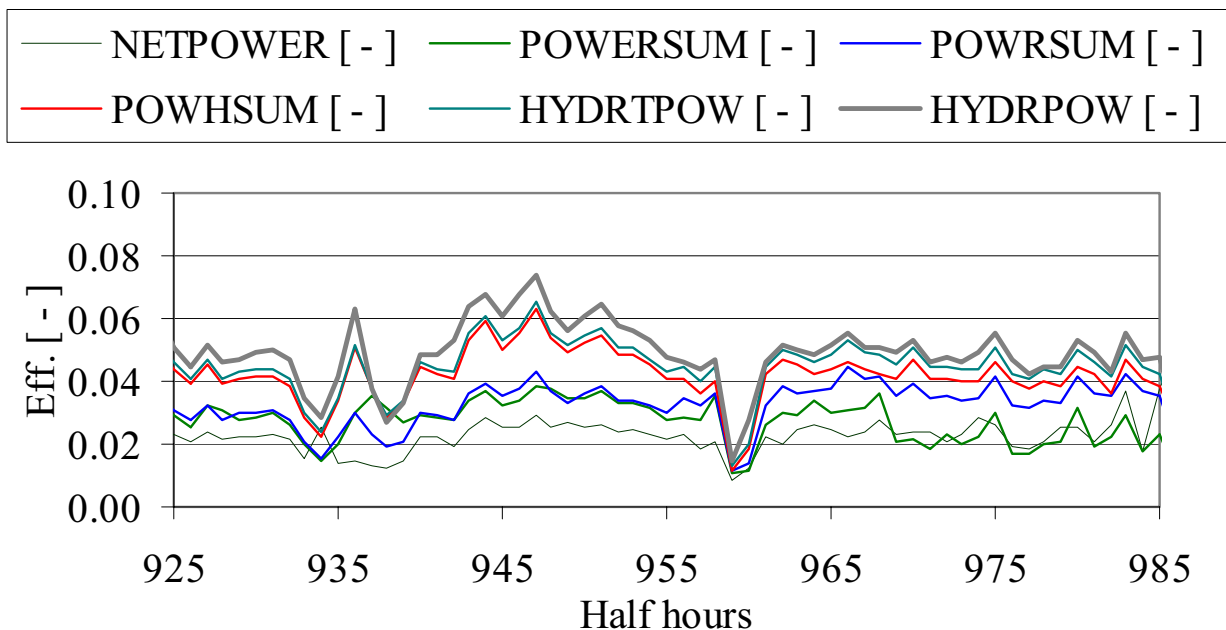
Figure 3.2. Efficiencies corresponding to the produced power given in figure 3.1.

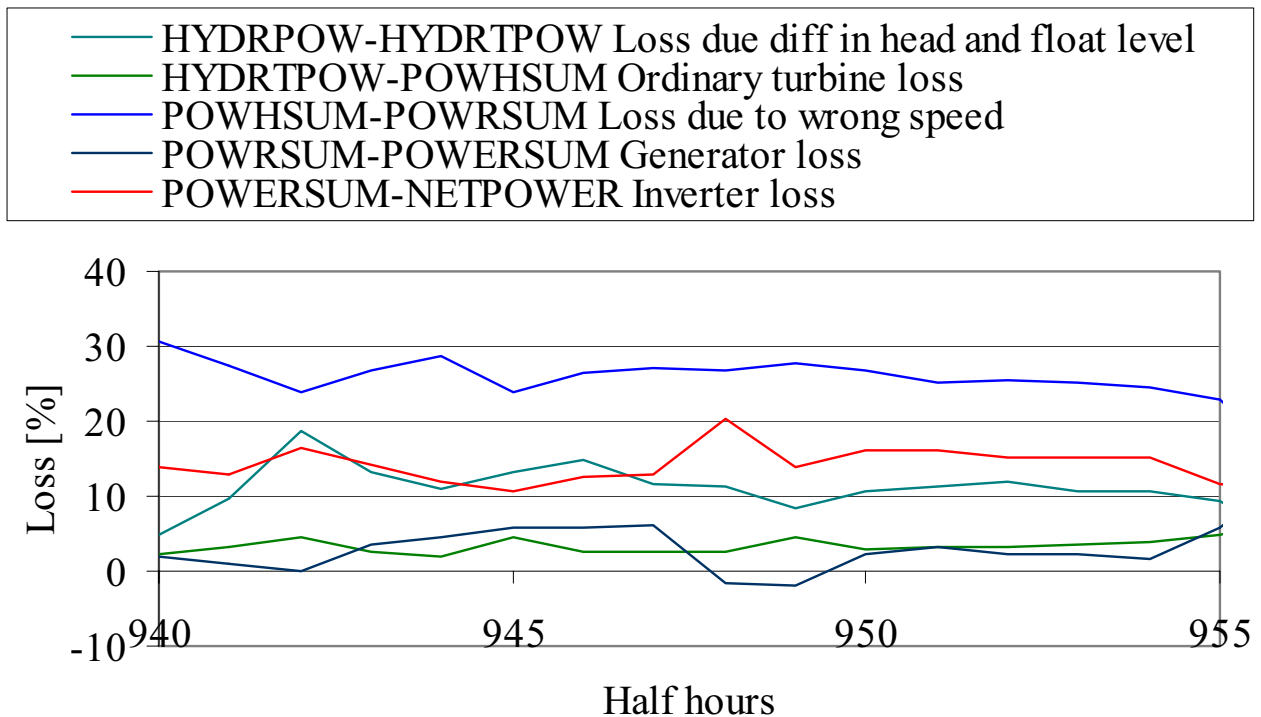
Figure 3.3. The various losses (in % of HYDRPOW) for a selected range of the analyzed period.
