Wave Dragon Prototype

Tilstandsvurdering **BILAG**

Energinet.dk projektnummer 6459

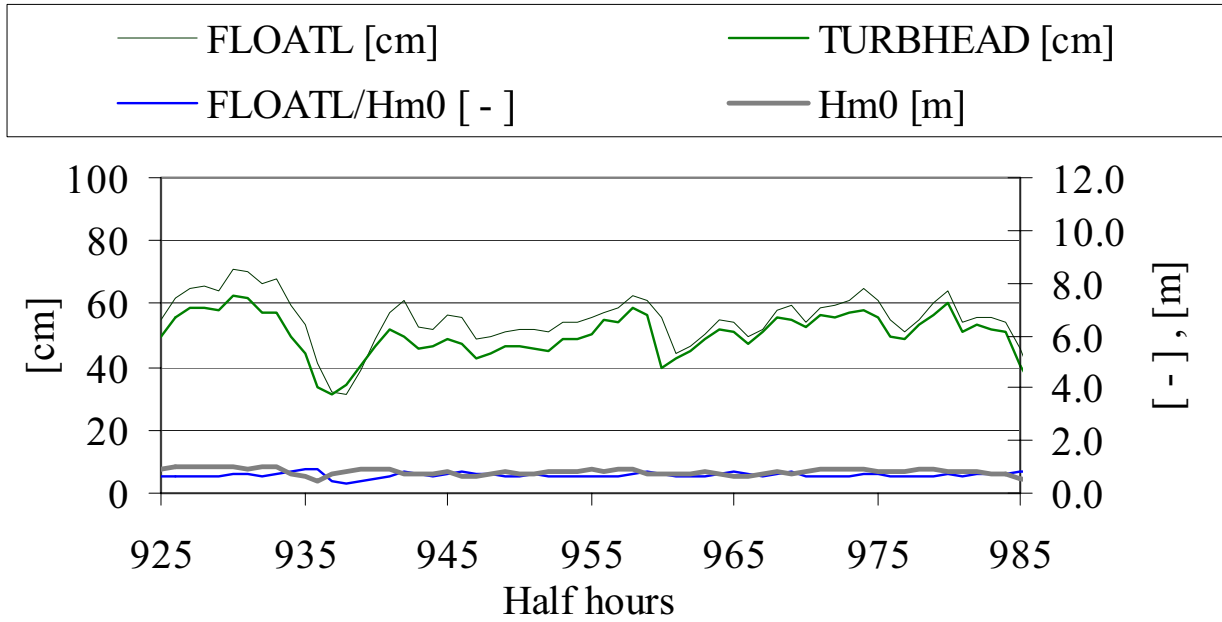
In figure 3.4 the half hour average values of the floating level (FLOATL), turbine head (TURBHEAD) and significant wave height (H_{m0}), as well as the ratio $FLOATL/H_{m0}$, are given for the analyzed period.

Figure 3.3. Important factors for the power production.

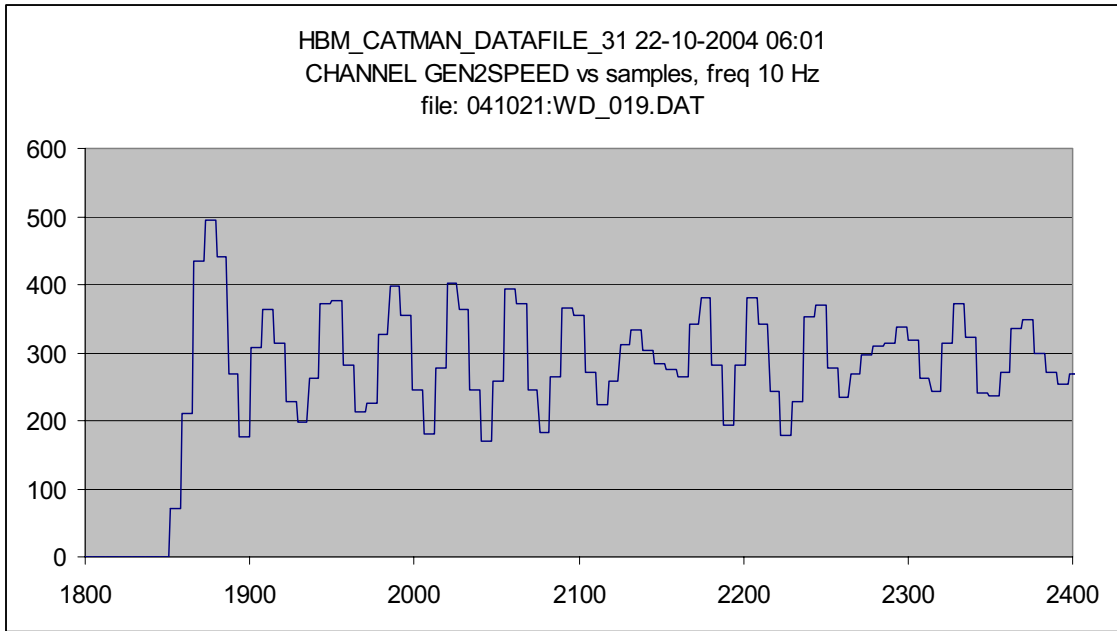
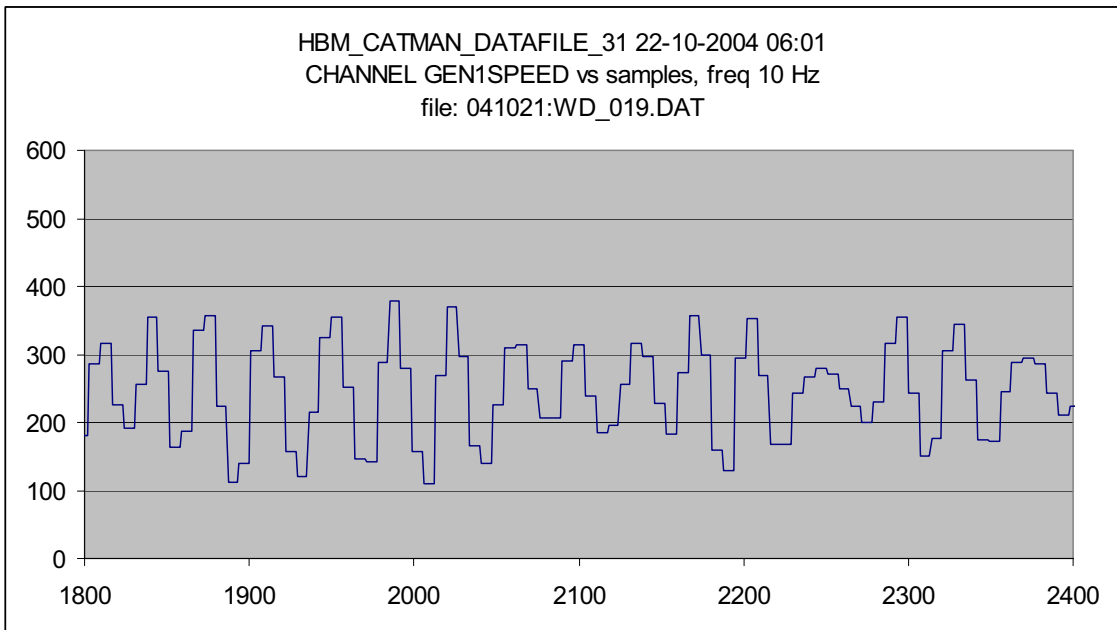
Figure 3.6. Turbines running in good wave and power production conditions.

The change in the turbine speed oscillations are pronounced from figure 3.4 to 3.5 and 3.6. The period of the oscillations are not far from the wave periods, for what reason it seems fair to say that the oscillations are tricked by the changing turbine head due to waves propagating under the platform. West Control was at WD-NB in July 2004 to change some burned IGBT's (transistors) and at this time the EEPROMS containing the West Control programming of the inverters was also replaced. A change in the programming might be responsible for the increased sensitivity to oscillations in the turbine head. This item is currently being investigated.

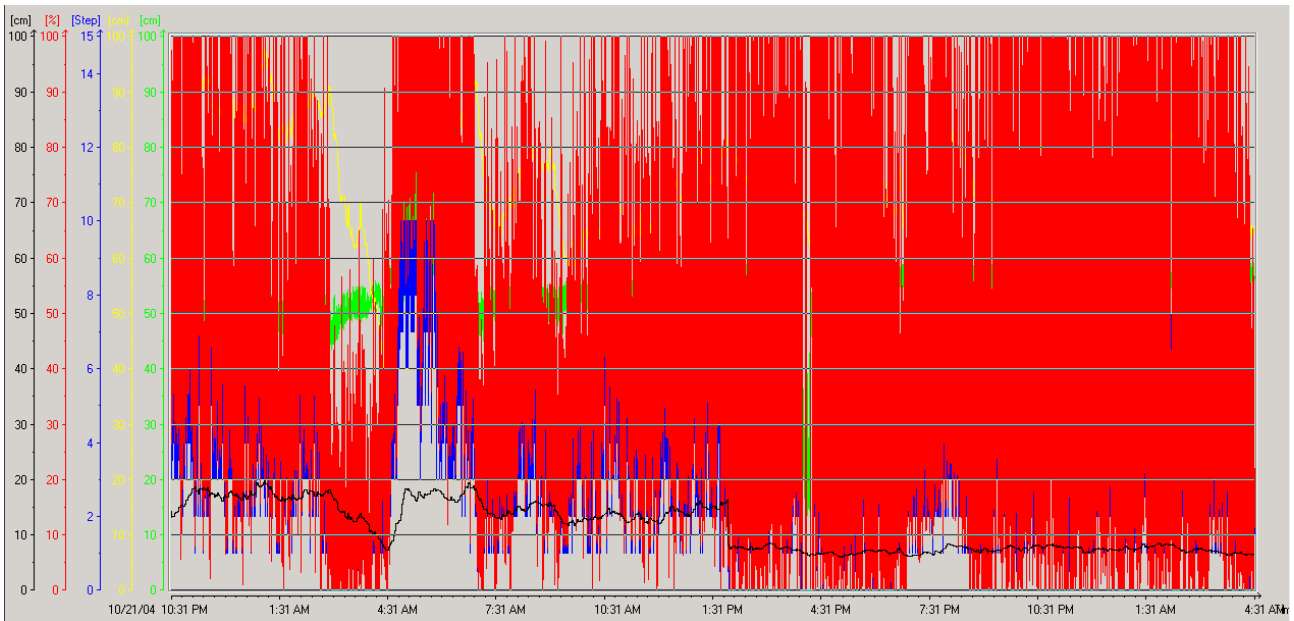
- Dummies are not included in the overtopping rates in the new data. From graphs on the SCADA system (see figure 4.2 for the period corresponding to the power data given in figure 3.1, figure 4.3 the half hour period corresponding to the first data point in figure 3.1 and the red dots in figure 4.1) it can be seen that there are quite frequent dummy turbine activity, and therefore significant amounts of water is 'lost' through these. For a single point, corresponding to the half hour shown in figure 4.3, the flow through the dummies are estimated to be 50 % of what goes through the other turbines (in average during the period).

- Spilling. From figure 4.2 - 4.3 it is also seen that the reservoir level is frequently above 100 %, ie. spilling occurs. Rough quantification of the spilling might be possible by calculation of the water level along the edges of the reservoir, comparing it to the crest height around along the edges, and then using an expression for the flow over an edge.

Figure 4.2. Screen dump from SCADA, graph 2, during the 30 hours period shown in figure 4.1.

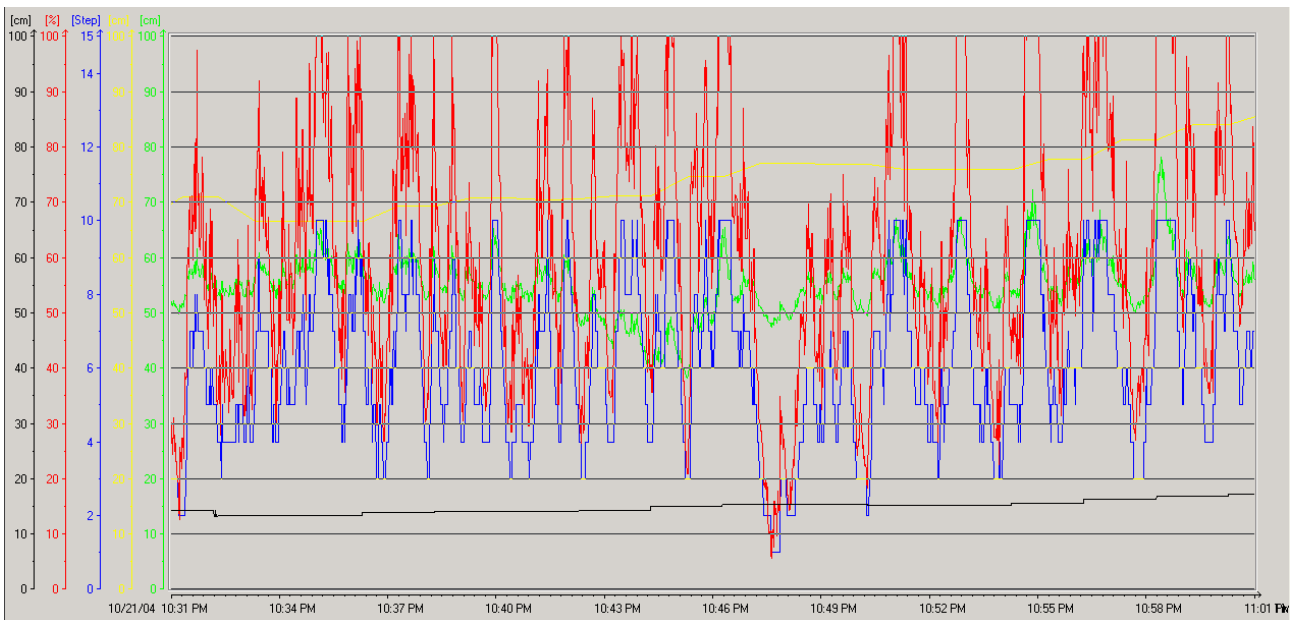
Figure 4.3. Zoom of figure 4.2, the first half hour.

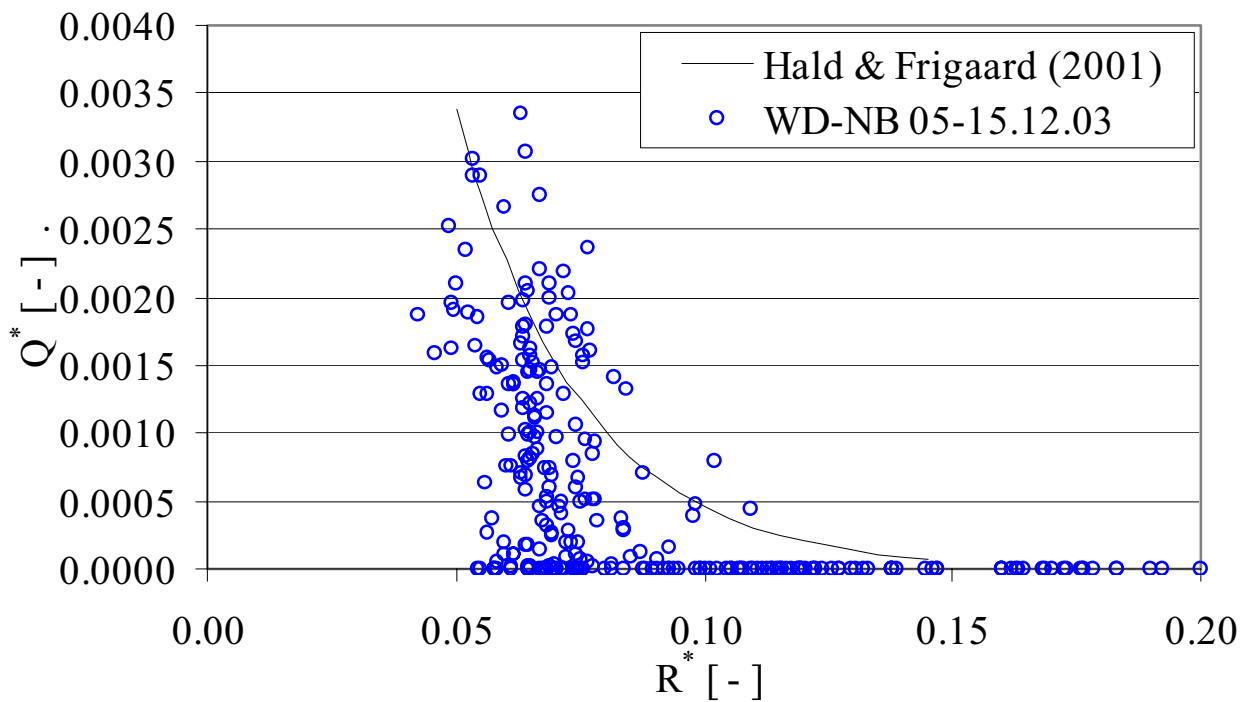
Generally, as in figure 4.1 quite some scatter is seen and a large portion of the data points falls below the prediction line. The possible explanations for this are again the above mentioned points.

Figure 4.4: All the non-dimensional overtopping rates from Appendix B assembled in one graph. The data is also shown in figure 4.5.

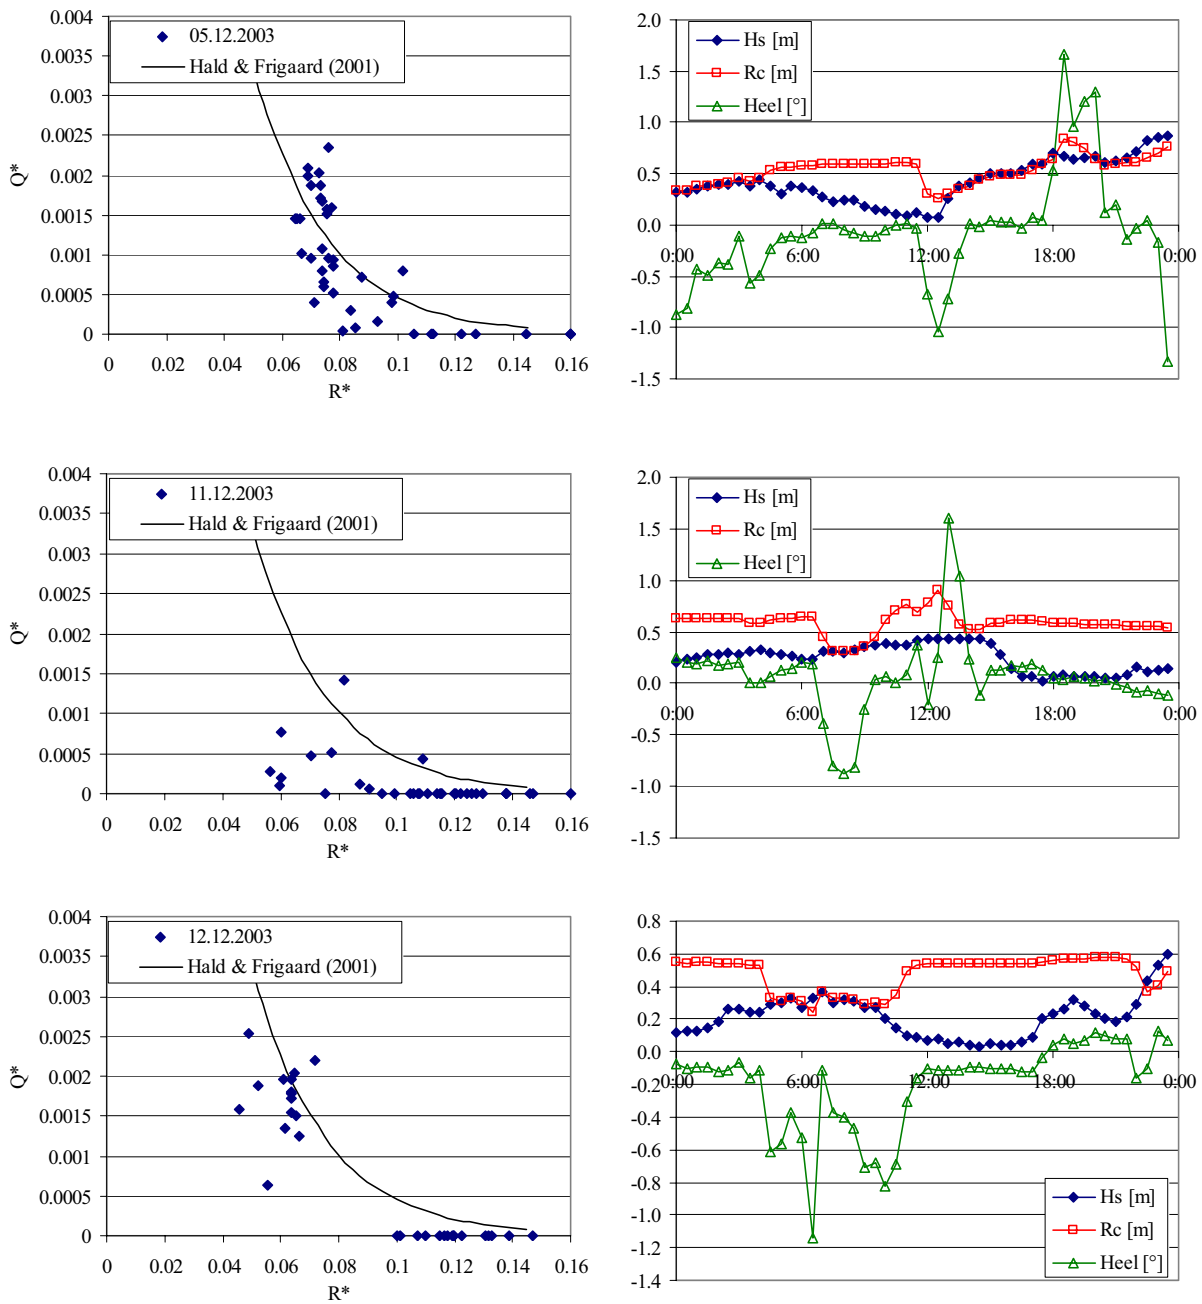
- Periods with heel close to 0 and R_c close to H_s seems to result in overtopping rates close to the prediction line.
- Significant oscillations in the heel seem to reduce the overtopping rates badly.

Figure 4.5a: Non-dimensional overtopping rates plotted for one day at a time (left) along with half hour averages of the heel, crest freeboard (compensated using heel) and significant wave height (right).

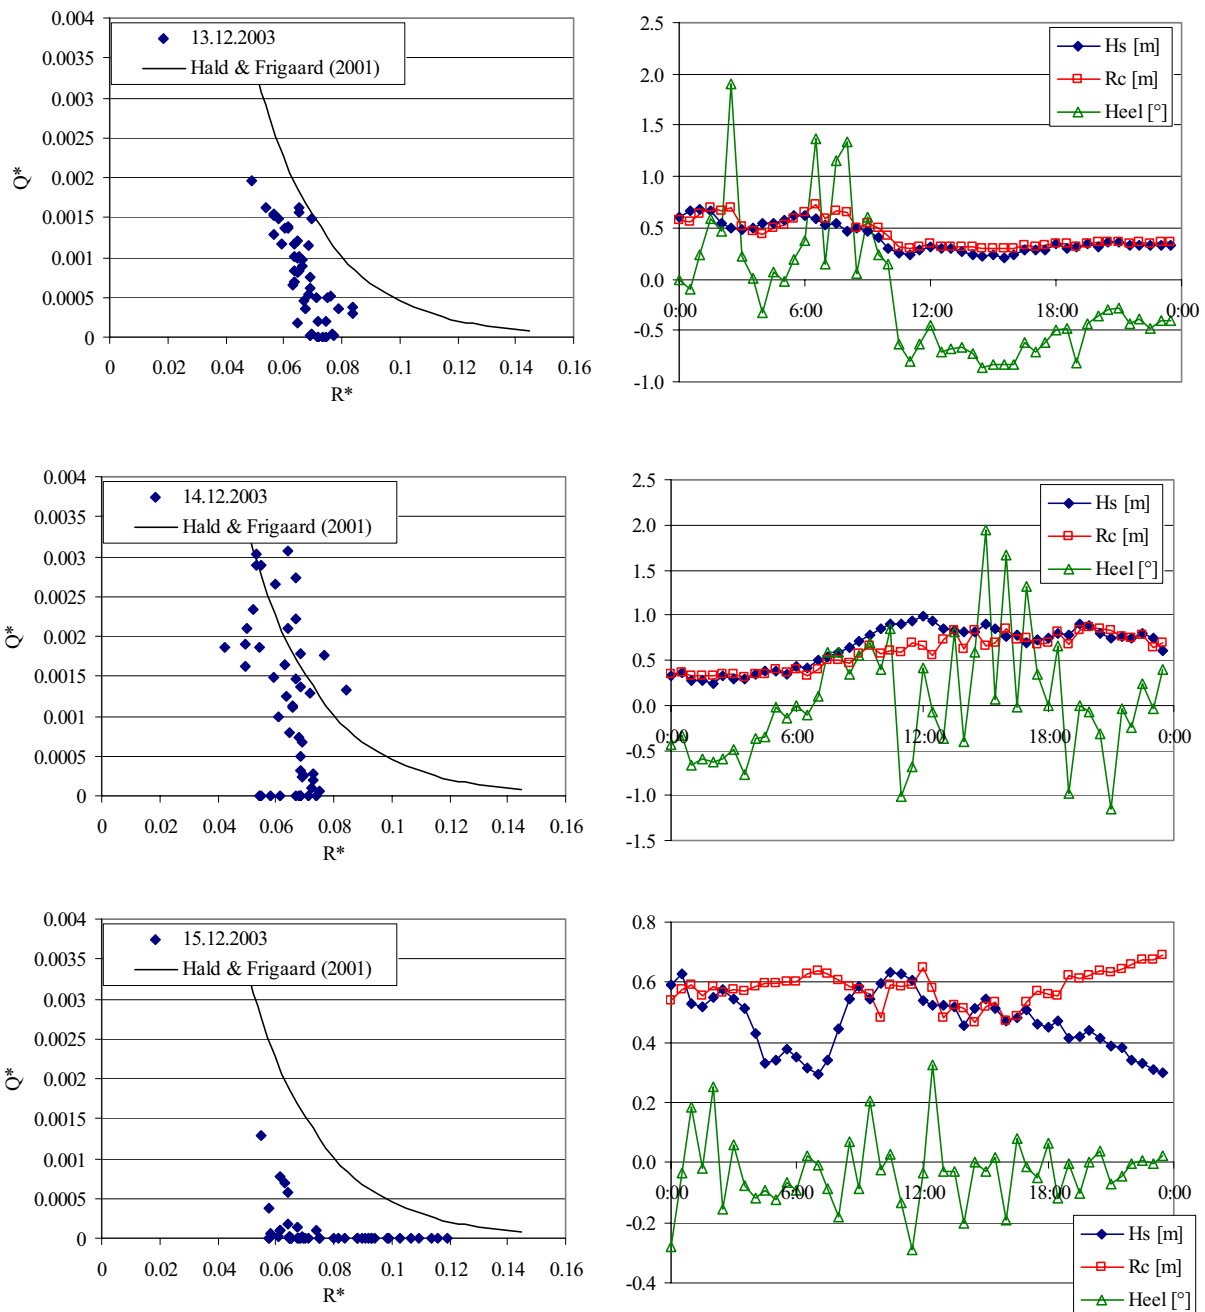
Figure 4.5b: Non-dimensional overtopping rates plotted for one day at a time (left) along with half hour averages of the heel, crest freeboard (compensated using heel) and significant wave height (right).

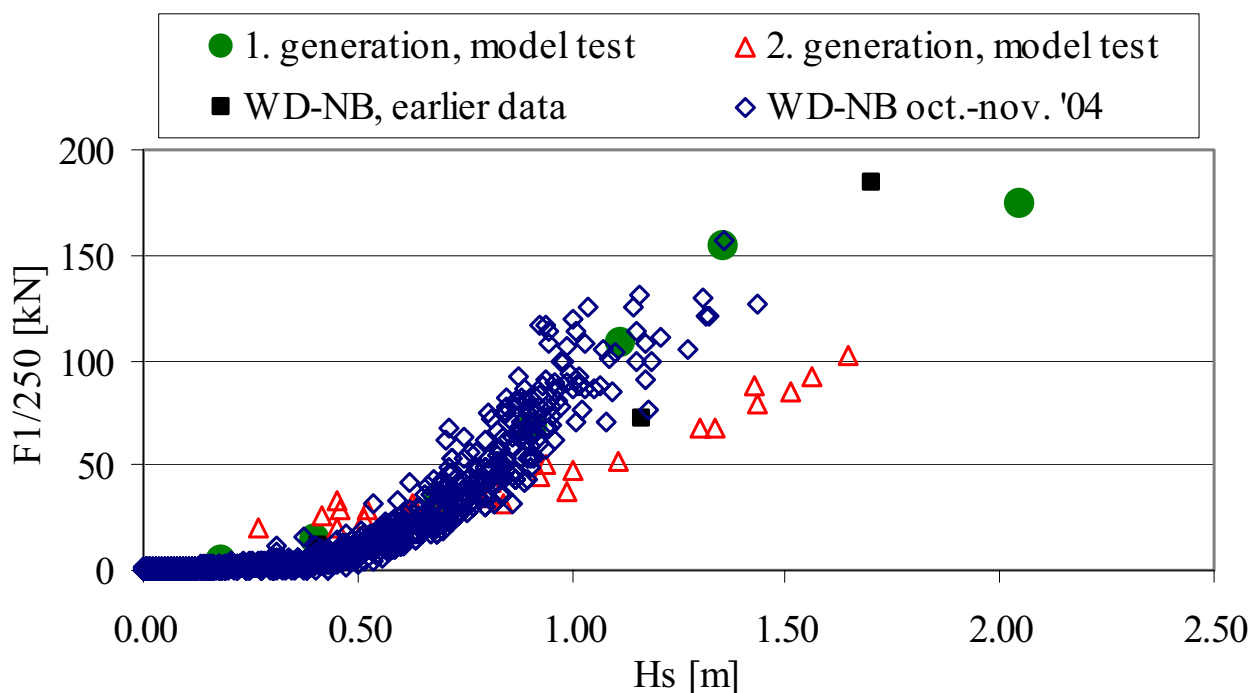
Figure 5.1. Mooring force in main mooring line attached to mooring pile in terms of $F_{1/250}$ (average of the 1/250 largest force peaks). The ‘WD-NB, earlier data’ is data observed at the SCADA system, ie. not really statistical data, but merely max points observed at the indicated single wave height.

From this figure it seems that the stiffness of the mooring system is too large – more like the situation as in the 1. generation model tests than in the 2.

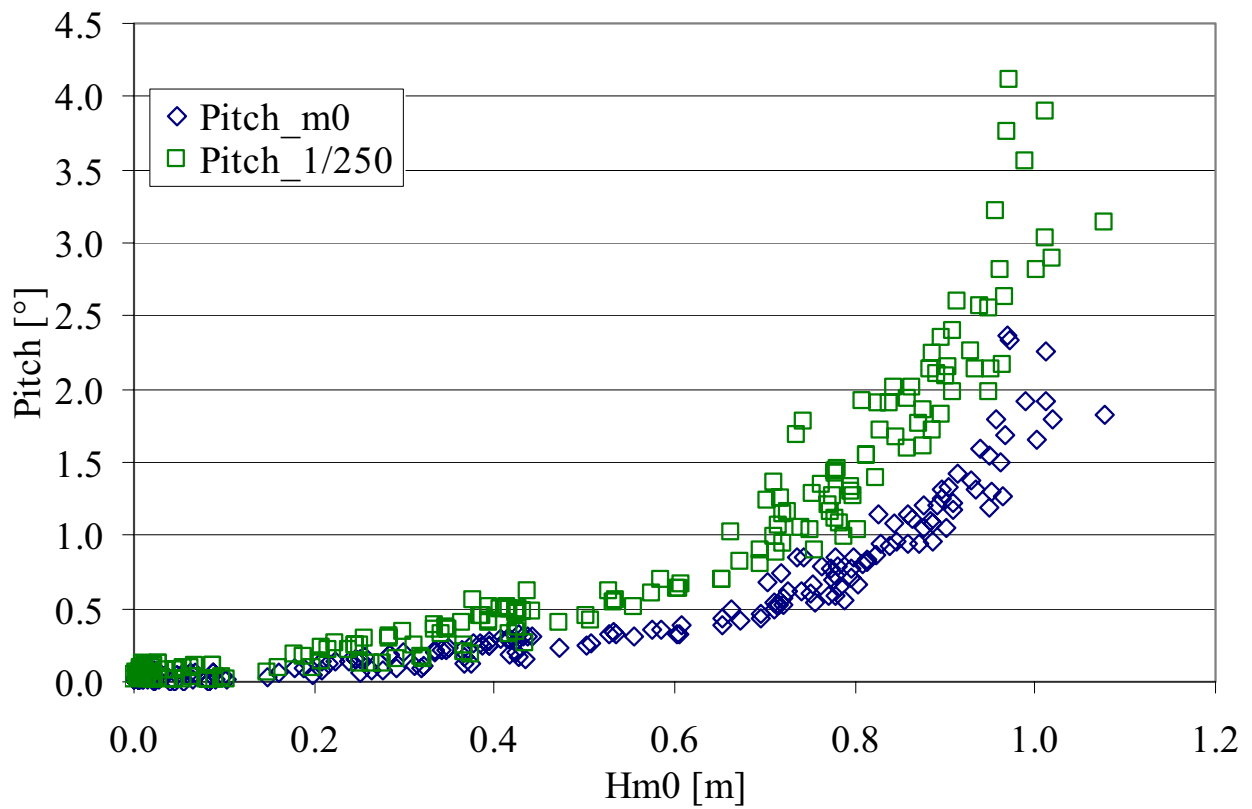
Figure 6.1. Motions in pitch, calculated corresponding to significant wave height (4 times the standard deviation), $pitch_{m0}$, and the mean of the 1/250th largest oscillations, $pitch_{1/250}$, both as a function of the significant wave height H_{m0} .

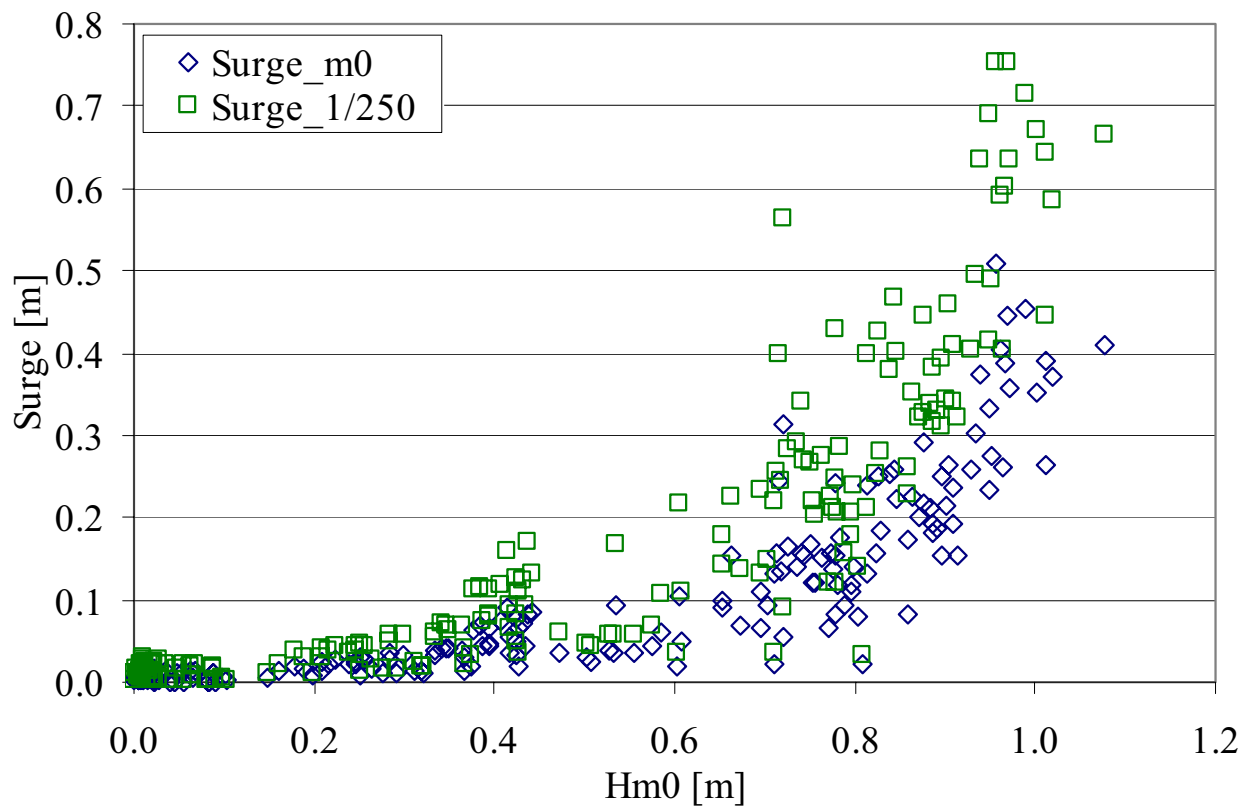
Figure 6.2. Motions in surge, calculated corresponding to significant wave height (4 times the standard deviation), $surge_{m0}$, and the mean of the 1/250th largest oscillations, $surge_{1/250}$, both as a function of the significant wave height H_{m0} .

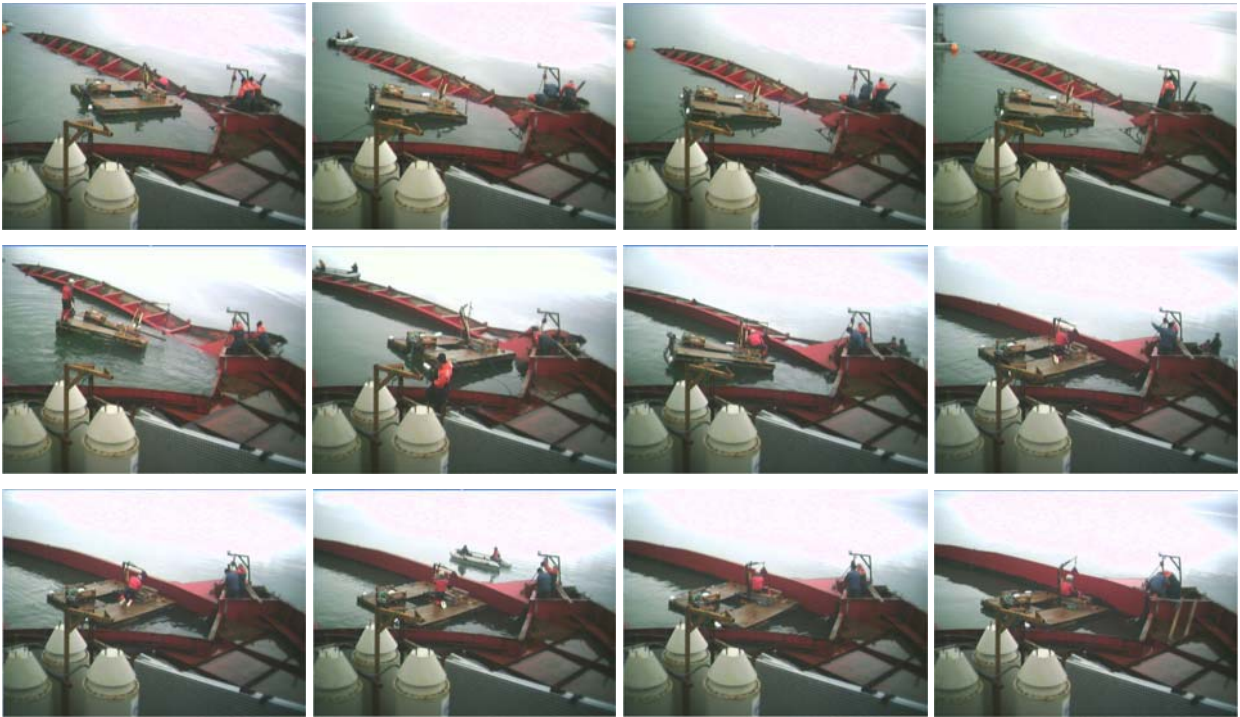
Between Christmas and New Year 2003 the starboard reflector was dislocated due failure of back rope between back of reflector and back corner of platform. The reflector was reinstalled the following day with calm weather, see figure 7.2.

Figure 7.2. Reinstallation of starboard reflector after dislocation, occurring between Christmas and New Year 2003.

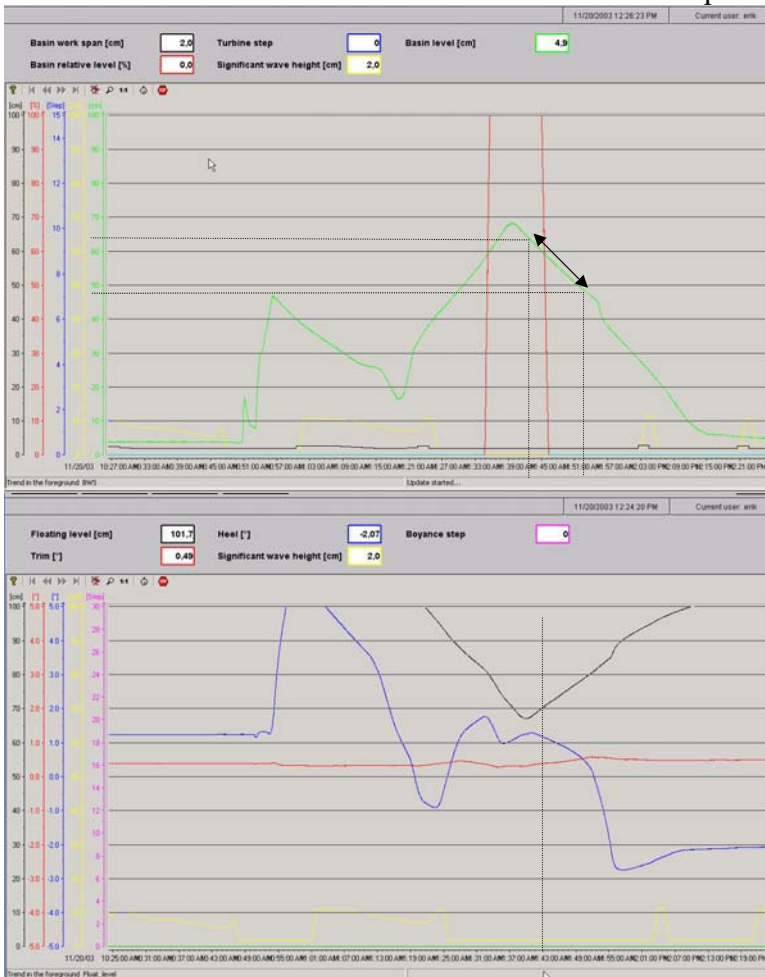
Alle turbiner lukkede – en turbine tætnet med silicone på kanten af cylinderspjældet.

På 10 minutter (11:43 til 11:53) ses vandspejlet at falde med stort set konstant hastighed fra et niveau på 64 cm til 47,5 cm, d.v.s. 16,5 cm.

Idet netto bassinarealet er beregnet til at være $165,5 - 6 = 159,5 \text{ m}^2$ bliver læk tabet $2,63 \text{ m}^3$ svarende til 44 l/s eller en mistet elproduktion på ca. 300 W ved højt flydeniveau.

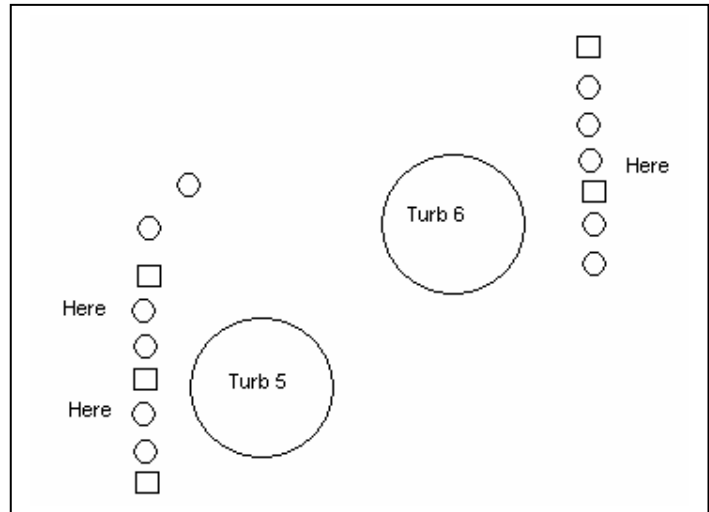
Tried to fill holes in the bottom of the turbine area, but had trouble making the filling stick in the holes. There was too much water in the turbine area. It is necessary to remove all the water from turbine area to be able to fill holes, but the wind was too strong to do so. Tree holes were filled as illustrated:

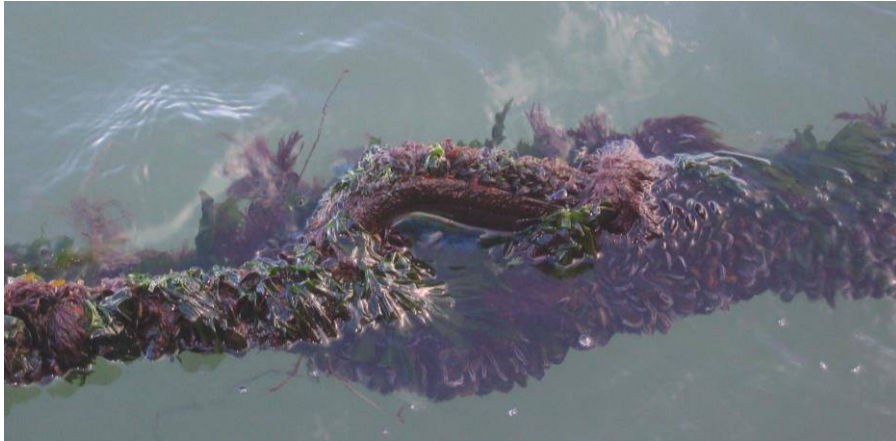
Figur 6.2 Begroning på tovværk efter 1½ års ophold i vandet.

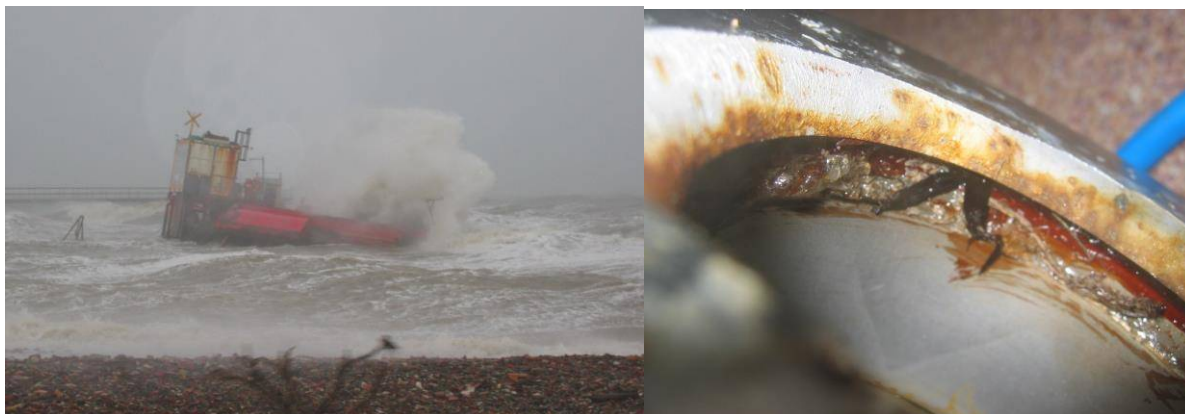
Figur 9.1 Wave Dragon strandet på standen ved Prøvestationen efter stormen den 8. januar 2005 (venstre) efter brud i træk målecelle (højre), der forbandt forankringslinjer og forankringspæl.

Stormen den 8. januar 2005 resulterede i et brud i en målecelle, der forbandt forankringskablerne med forankringspælen /14/. Denne hændelse anses ikke for fatal, da der inden dette tidspunkt er registreret større kræfter i forankringen i stormsituationer. Selve forankringssystemet anses derfor for at fungere tilfredsstillende.

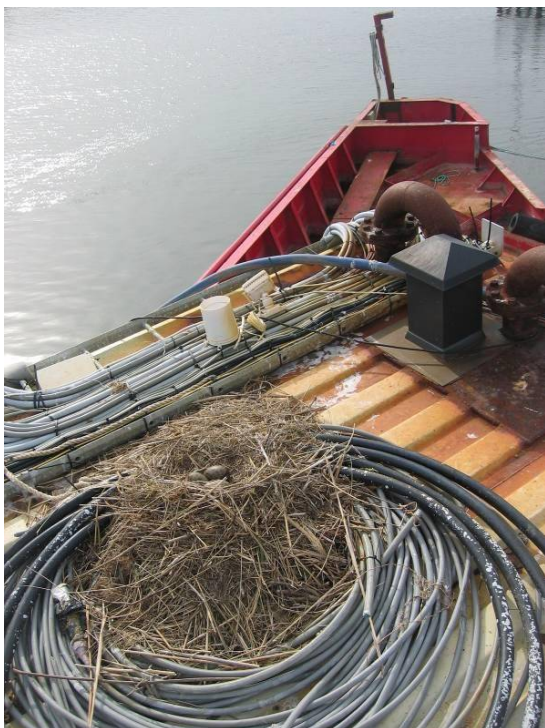
Figur 10.1 Mågerede anbragt i el-kabler.

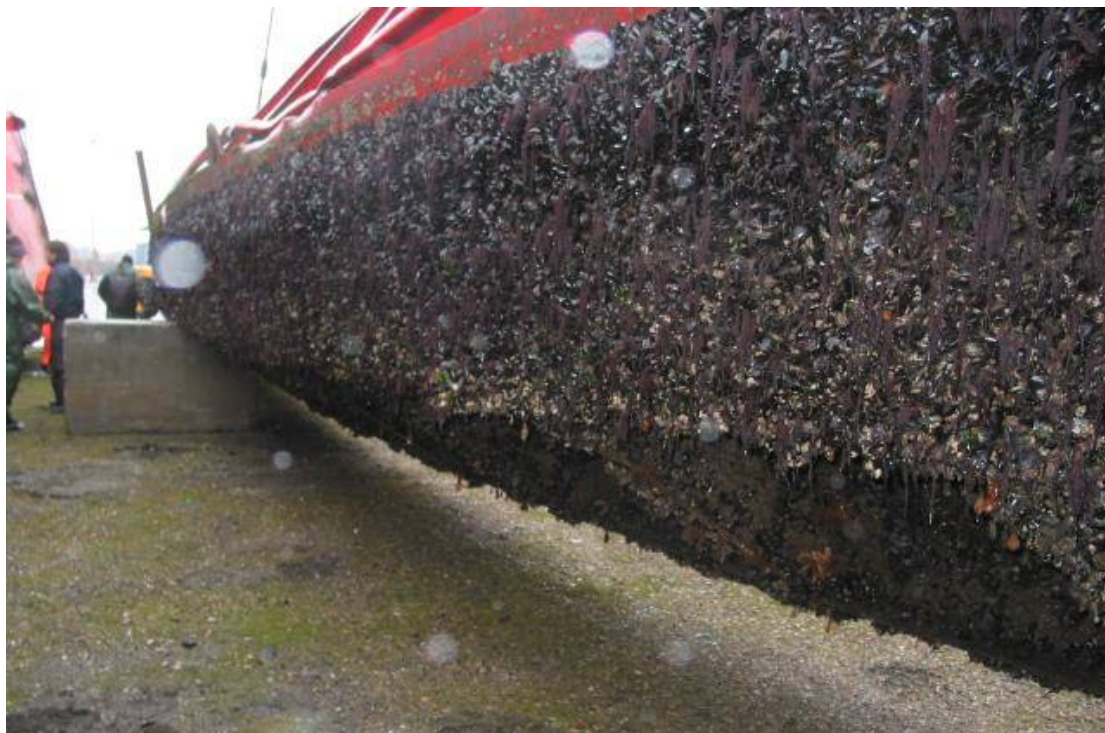
Figur 10.3 Reflektorarm med begroning af blåmuslinger placeret på havnen i Thyborøn december 2004.

Stålkonstruktionen er tæt besat med et 10-20 cm tykt lag af blåmuslinger, se figur 10.3.

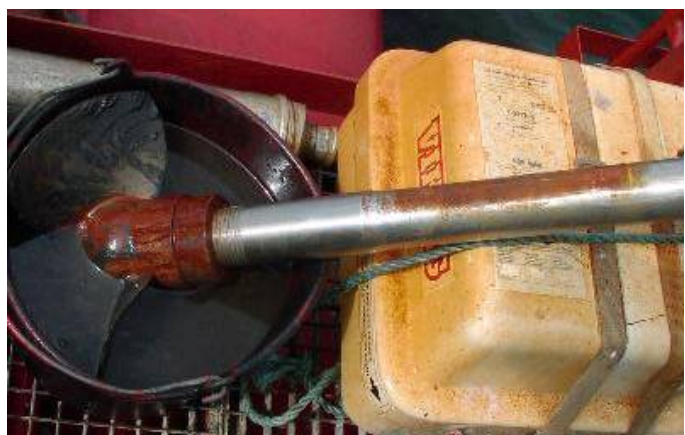
- 1.6. bearing spacer: heavily corroded.
Reason: no paint at all.
- 1.7. turbine shaft:
good condition in view of corrosion, but top end wrongly machined, so that the clamp fit could not be installed properly.
Reason: The analysis has shown that Matti Sorto's drawing for the modification was wrong, and Promecon have executed the machining as per the drawing, not

noticing that about 90% of the clamping area have been machined away. The shaft was obviously fitted without taking notice of this. Probably the loss of the turbine shaft and runner were only prevented by a grub screw in the shaft coupling!

2.8. turbine shaft:
The turbine shaft was cleaned and the top end re-machined to give a proper shrink fit in the specially made bearing sleeve. A new stainless steel clamp ring was fitted.

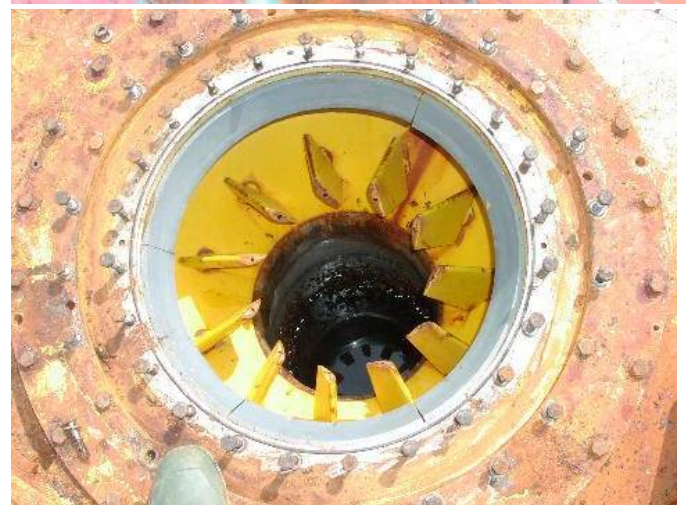
- 1.14. turbine runner:
fair condition, slight corrosion on runner blades. Hub cone missing, thus corrosion inside hub.
A closer analysis revealed that Promecon obviously have not bothered to fit the turbine cone at all. They also fitted a normal steel washer to hold the hub instead of a stainless one, which gave corrosion problems.

A stainless steel thrust washer was machined and fitted to replace the corroded black steel one. A new hub cone was machined from PVC and was fitted with a stainless draw bolt.

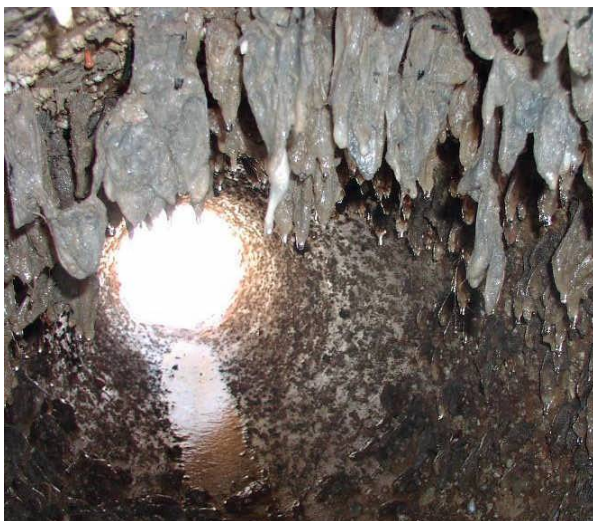
The draft tubes painted with the normal epoxy paint system were found heavily overgrown with marine growth; the layer being about 2 cm thick at the upper end and growing to 7 cm at the lower end. The tubes painted with the Hempel anti-fouling paint were found almost clean, with only a few mussels stuck to them that could easily be removed by hand. Interestingly this applies also to turbine No. 3, which had not been run at all up to now. The pictures below show an epoxy painted and a Hempel painted draft tube in comparison. The growth has already collapsed a bit as the pictures were taken after leaving the tubes out in the winter weather for one day.

draft tube with conventional epoxy paint

Furthermore the draft tubes treated with the conventional epoxy paint will have to be sandblasted and treated with the Hempel paint system.

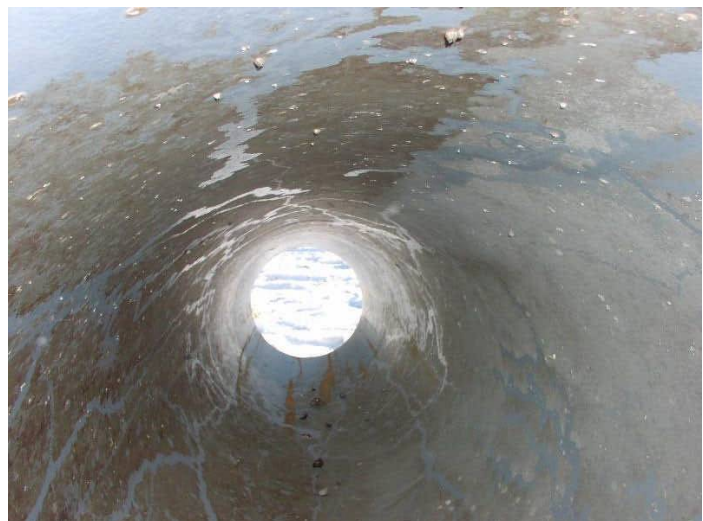
draft tube with Hempel anti-fouling paint

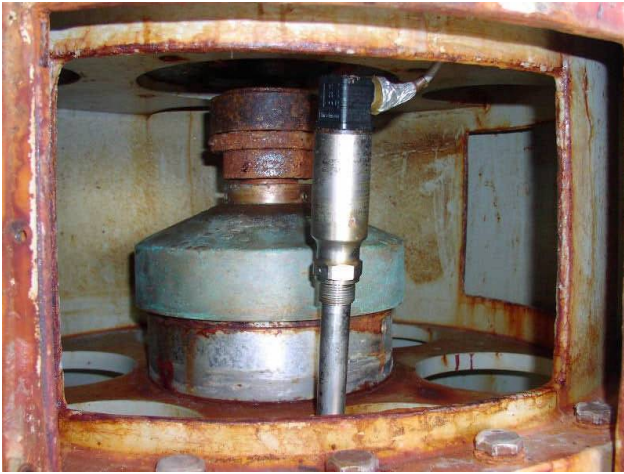
These turbines had already been rebuilt during the summer 2004. The runners and discharge rings were found in good condition, without any damages. The thrust bearing assemblies looked as if they had been flooded with salt water for some time. This might have happened while the Wave Dragon was on the drift as some of the turbines were still open when the cable connection was lost, and the platform has probably got heavily flooded during the storm.

thrust bearing assembly turbine no. 2

These turbines were not yet dismantled. A decision on this will have to be taken at the next visit. On turbine no. 5 it will probably suffice to change the bearing oil, but on no. 2 and 4 it might be wise to replace the ball bearing, which will necessitate taking out the generator and the turbine shaft.

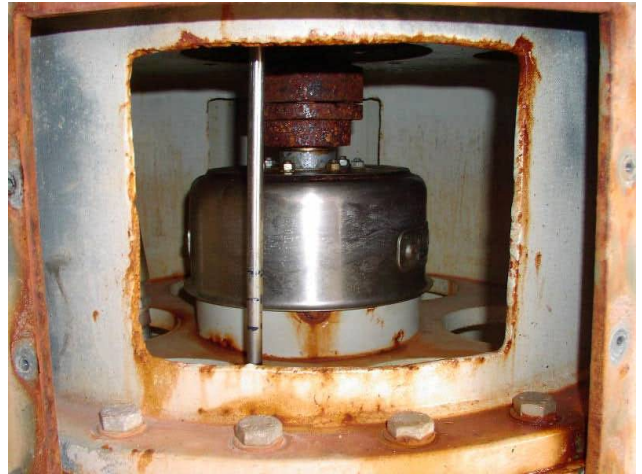
thrust bearing assembly turbine no. 5

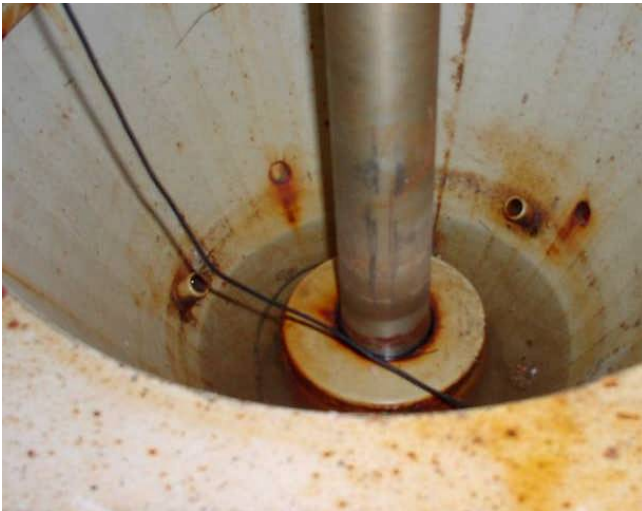
The radial (rubber) bearings seemed to be in good condition. The space around them contained clean water, with only very little sand.

rubber bearing assembly turbine no. 4

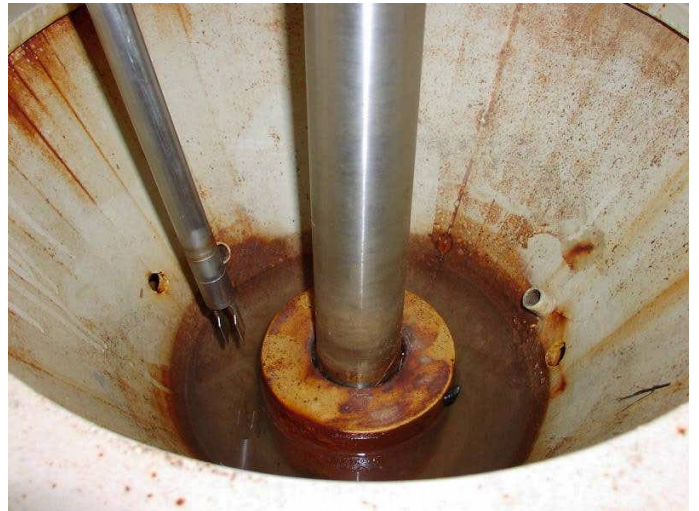
rubber bearing assembly turbine no. 5

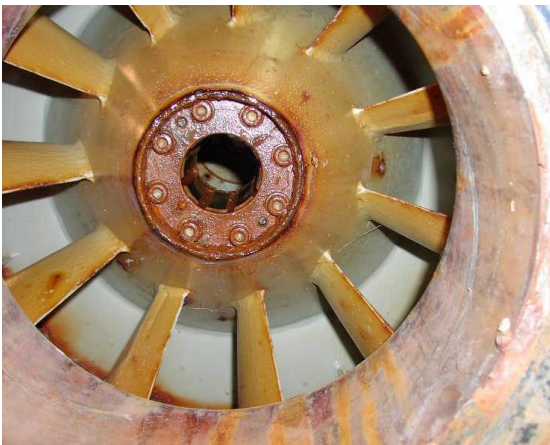
The thrust bearings were almost completely destroyed by corrosion, and contained only about 100cc of oil/water mixture as lubricant. The radial bearings were completely filled with sand. The discharge ring and guide vanes were in good condition, but the runner, especially in case of turbine no. 7, was rather overgrown with small shells. We think this is mainly due to the fact that the turbine has never been operated while being in the sea for about 15 months.

discharge ring and guide vanes turbine no. 7

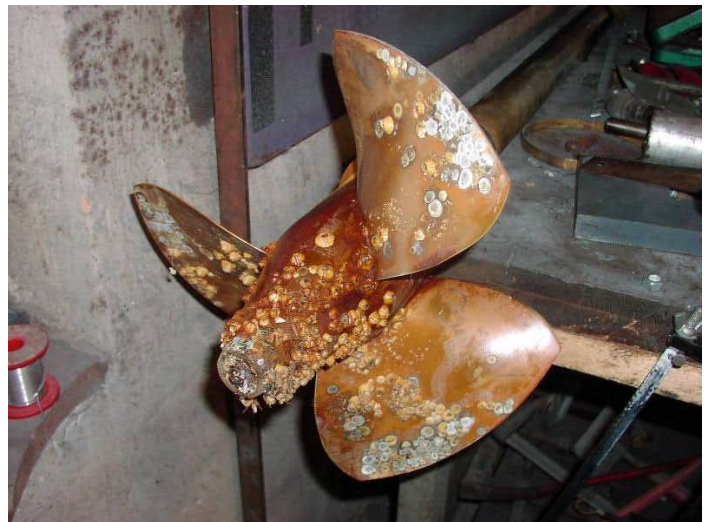
runner turbine no. 5

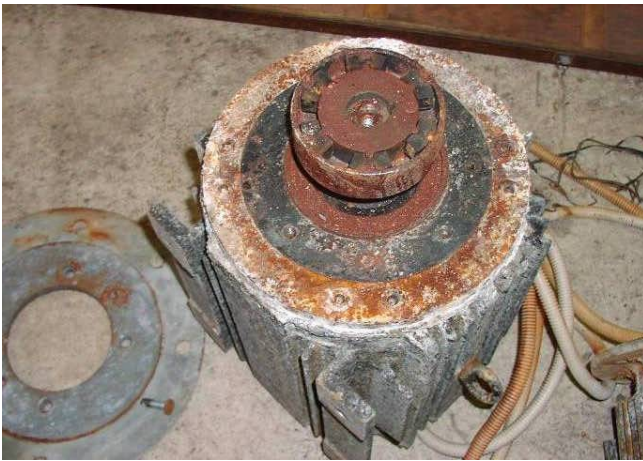
The generators were found salt encrusted and corroded. They will be opened, cleaned and sealed before re-installation. The turbines have been completely dismantled and will be stored, together with the other turbines, at the Folkecenter until re-assembly.

generator turbine no. 7

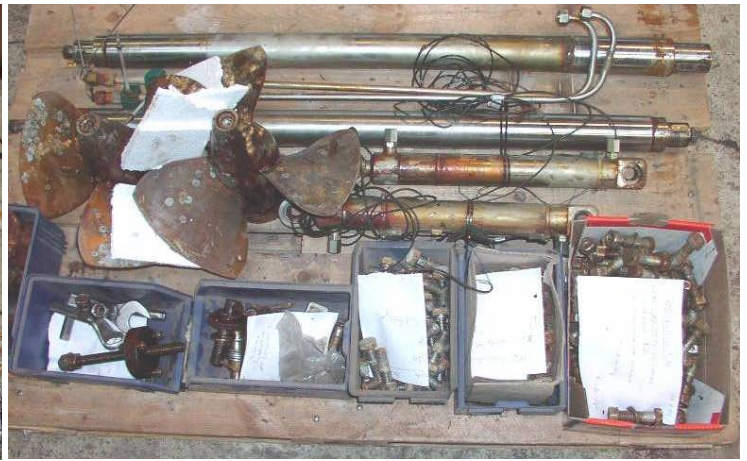
In dismantling, no damages due to the stranding have been found, but the corrosion damages to the thrust bearings and generator and sand filling to the radial bearing were as expected.

dismantled components turbines no. 3 + 7

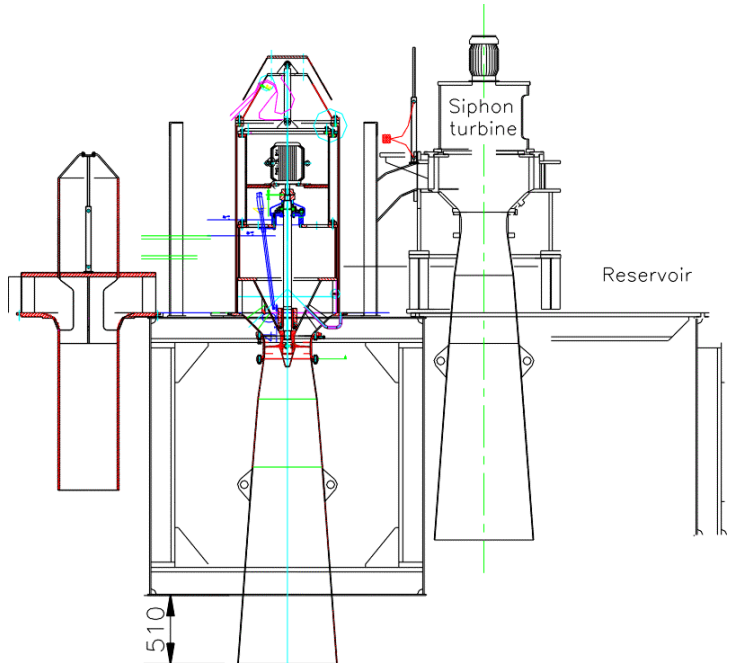
situation of cylinder gate turbine draft tubes

From the above drawing the draft tubes need to be shortened by 550mm. The decrease of turbine efficiency resulting from the shortening of the draft tubes is shown in the following tabulation. The calculation is based on the assumption of a uniform velocity distribution in the draft tube outlet and an exit loss factor of 1.0.

When the draft tube is shortened by 550mm, the exit losses will increase from 2.8% to 5%, thus a reduction in turbine efficiency of 2.2% must be expected. This seems well justified in consideration of the risks of damage that can thus be avoided.

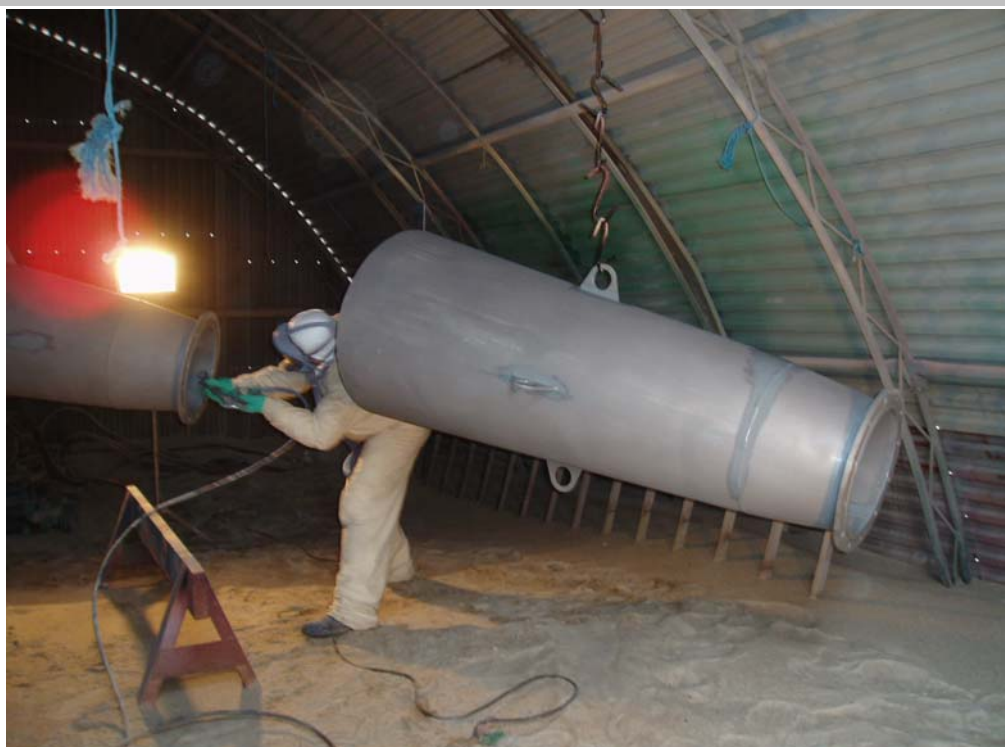
Photo no.: 4

Påføring af HEMPADUR 45143/11480, bemærk udstikning.
