Wave Dragon Prototype

Tilstandsvurdering **BILAG**

Energinet.dk projektnummer 6459

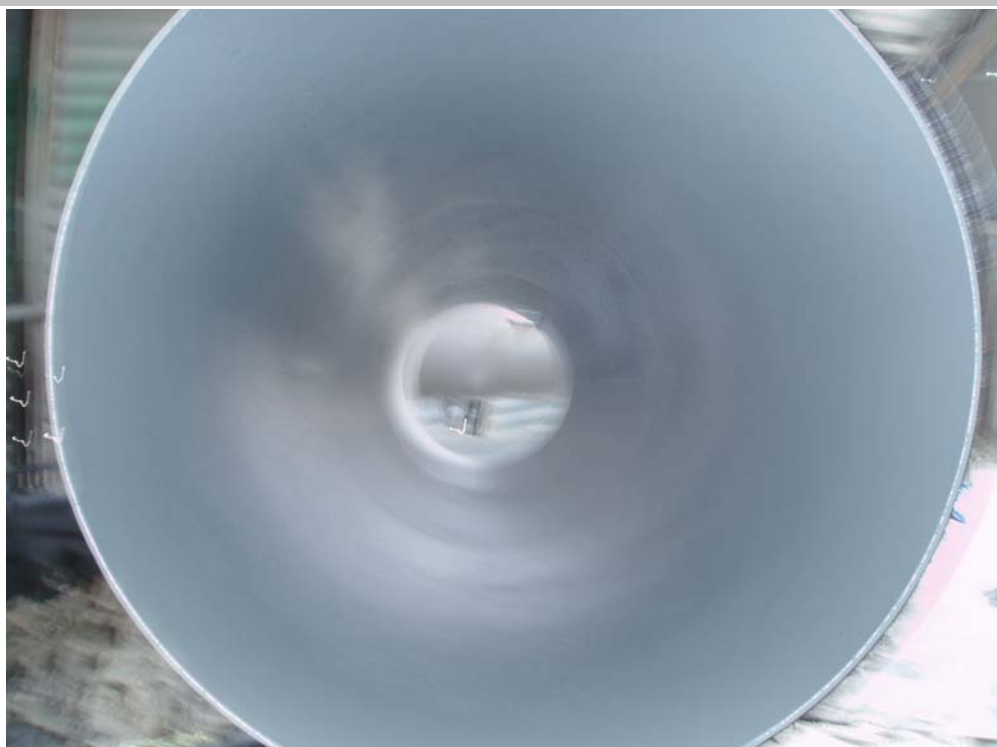
Photo no.: 28

Slut resultat indvendig Turbinerør.

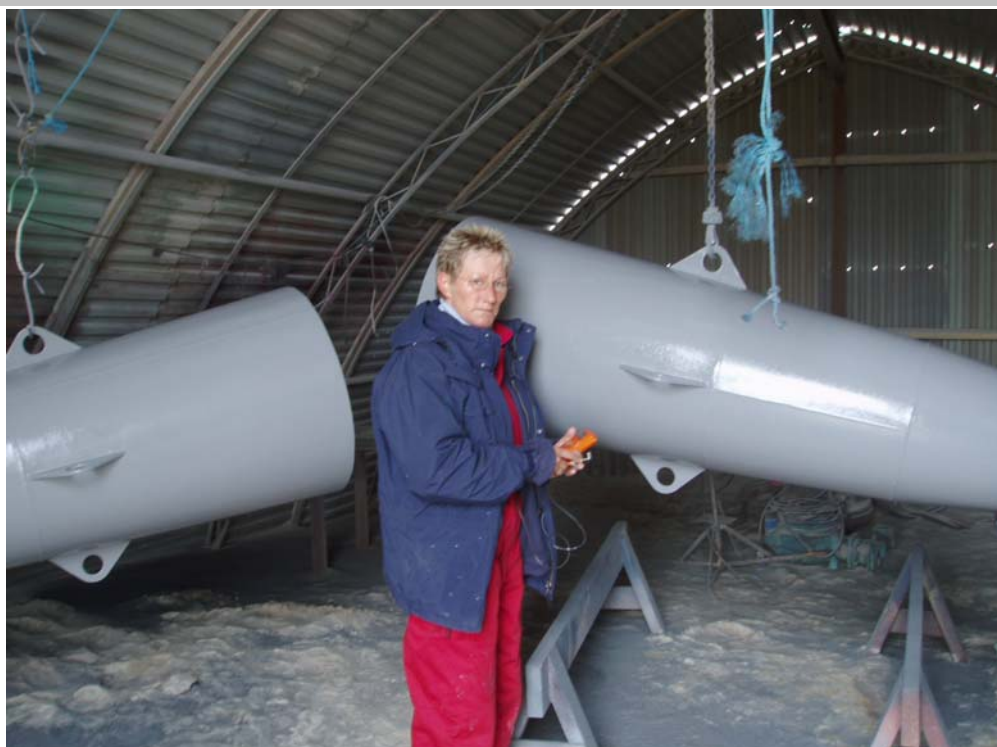
Photo no.: 30

Slut kontrol, DFT målinger.

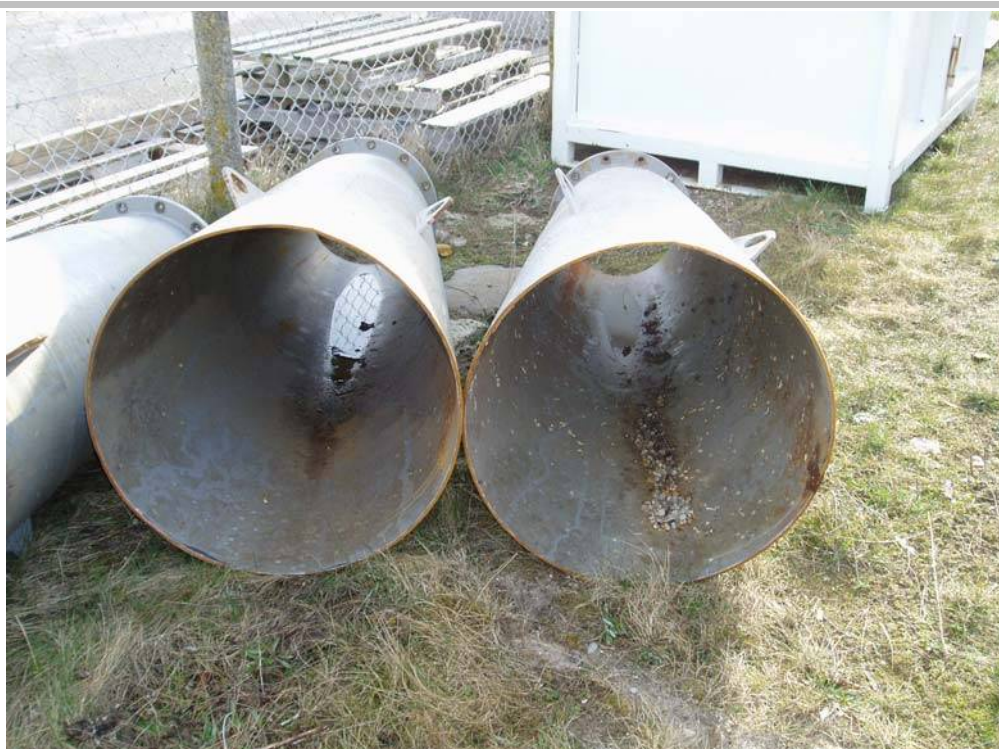
Photo no.: 32

De gamle Turbinerør.

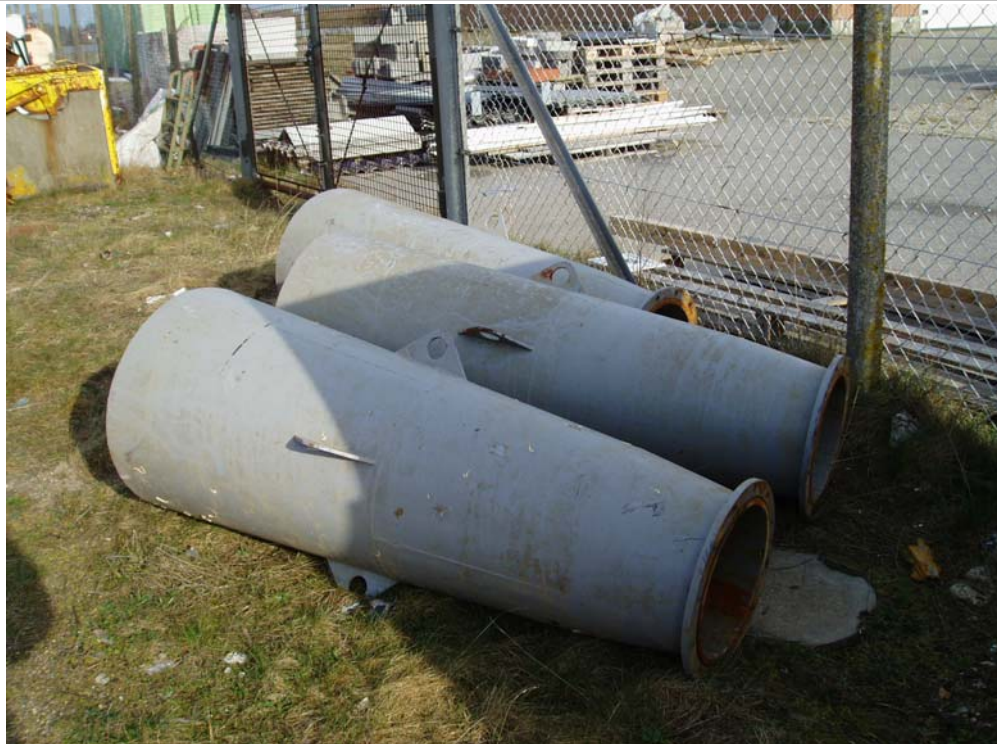
Photo no.: 33

De gamle Turbinerør.

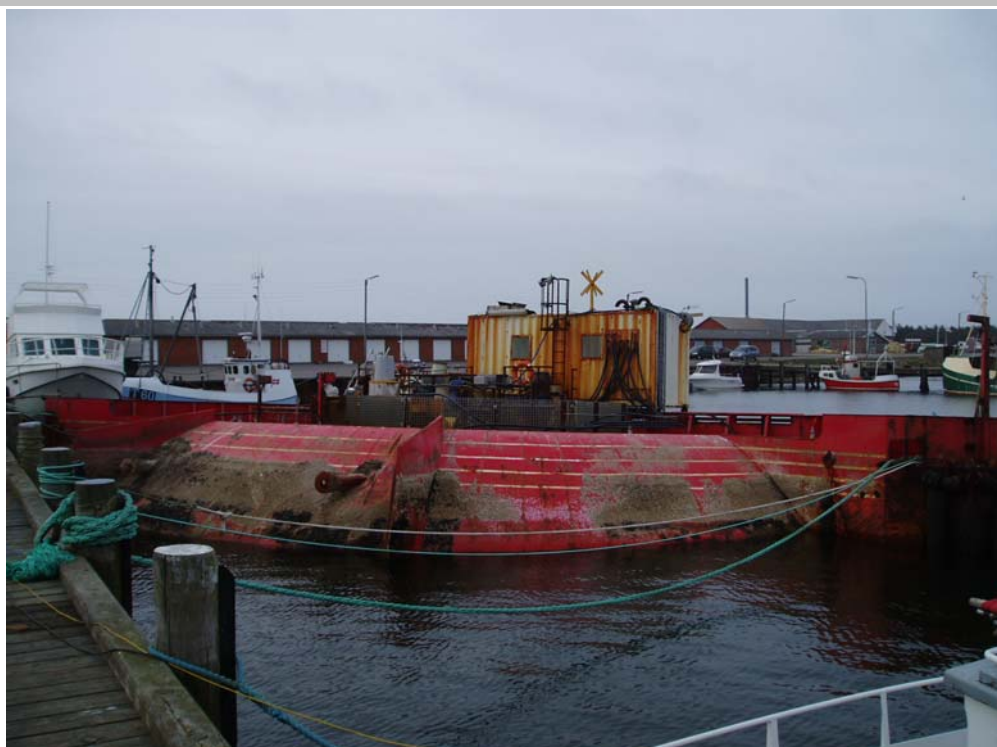
Photo no.: 34

Wave Dragon, trænger til HEMPEL maling.

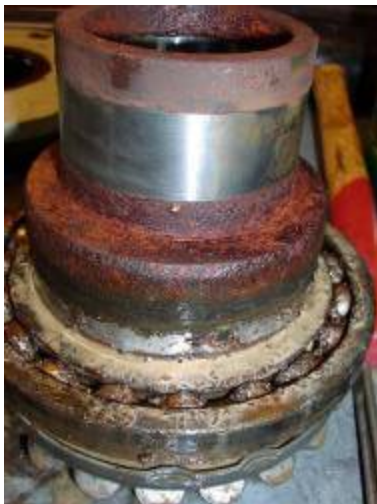
Fig. 3.2. shows a dismantled turbine bearing which had been designed according to standard river hydropower practice. After 9 months of offshore use the seal had broken down, with subsequent intrusion of salt water and corrosion damage to the bearings.

fig. 3.2.: Corroded components of a turbine bearing.

Subsequently, the bearing has been redesigned, using seawater resistant materials and employing a combination of a gravity seal and a lip seal, see fig. 3.3. This solution has worked without problems since.

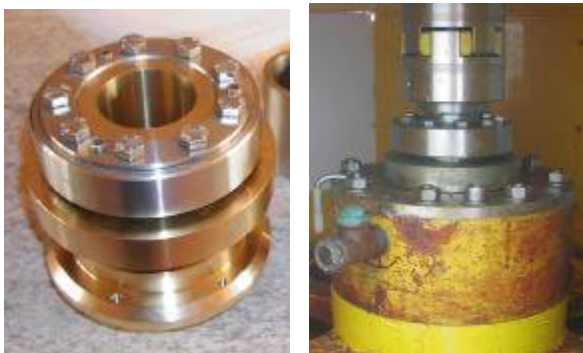
fig. 3.3.: Redesigned bearing

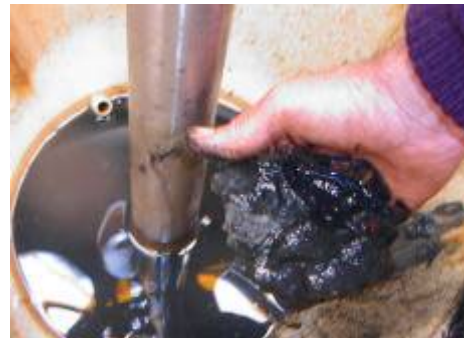
fig. 3.4.: Sand-filled water-lubricated bearing

Fig 3.4. shows a water lubricated radial shaft bearing after one year of operation. Due to an unfavourable layout of the lubrication system the bearing filled up with sand, and finally the water supply was blocked by mussels growing in the feed pipes. A modification of the water supply solved the problem.

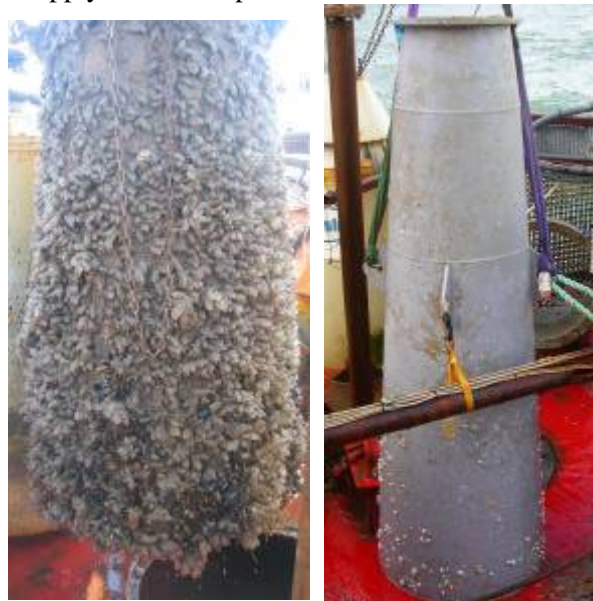
fig. 3.5. and 3.6.: Draft tubes with and without marine growth

Figs. 3.5. and 3.6 show two turbine draft tubes that have been in the sea for one year. The tube on the left hand side was coated with a standard epoxy paint system. After one year in the sea, the layer of mussels and sea squirts was up to 10 cm thick on the outside as well as inside the tube. The tube on the right hand side was covered with a non-toxic silicone-based

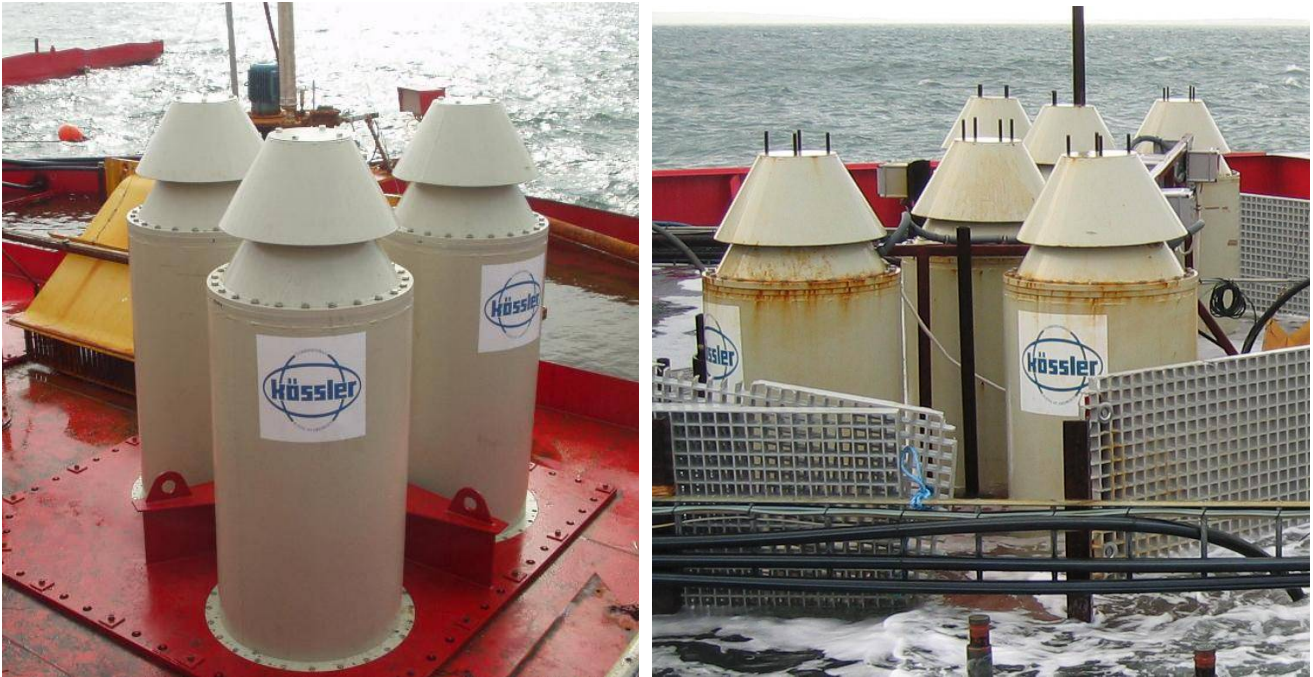
As with the Wave Dragon structure, the corrosion protection of the turbines was not intended to last for a very long time. The first corrosion marks became visible after a year at sea, see fig. 2.

fig. 2: turbines after installation and one year later

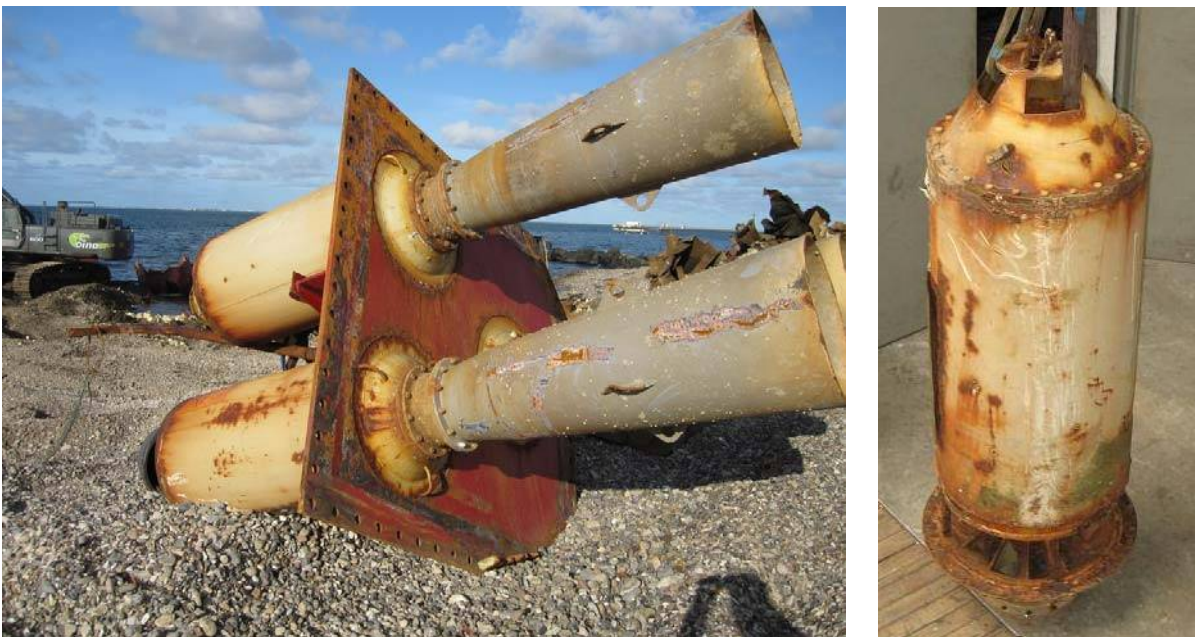
Approximately 10 months after dismantling of the Wave Dragon prototype, two of the cylinder gate turbines were transported to TUM in order to dismantle them and inspect their components. When looking at their condition, it needs to be taken into account that the turbines had not been treated very kindly during the dismantling of the WD structure, see fig. 3. Thus some components showed additional damage which could be attributed to this handling.

fig. 3: turbines on the beach during dismantling of the WD structure and one of them on arrival in Munich

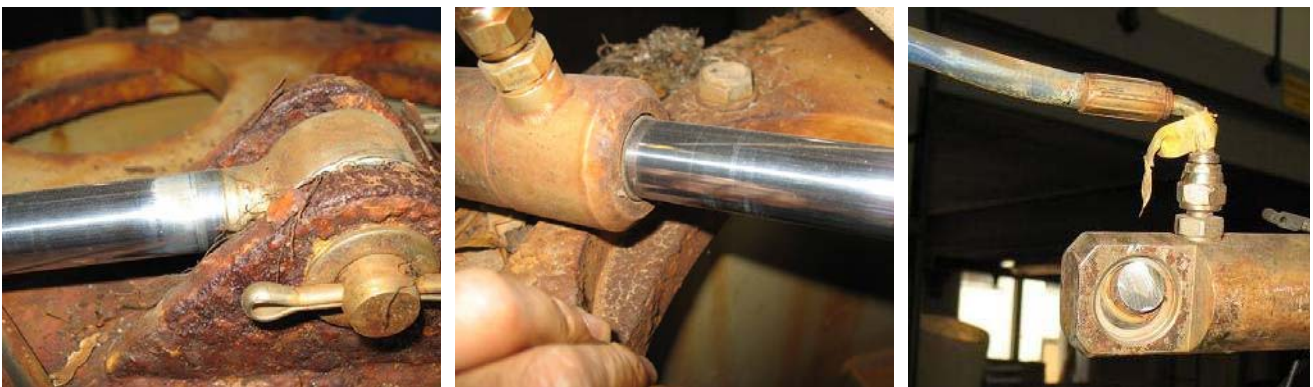
Both cylinder and fasteners have stood the corrosion attack very well. There were no cylinder leaks observed at any time. The tarnishing of the cylinder is just extraneous rust from the black steel parts in the neighbourhood, which could easily be wiped away, as seen on the piston rod. The shackle bolts had to be cut off, however, as they were seized within the black steel rod eyes on the generator case due to corrosion of the latter.

fig. 5: hydraulic cylinder for operating gate

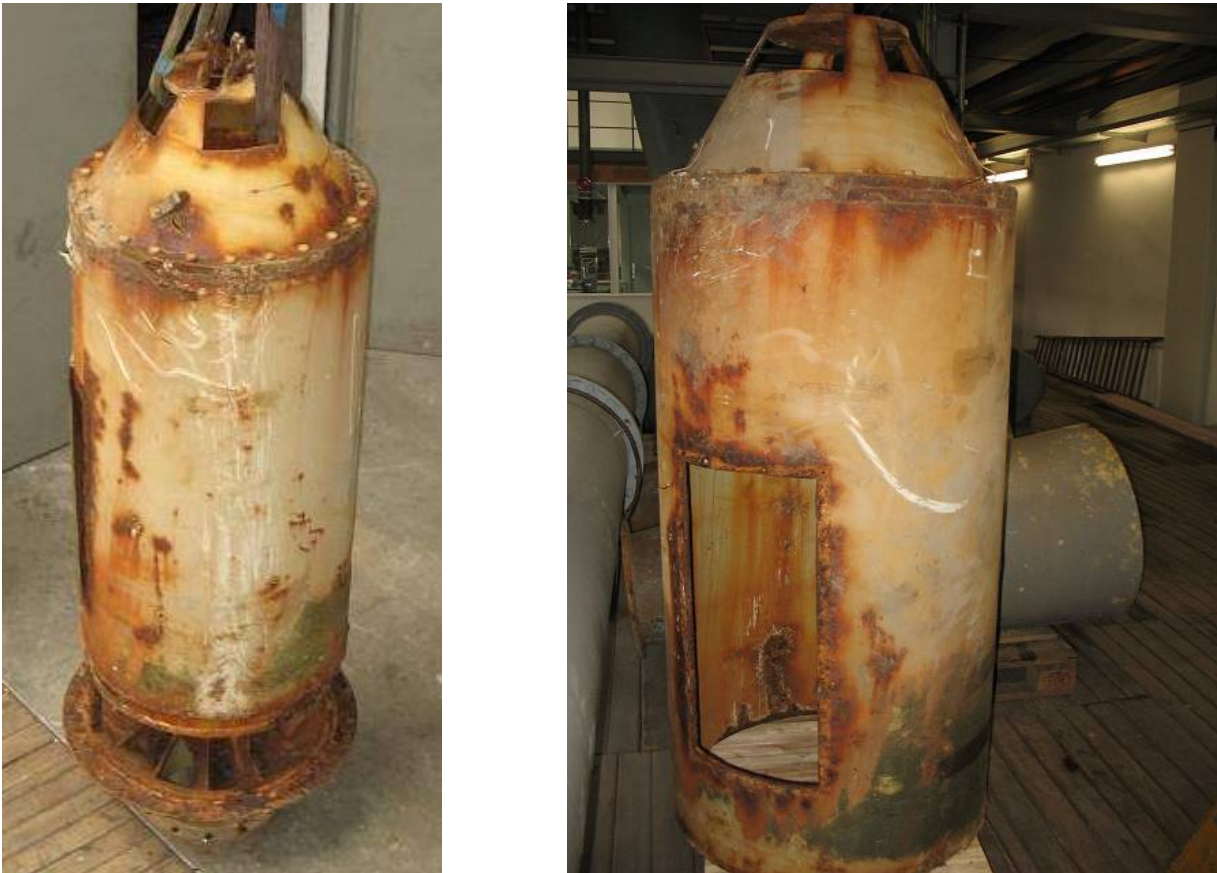
fig. 6: cylinder gate

As can be seen from fig. 6, the coating only worked well in the few places where it never received any blemishes. Apart from any scuffing during handling and assembly, which might be avoidable to an extent, it is obvious that corrosion started also from all the fixing bolts and thread holes, where the coating already gets damaged when the bolts are tightened, and from any edges where the coating is normally thin and vulnerable, see fig. 7.

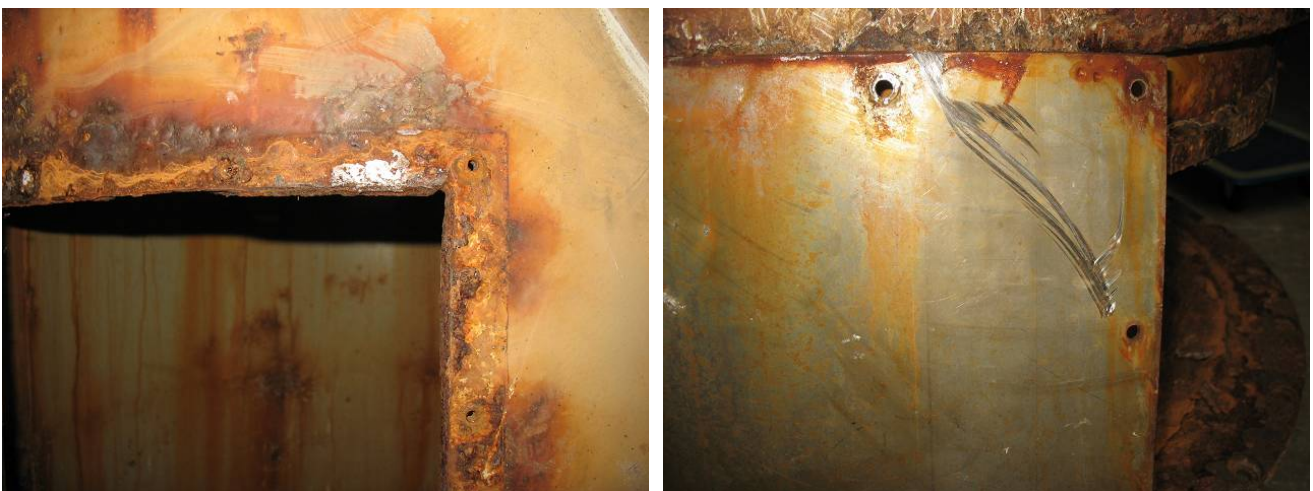
In order to permit access to the bearings, inspection windows had been cut into the gates at a later stage. This work has been performed partly at sea and partly at the Folkecenter workshop near Nissum Bredning. Thus it was not possible to carry out the coating of the edges with primer and top coat to a very high standard. The inspection window was closed with a plate of 1.4301 stainless steel, held in place with M6 hex bolts from A2 steel. Apart from a tarnish from extraneous rust the plate coped well with the corrosion attack, see fig. 9. The threads had been treated with water resistant grease before fitting the bolts and most of them could still be unscrewed about 5 years later.

fig. 9: cylinder gate cover plate

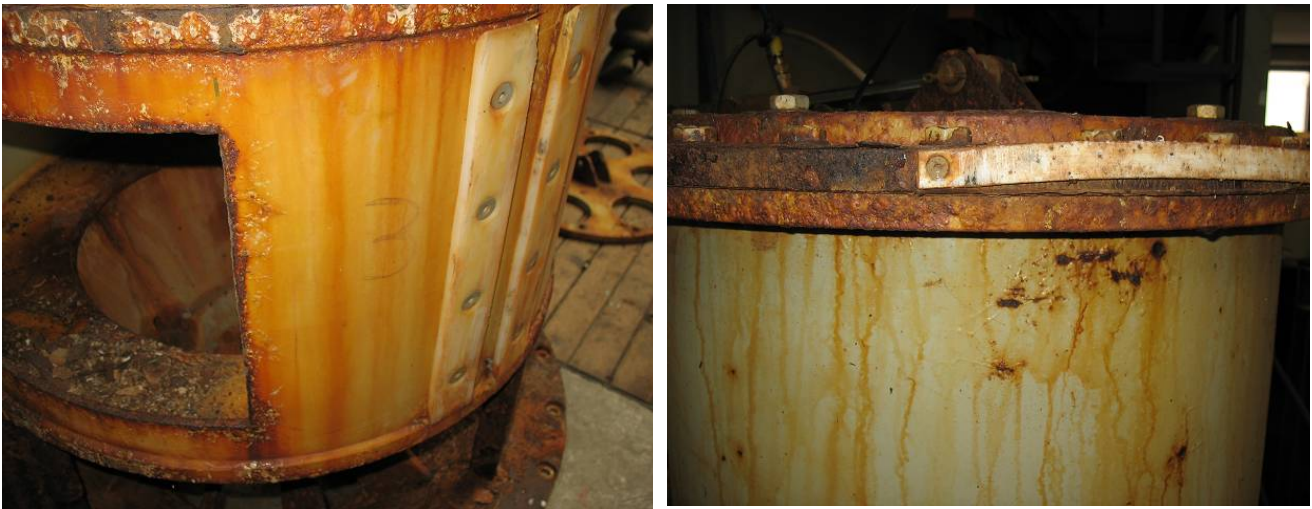
The gate cylinder was prevented from rotating by two PE guide rails and was intended to glide on Teflon strips, see fig. 10. While the former stood well up to the job, the Teflon strips were partly torn away by the increasingly rough inner surface of the cylinder gate. Probably this problem was aggravated by rust swelling up underneath the bearing strips.

fig. 10: cylinder gate guide rails and bearing strips

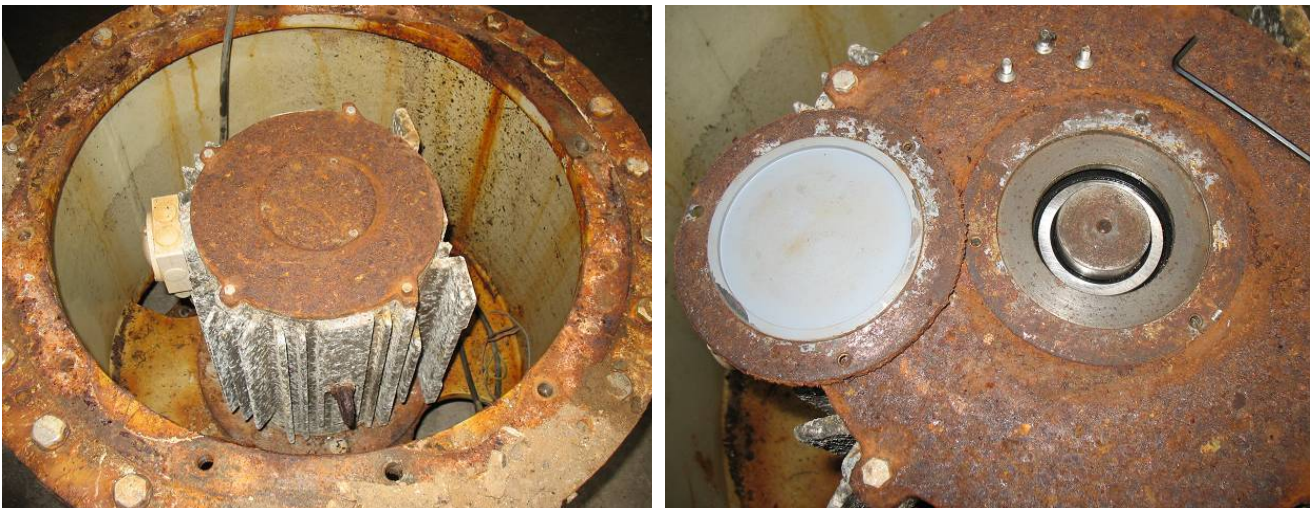
The permanent magnet generators had been made by a firm in Czechoslovakia. It was possibly due to communication problems that they were obviously not produced to withstand any salt water attack. Their aluminium case and steel top cover plate had only received some decorative painting and the name plate said they were only specified protection class IP54. It can be seen from fig. 11 that the generator casing has suffered from the corrosion attack. The rear top bearing cover had no O-ring seal. It was re-fitted with some sealant during a repair. While this could apparently not completely prevent the ingress of humidity, it seemed sufficient to protect the bearing from corrosion.

fig. 11: permanent magnet generator

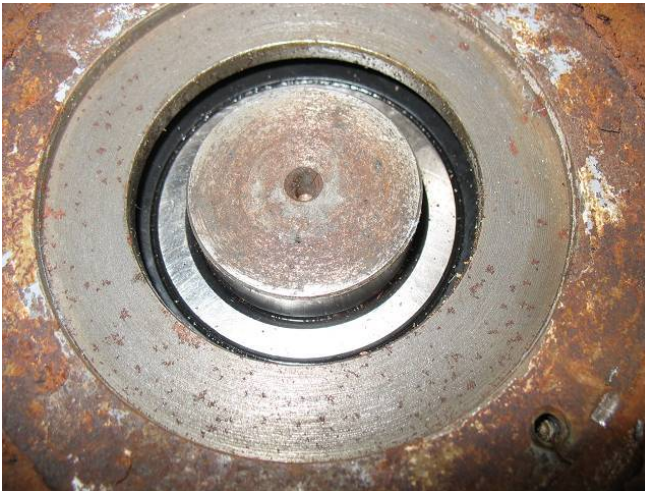
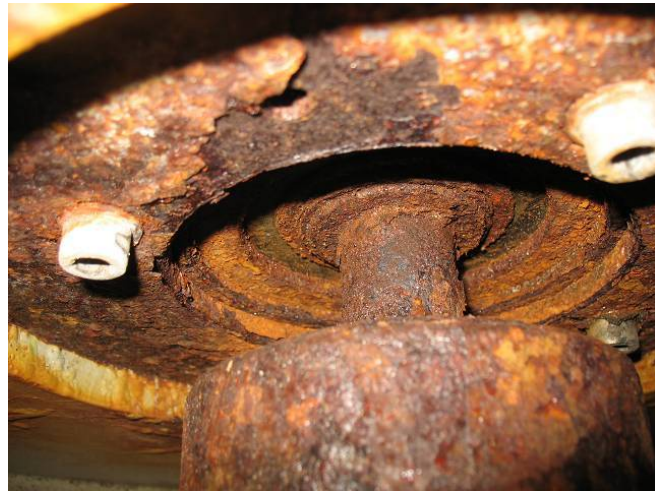
Fig. 12 shows the bottom (drive) side of the generator. No corrosion resistant materials had been used here, and the bearing, being a lip-sealed type, was exposed to the eventual salt water spray occurring here. As a result, the shaft was found heavily corroded and the bearing destroyed by corrosion – the shaft could not be turned by hand any more when the turbines were dismantled. Due to the restricted space available, the generators were delivered without a connection box. This proved very cumbersome when dismantling and reassembling the turbines during a repair. They were thus converted to carry a junction box for which purpose, due to poor local availability, domestic outdoor junction boxes were used. Apart from the use of a few nuts from unsuitable

fig. 12: generator top and lower bearing

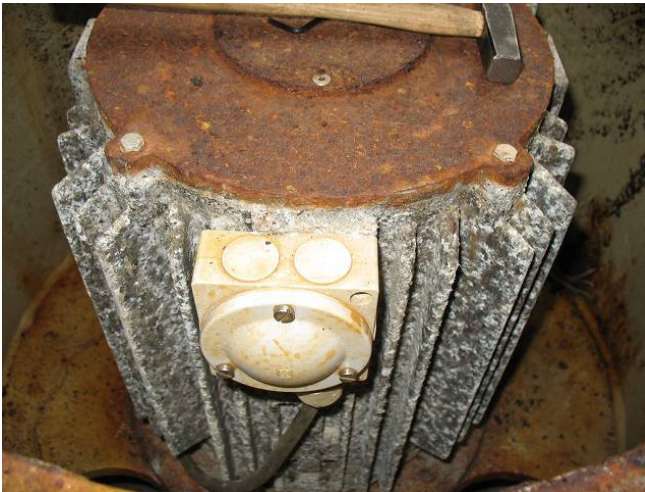
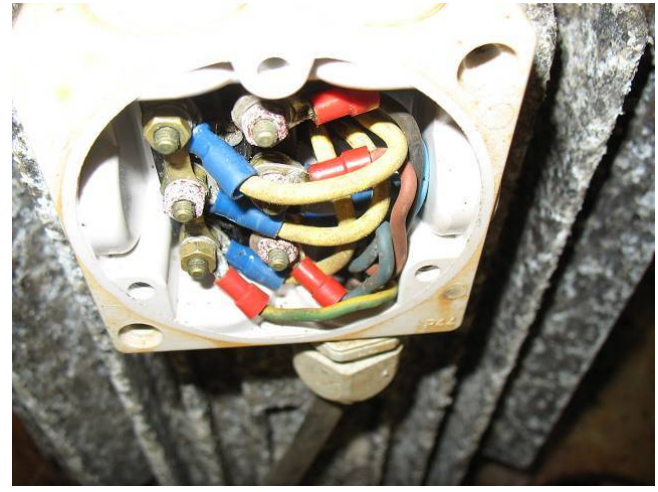
material (zinc plated instead of brass) these boxes with a rubber seal cover did work quite well, see fig. 13.

fig. 13: generator terminal box

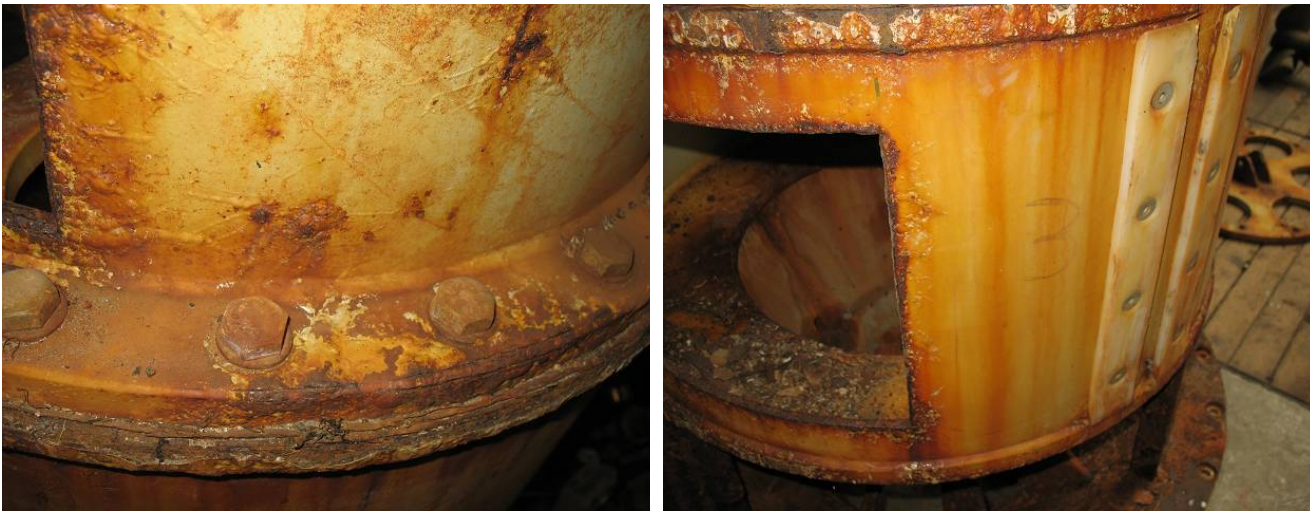
The generator case and turbine shaft case were, like the cylinder gate, manufactured from S235 JGR2 steel plate, welded, sand blasted and coated with one 0.04mm layer of FRIAZINC R zinc primer followed by a 0.2mm thick layer of ICOSIT SW500 epoxy top coat. Like with the cylinder gate, the corrosion protection proved only successful in places where no mechanical impact of any kind was sustained.

fig. 14: generator case and turbine shaft case

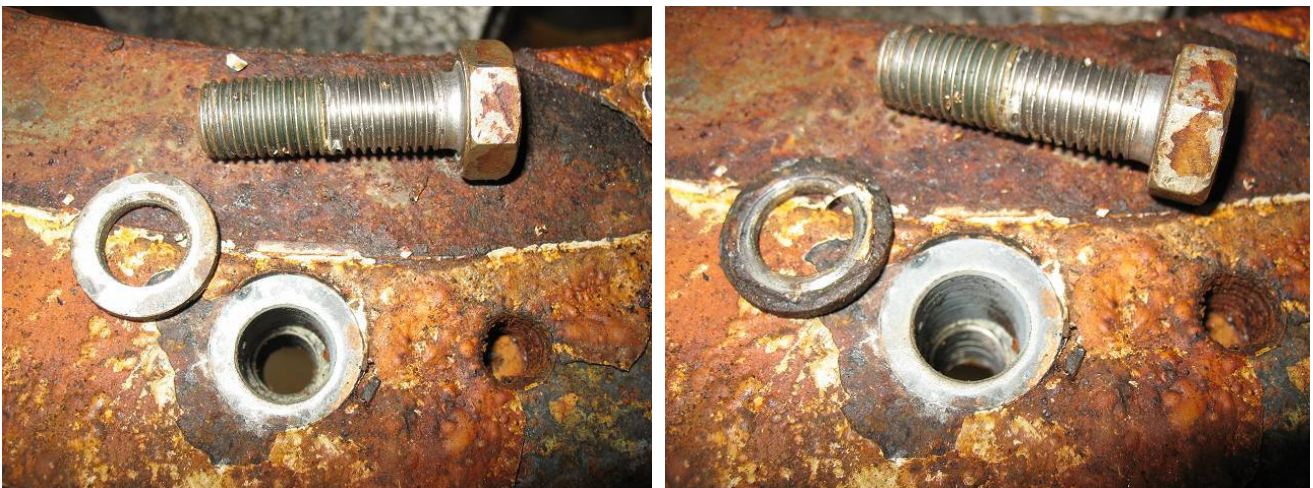
Some of the bolt connections had originally been made with zinc plated bolts. These were exchanged for A2 stainless steel bolts at a later re-assembly. Fig. 15 shows one of the bolt connections with the typical problem: The paint layer is squashed away under the bolt head, and some of it chipped off next to the area of the bolt head. In this case, a zinc plated washer has been used instead of a stainless steel one. On the underside, where it was protected by the grease used in the assembly, the washer is still near perfect, while on the upper side, it is heavily corroded where it was exposed to the elements. The inside of the bore and the thread in the black steel part appear almost pristine, which must be credited to the extensive use of water repellent grease during the assembly. The A2 bolts are, save from some tarnishing due to extraneous rust, in perfect condition.

fig. 15: bolt connection of upper generator deck

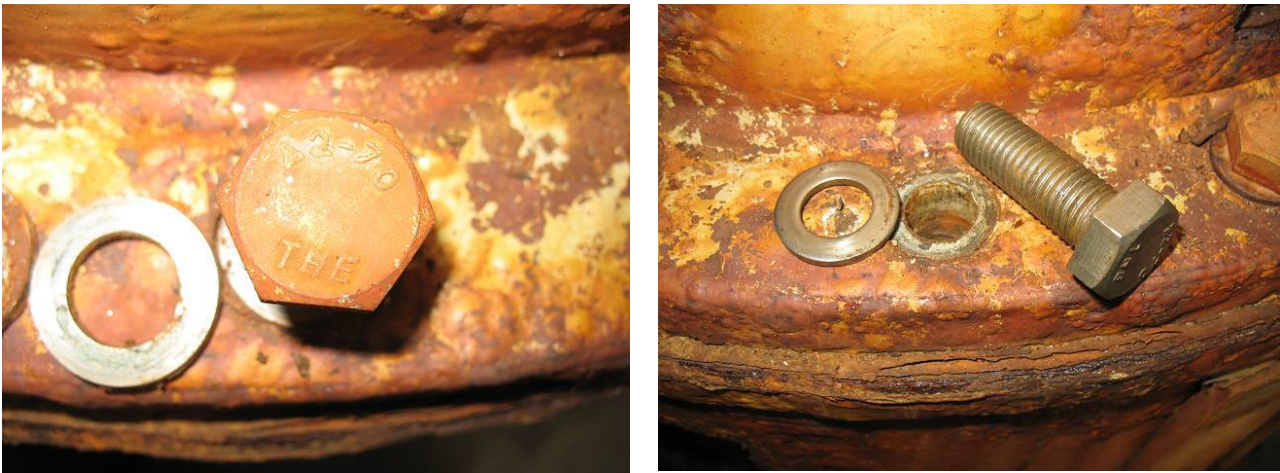
Fig. 16 shows another such bolt connection; in this case an A2 washer was fitted under the bolt head. Bolt and washer are free from corrosion, and, remarkably, there is no increased corrosion on the black steel parts near the stainless components.

fig. 16: bolt connection of generator case and turbine shaft case

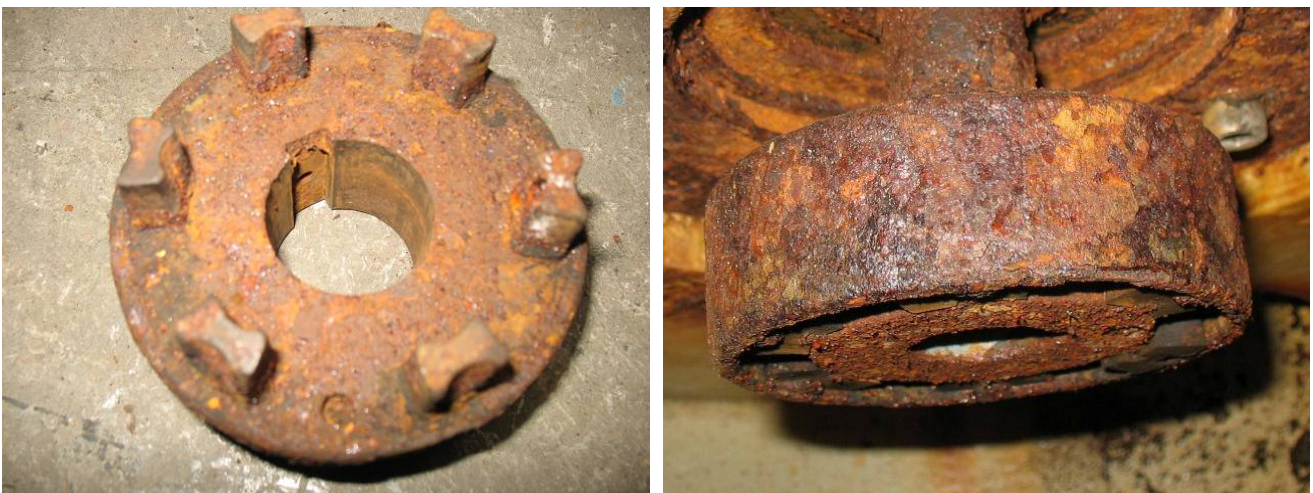
For reasons of cost, a standard Flender N-Eupex B110 shaft coupling made from EN-GJL-250 cast steel without any specific corrosion protection has been used. Despite the fact that the internal turbine parts were basically shielded from the elements, it seems they were exposed to salt water spray rather often.

The component was still functional, albeit heavily corroded, see fig. 17

fig. 17: generator shaft coupling

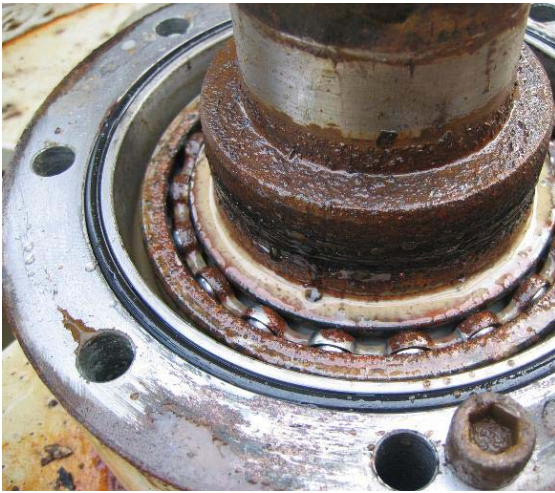
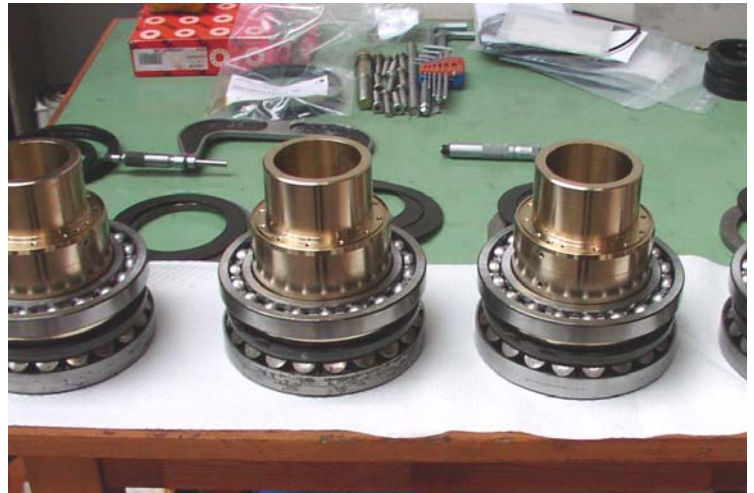
The turbine thrust bearing assemblies were derived from standard river hydropower practice. Unfortunately the designer had not borne in mind that they were to be exposed to salt water. The shaft sleeve was found heavily corroded after a few months time, and the lip seal gliding on it was destroyed, which permitted salt water entry into the bearing. Thus, the bearings were redesigned with a different sealing system and a shaft sleeve made from corrosion resistant CG-Cu Al10 Ni Fe Aluminium bronze, see fig. 18. The whole bearing assembly was also protected against dripping and spray water by a hood spun from CuZn18 gilding metal. The Aluminium bronze bearing sleeve and the redesigned seal have apparently worked quite well. The oil contained in the bearing had some humidity in it, but there was no obvious corrosion damage to the bearings, see fig. 20. The bearing hood was found almost pristine on the inside. It had some corrosion on the outside, but

fig. 18: thrust bearing rebuild in the year 2005

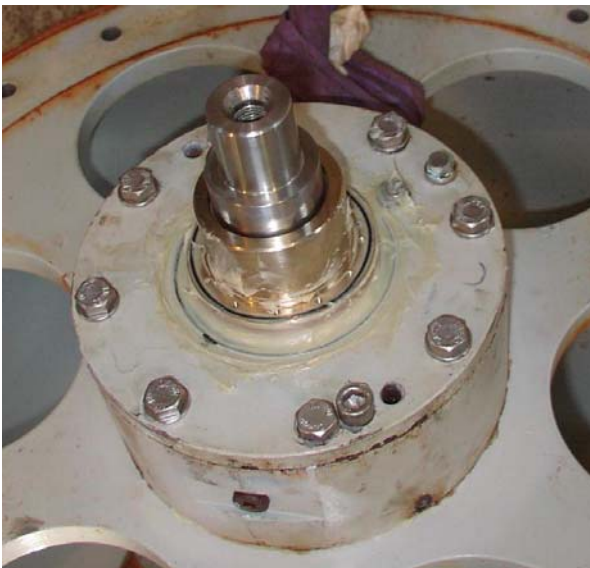
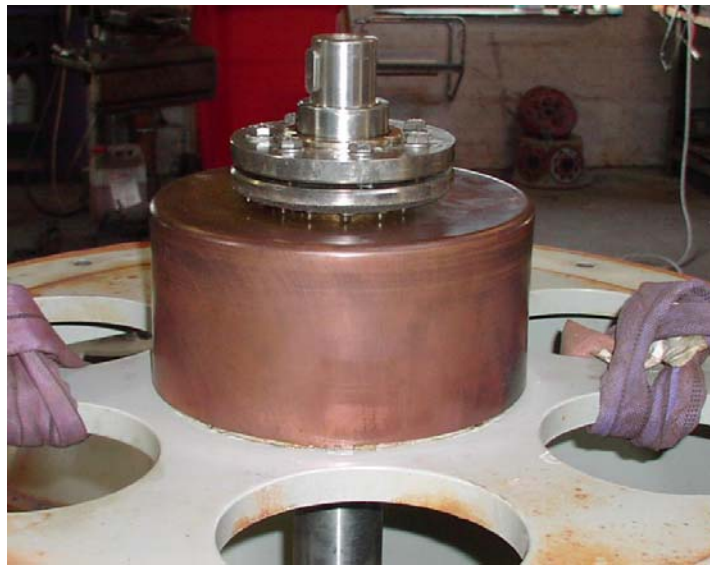
fig. 19: thrust bearing after rebuild in 2005

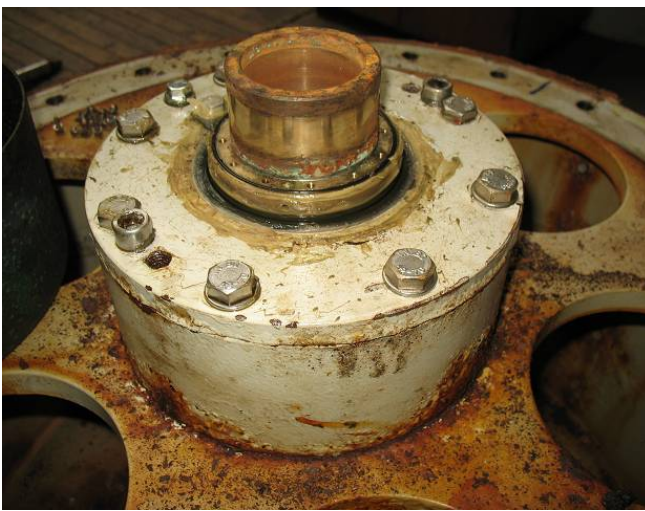
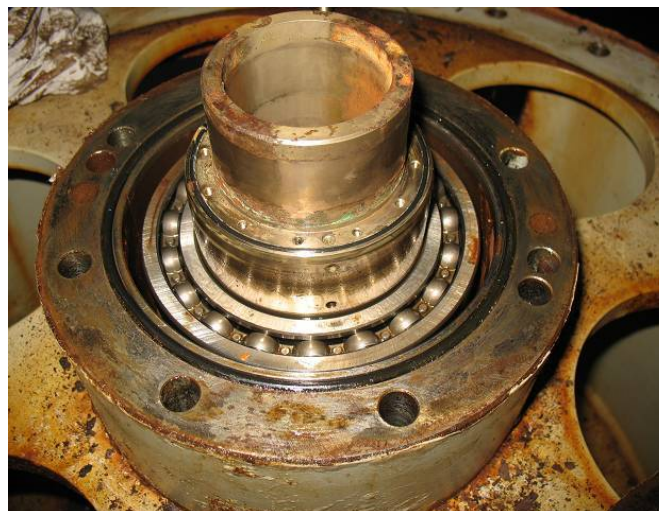
fig. 20: thrust bearing after dismantling in 2012

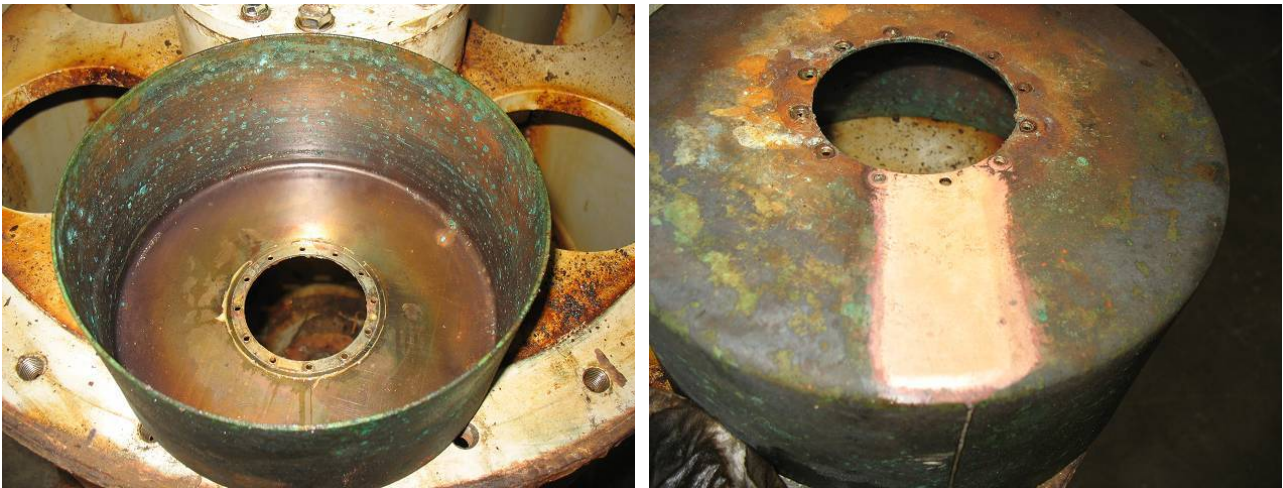
when the light scaling on the surface was removed by a quick etching of hydrochloric acid, the metal came out bright and without corrosion marks, see fig. 21.

fig. 21: thrust bearing shield 2012

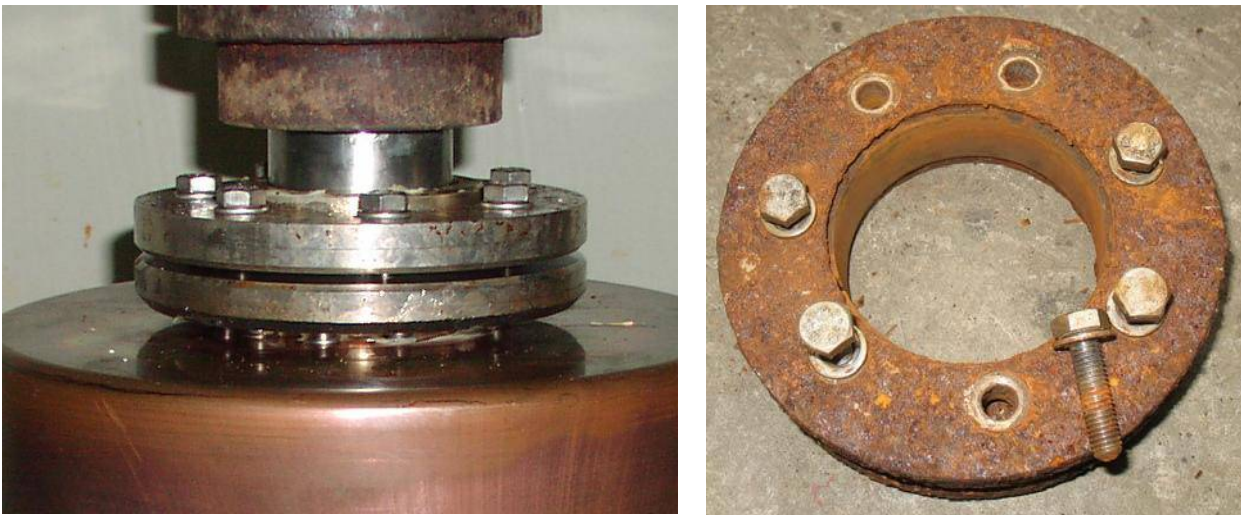
The turbine shaft was held in the bearing sleeve by means of a Benzler type 3071 shrink disc. The material specification is unfortunately unavailable. However, it seems that the disc itself consisted of a nickel-chromium steel with a moderate corrosion resistance. While the discs were still in quite good condition during the overhaul in 2005, they were now found strongly corroded, see fig. 22.

fig. 22: shrink disc assembly during overhaul in 2005 and now in 2012

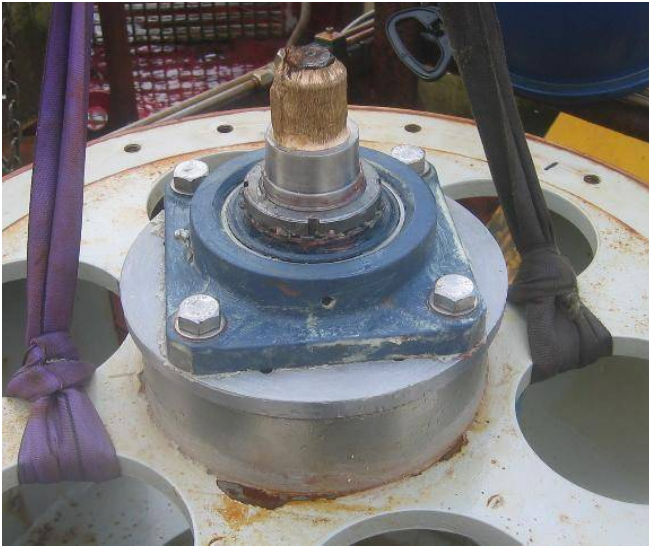
During the 2005 rebuild of the Wave Dragon turbines, some of the bearing assemblies had been replaced with a relatively cheap solution based on a readily available flange bearing assembly, see fig. 23. The bearing was SKF No. FYJ 65 KF, with a case consisting of grey cast iron. The mounting platform consisted of a top plate machined from 1.4301 stainless steel and a spacer ring below it machined from 1.4021 steel. The whole bearing assembly was also protected against dripping and spray water by a hood spun from CuZn18 gilding metal.

fig. 23: roller thrust bearing rebuild in the year 2005

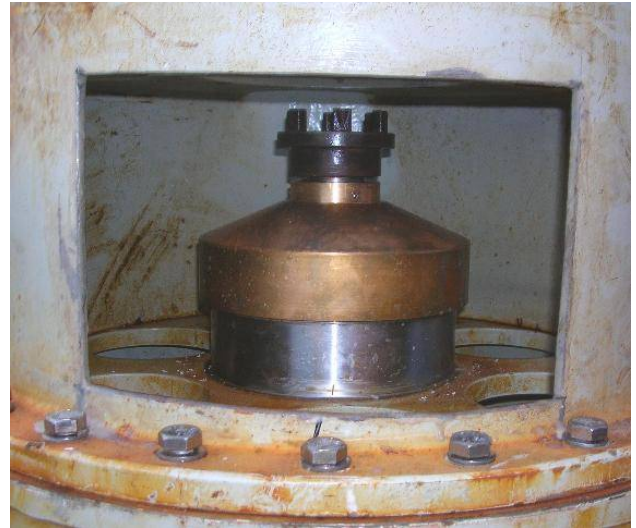
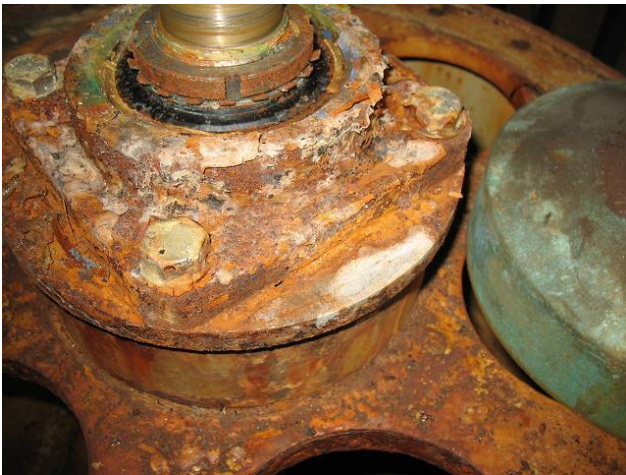
This temporary solution did work until the end of the testing programme, but it did not cope with the corrosion attack too well, see figs. 24 and 25. The bearing protection shield itself was in good condition, but it was obviously not able to keep the salt water away from the bearing. The cast iron bearing case was rusted as well as the carrier plate and spacer below it. This is surprising especially in the case of the carrier plate, as it was reportedly made from 1.4301 stainless steel. We suspect it was either made of 1.4021 like the spacer below, or possibly the presence of the cast iron bearing case has aggravated the corrosion attack.

fig. 24: roller thrust bearing assembly

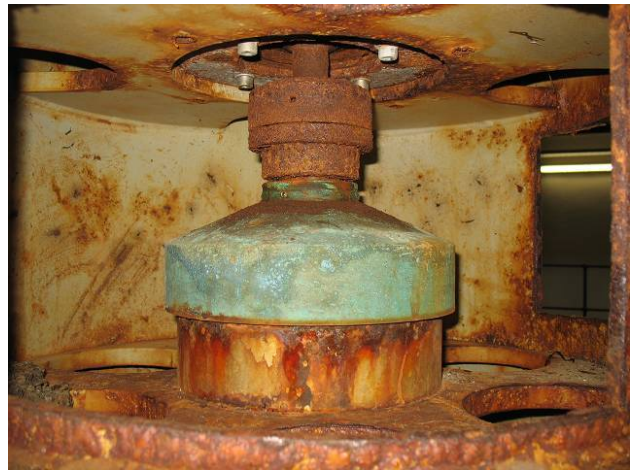
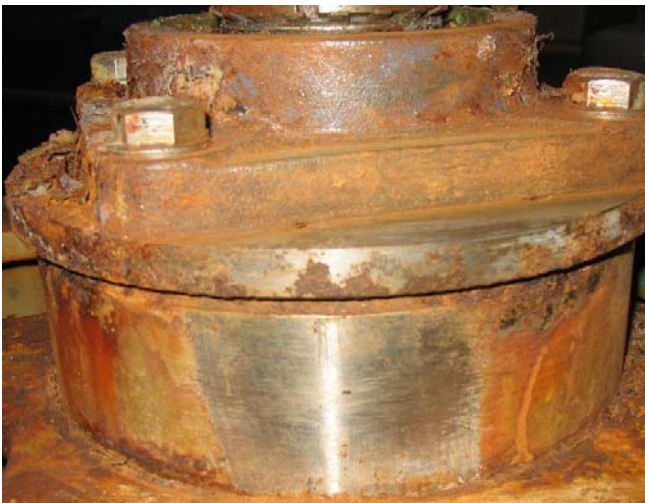
fig. 25: roller thrust bearing assembly

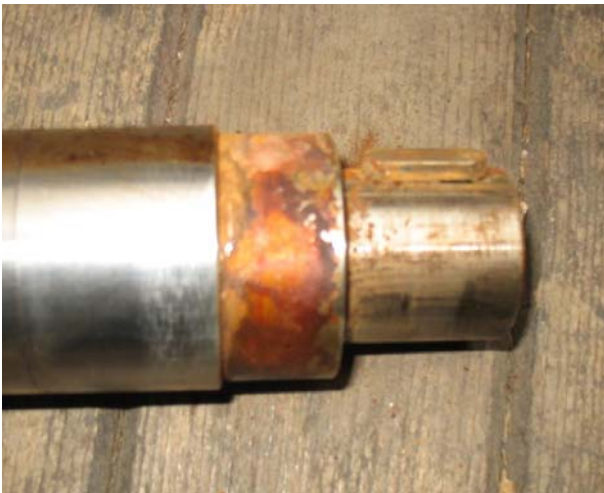
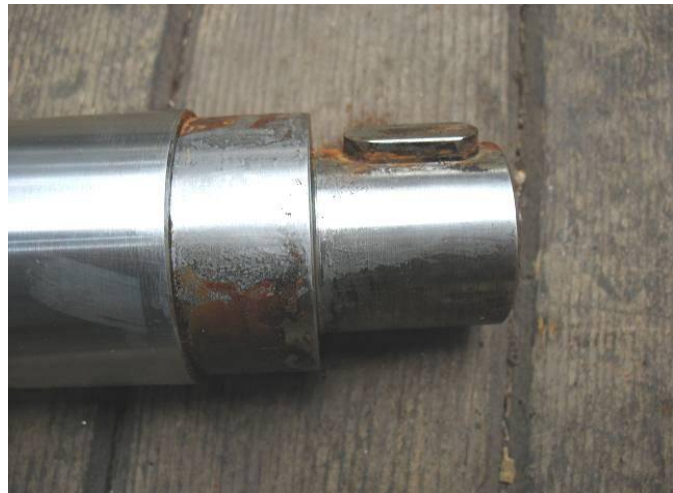
The runner shaft had been manufactured from 1.4460. This is an acid-resistant austenitic-ferritic steel with very good corrosion resistance particularly in chloride-bearing environments; it is normally used for propeller & pump shafts, spindles, and stirrers operating in corrosive fluids. Except for some tarnishing due to extraneous rust, the shaft had no signs of corrosion, see fig. 26. Fig 27 shows the upper shaft end after dismantling and with the extraneous rust partially cleaned off.

fig. 27: turbine runner shaft, upper end
