Wave Dragon Prototype

Tilstandsvurdering **BILAG**

Energinet.dk projektnummer 6459

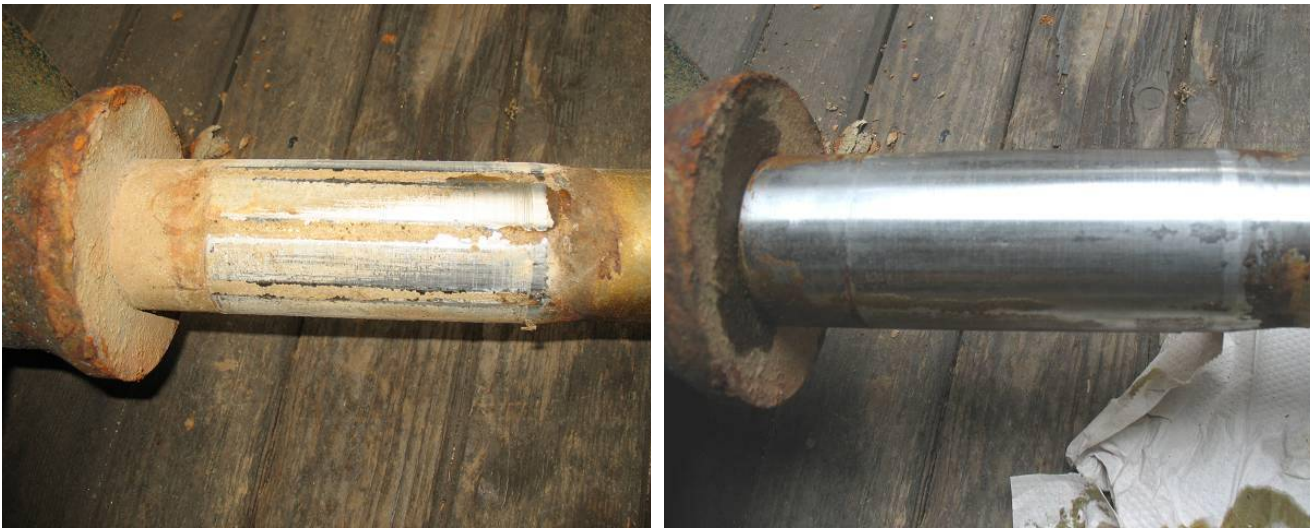
Fig. 28 shows the part of the shaft that had run in the radial rubber bearing. Due to the long period of standstill after the end of the testing programme, chalk deposits had formed on the shaft in the lubrication grooves of the bearing. After cleaning these off, the shaft showed only some spots of light discoloration, see second picture in fig. 28.

fig. 28: turbine runner shaft, radial bearing section

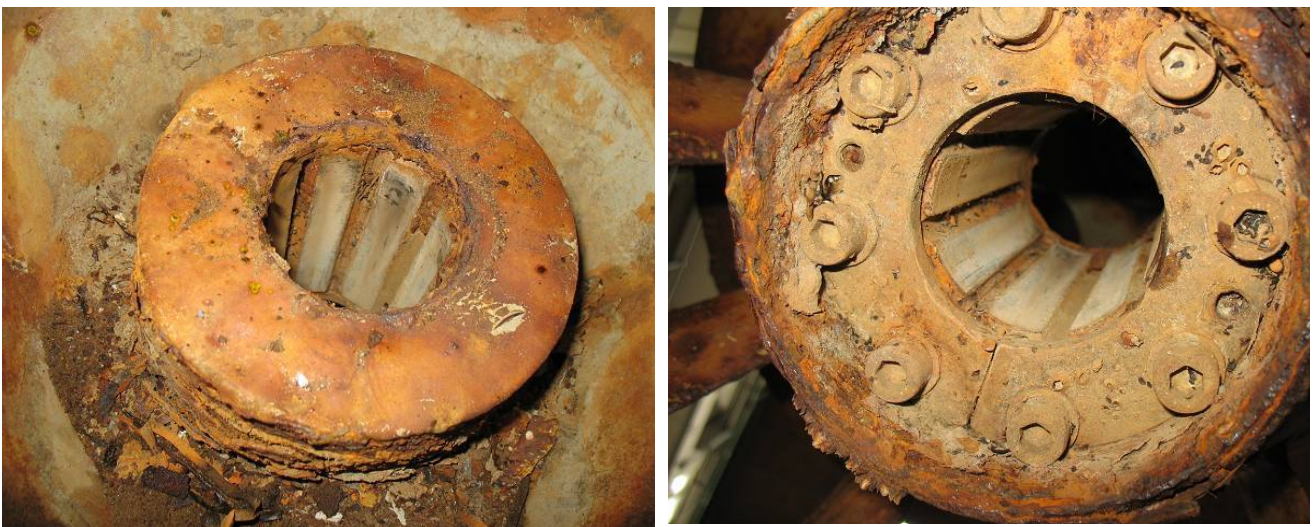
Fig. 29 shows the radial shaft bearing, which is a water lubricated rubber type bearing as used for propeller shafts in small ships. The bearing shell had been made from S235 JRG2 steel bar, the ring retaining the rubber bearing elements was made from 1.4301 stainless steel and held in place by A4 bolts. From the pictures it is apparent that the bearing shell has suffered strong corrosion on all the exposed surfaces; the retaining plate and bolts are only covered with lime scale and extraneous rust. The inside of the bearing shell shows only very light corrosion, in some areas there was a dark discoloration only - obviously the fit of the rubber elements was tight enough to prevent the exchange of water and oxygen here, see fig. 30

fig. 29: runner shaft radial bearing

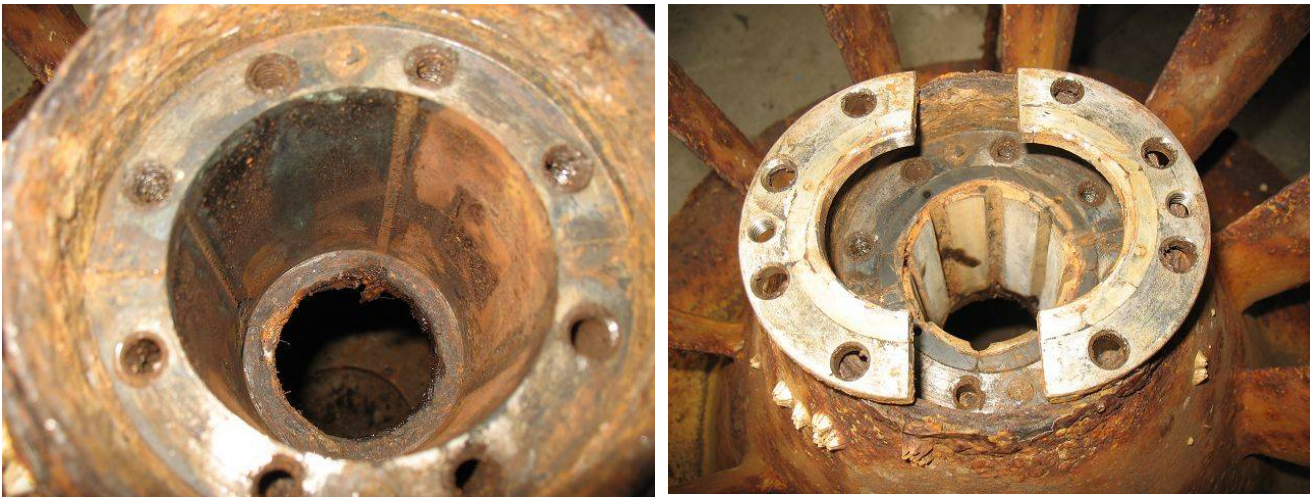
fig. 30: rubber element retainer and inside of radial bearing shell

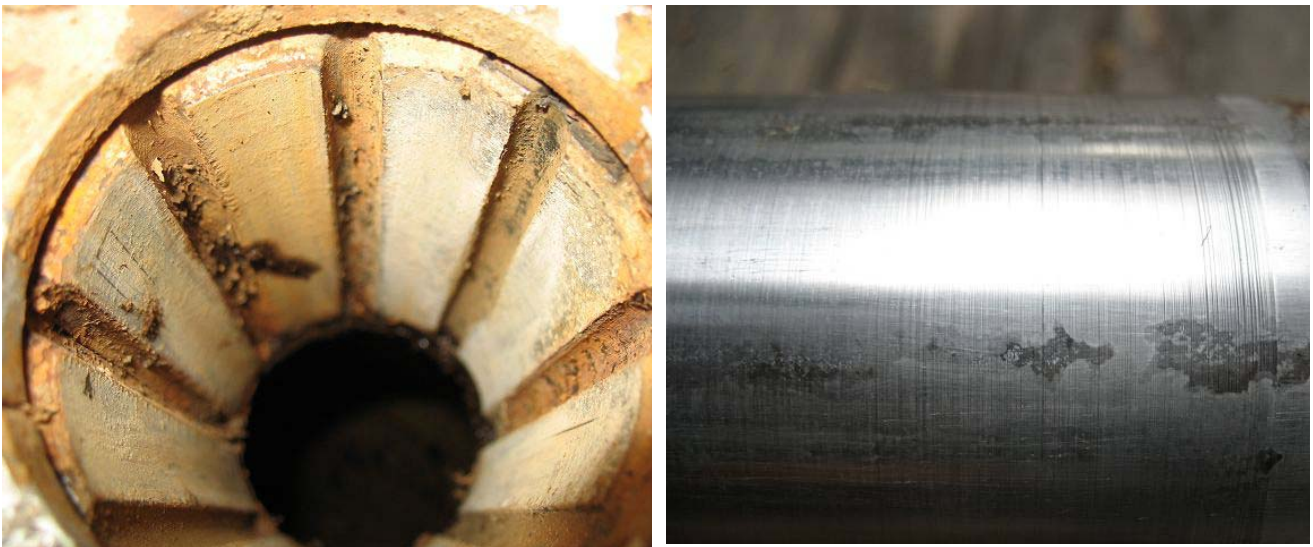
The bearing was supplied with unfiltered sea water as lubricating fluid. The sand particles carried in the lubricating water could be found inside the bearing, and a closer examination of the shaft showed that the sand has worn a number of slight grooves into the surface of the shaft, see 2nd picture in fig. 31.

fig. 31: inside of bearing elements and radial bearing section of the turbine runner shaft

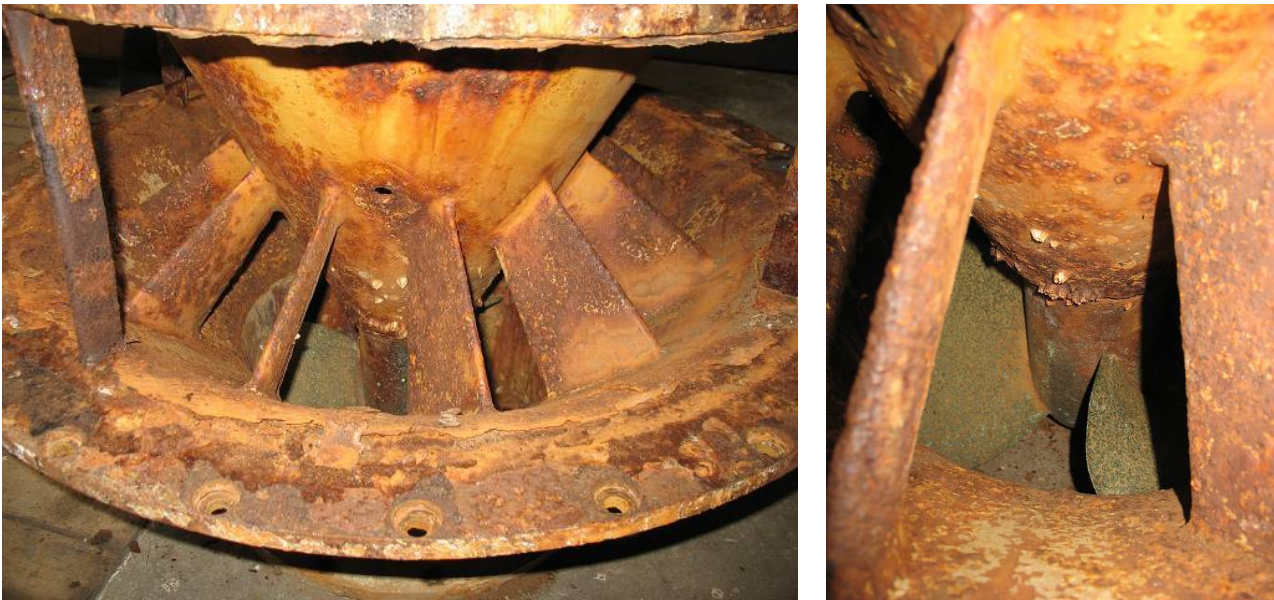
Like the turbine case parts and the cylinder gate, the stay vanes, guide vanes and inner turbine cone had been manufactured from S235 JGR2 steel plate, welded, sand blasted and coated with one 0.04mm layer of FRIAZINC R zinc primer followed by a 0.2mm thick layer of ICOSIT SW500 epoxy top coat. As these turbine parts had frequently received various kinds of mechanical impact from foreign matter contained in the sea water, the corrosion protection failed almost completely here, see fig. 32. While there was no substantial problem during the testing period, it is apparent that better corrosion protection measures need to be taken for the turbines in a production prototype. There is also some marine growth visible on the inner turbine cone - a number of sessile barnacles had settled down here.

fig. 32: inside of bearing shell and radial bearing section of the turbine runner shaft

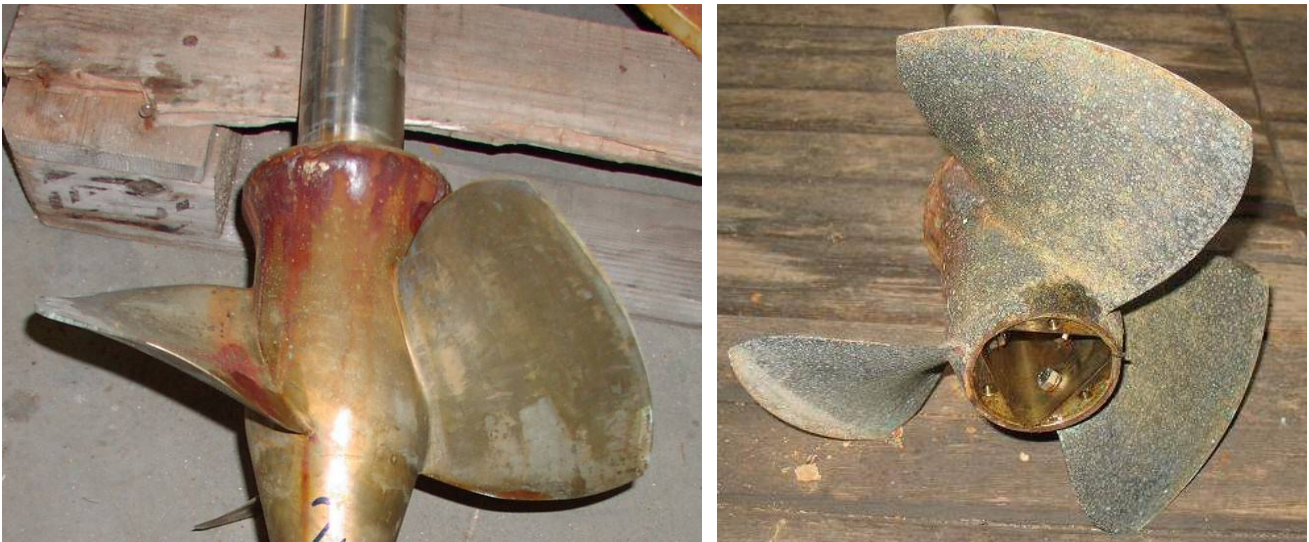
The turbine runners had been CNC machined from Cu Al10 Ni5 Fe4 aluminium bronze, Wst.-Nr. 2.0966. This is a material known for its very good corrosion resistance in seawater environments, and for its very good corrosion fatigue resistance. During the turbine overhaul in 2005, the runners showed only some tarnishing due to extraneous rust, see fig. 33, and, in the case of turbines that had stood still for longer periods, some barnacle growth on the blades. The dismantling in 2012 showed a different picture, though: some dark and hard deposit/corrosion layer had formed on the entire surface of the runners, see 2nd picture. Possibly this layer has only formed during the time when the prototype was laid up on the beach.

fig. 33: turbine runner during overhaul in 2005 and now

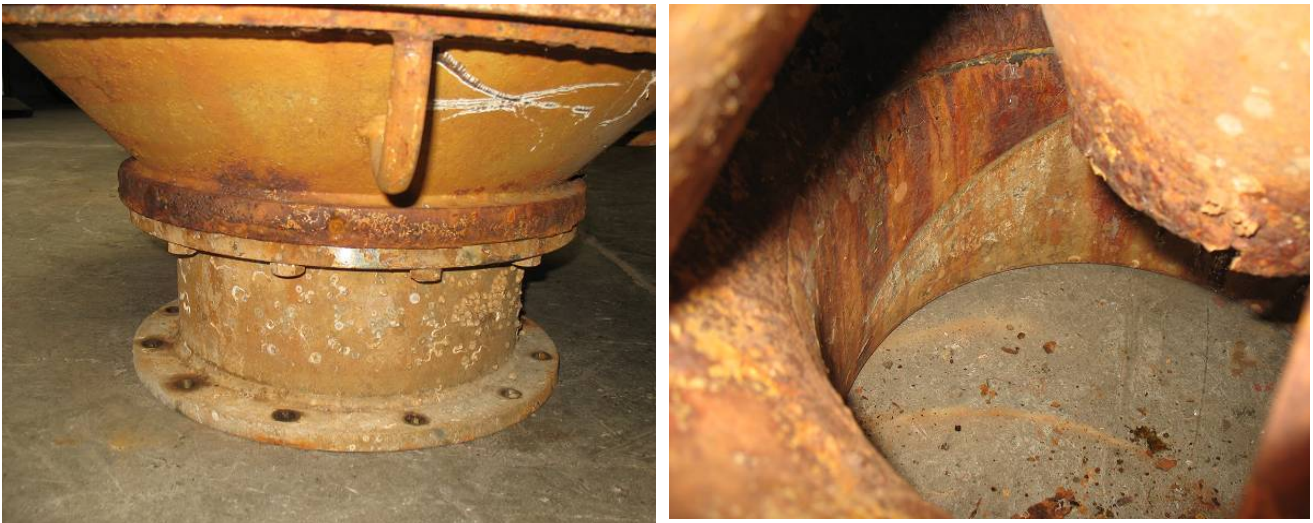
The runner shroud had been welded and machined from 1.4301 stainless steel. On the outside, it showed a deposit of limestone and some barnacles adhered to it, see fig. 37. On the inside, it was found heavily encrusted with extraneous rust. This is explained by the fact that, even with the turbines shut down, there is a constant small seepage of water from the surface from the reservoir through the turbine which carries along rust particles from the reservoir bottom.

fig. 37: runner shroud

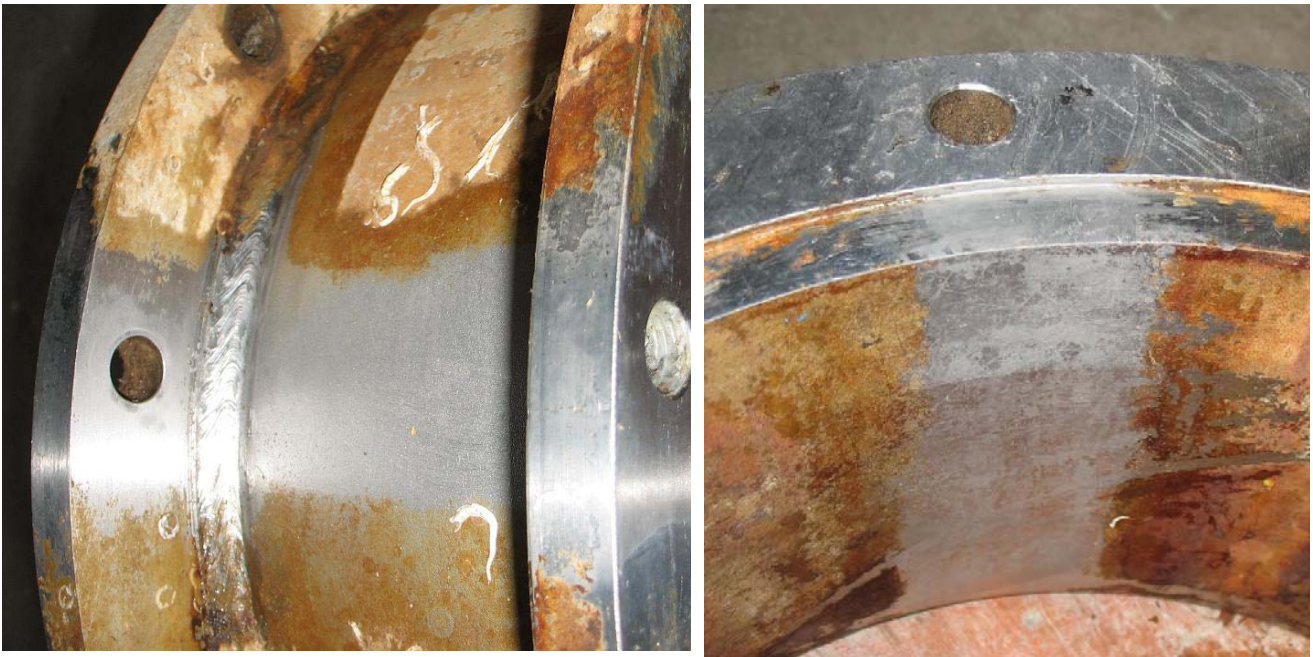
However, after cleaning up the surface, the metal itself showed no signs of corrosion damage at all, see fig. 38. Interestingly, even the outside of the tubular part, which was neither machined nor polished, was found completely free of corrosion.

fig. 38: runner shroud after cleaning

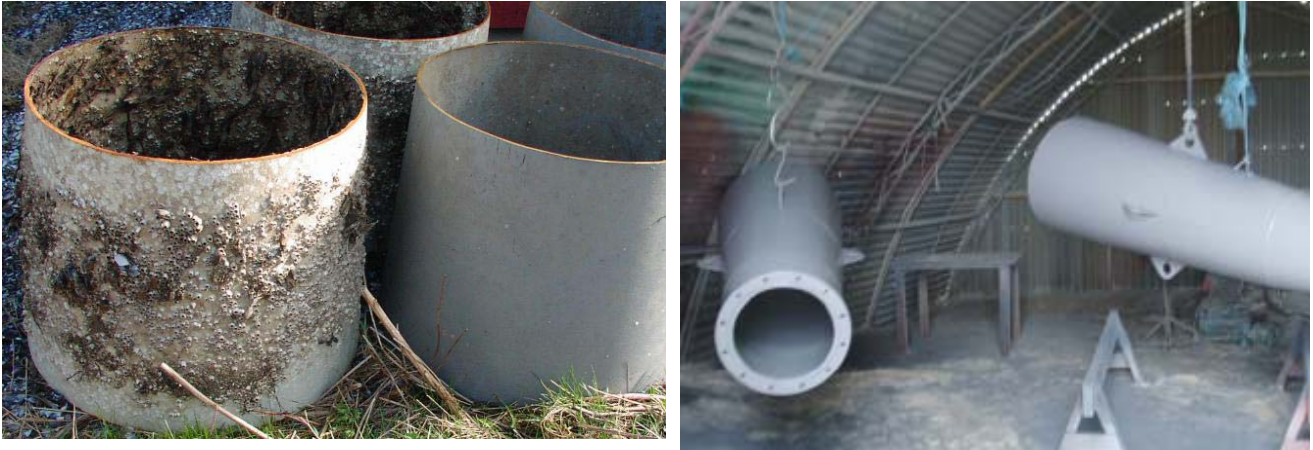
Two of the draft tubes had been painted with a non-toxic antifouling coating called Hempasil. On these draft tubes, only a minimum of growth was found, and what weeds and barnacles had settled down could be wiped off easily. Fig. 40 shows the ends of draft tubes that had been cut off in a design change in 2005 after being stored for some months on land. The epoxy coated tube section on the left still has the dried-up growth attached, while the Hempasil coated one on the right is completely clean. For this reason, the remaining draft tubes were sand blasted and given the same silicone coating. After sandblasting to sa 2.5 cleanliness, the coating was applied in 4 layers: two 0.15mm layers of Hempadur primer, one 0.12mm layer of Hempasil Nexus undercoat and a final 0.15mm layer of Hempasil silicone coating, see 2nd picture.

fig. 40: draft tube sections with epoxy and silicone paint

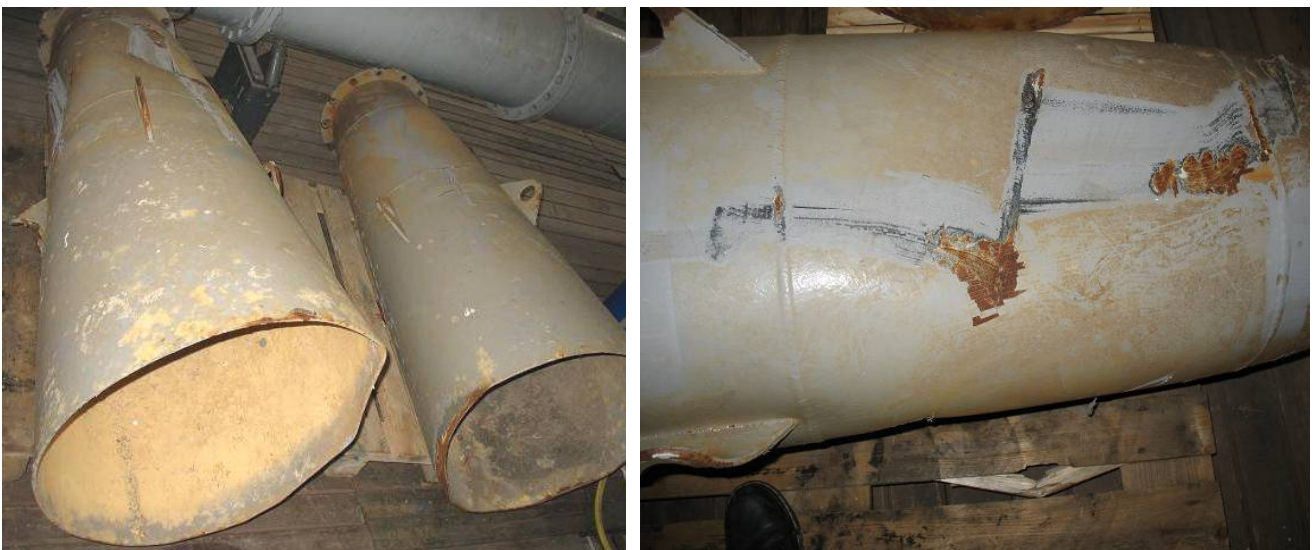
Apart from the excellent anti-fouling properties, this coating system has given very good mechanical resistance and corrosion protection so far. Figs. 41 and 42 show two of the draft tubes after dismantling the turbines. There is some dirt on the surface, but it is apparent that corrosion is only present in places where the draft tubes have been forcefully damaged during the scrapping of the Wave Dragon platform. Even the seating areas of the mounting bolt heads are free of corrosion damage, see 2nd picture in fig. 42.

fig. 41: draft tubes with silicone paint system

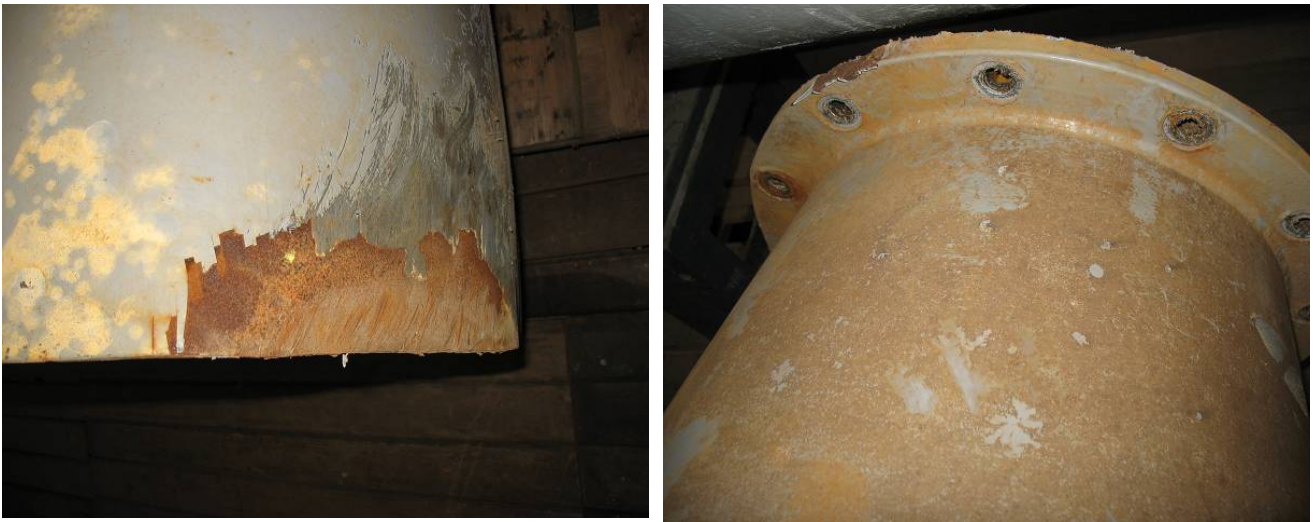
fig. 42: draft tubes with silicone paint system

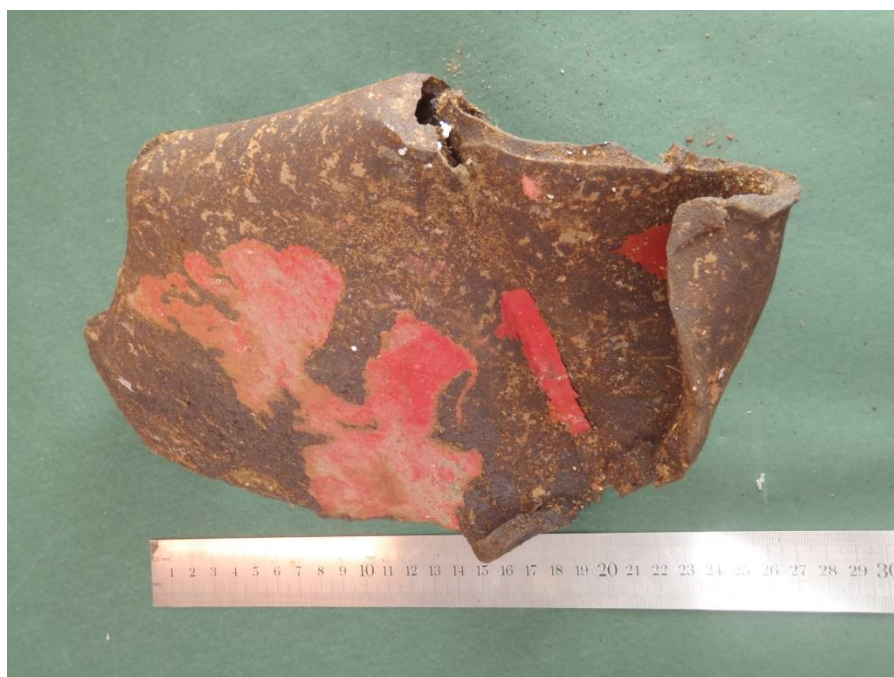
Item/ Location/	Comments, samples as received	Comments, after acid cleaning	Max. pit depths, mm
1 Above water level	<p>The coating remains in fragmented areas on the surface on: Side with ID tag: 5 % of the area Other side: 20 % of the area</p> <p>The coating appears loose in the small fragmented areas. In one larger area, approx. 10x15 cm, the coating adheres rather well. The unprotected part of the surface is covered with rust with limited tendency to pitting (Figure 2).</p>	Widespread minor pitting (figures 8, 9).	0.6 0.5
2 Around mean water level	Yellowish coating remains on approx. 50-60 % of the surface area. When scraping with a scalpel, the coating appears reddish below the top layer. The coating in general appears broken down and cannot be expected to provide protection. The unprotected part of the surface is covered with rust with some tendency to pitting (Figure 3).	Few micro pits (figures 10, 11).	0.2

Figure 2 Sample 1 as received.

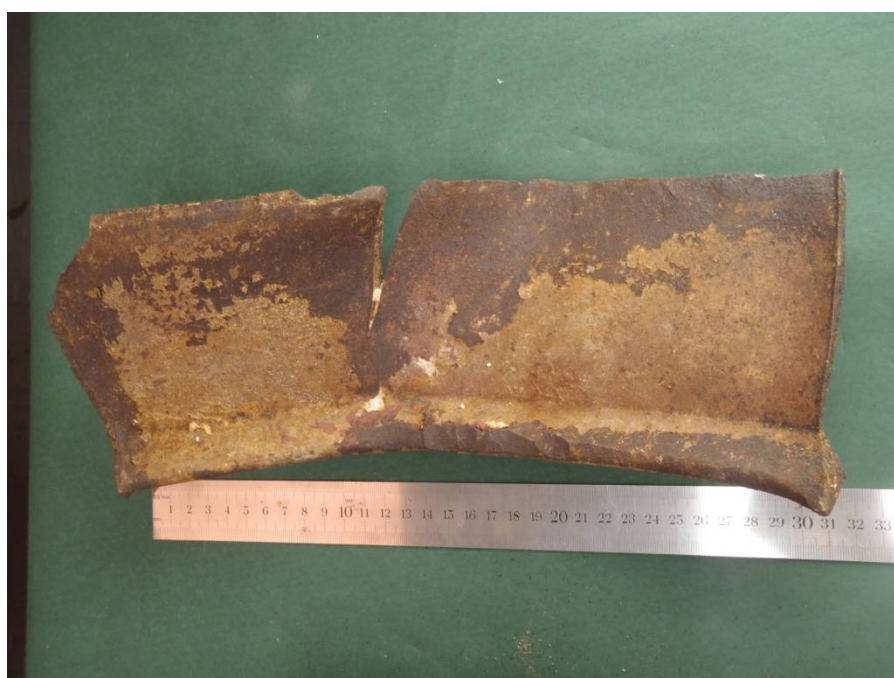
Figure 3 Sample 2 as received.

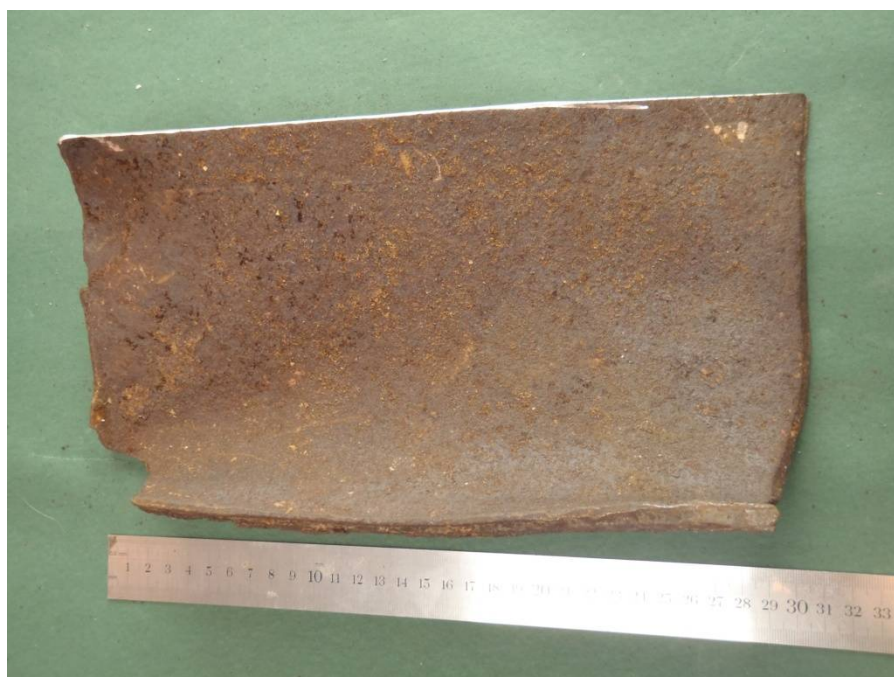
3 Bottom	<p>No coating is left on the surface.</p> <p>The specimen is completely covered with rust. Small flakes of corrosion products can be removed from the surface. Tendency to pitting observed. The thickness of the rust layer is assessed to < 1 mm (Figure 4).</p>	Widespread pitting (figures 12, 13).	0.8 1.0 1.1
? Unknown	<p>No coating is left on the surface.</p> <p>The specimen is completely covered with rust. Small flakes of corrosion products can be removed from the surface. Tendency to pitting observed. The thickness of the rust layer is assessed to < 1 mm (Figure 5).</p>	Localised corrosion more wide in area compared to samples 1 and 3 (figures 14, 15).	0.9 1.2 1.1
4a (small) Unknown	<p>Coating is left on < 5 % of the surface in small fragmented areas.</p> <p>The rest of the specimen is completely covered with rust. Small flakes of corrosion products can be removed from the surface. Tendency to pitting observed. The thickness of the rust layer is assessed to < 1 mm (Figure 6).</p>	Widespread pitting (figure 16)	0.8 0.6

Figure 4 Sample 3 as received.

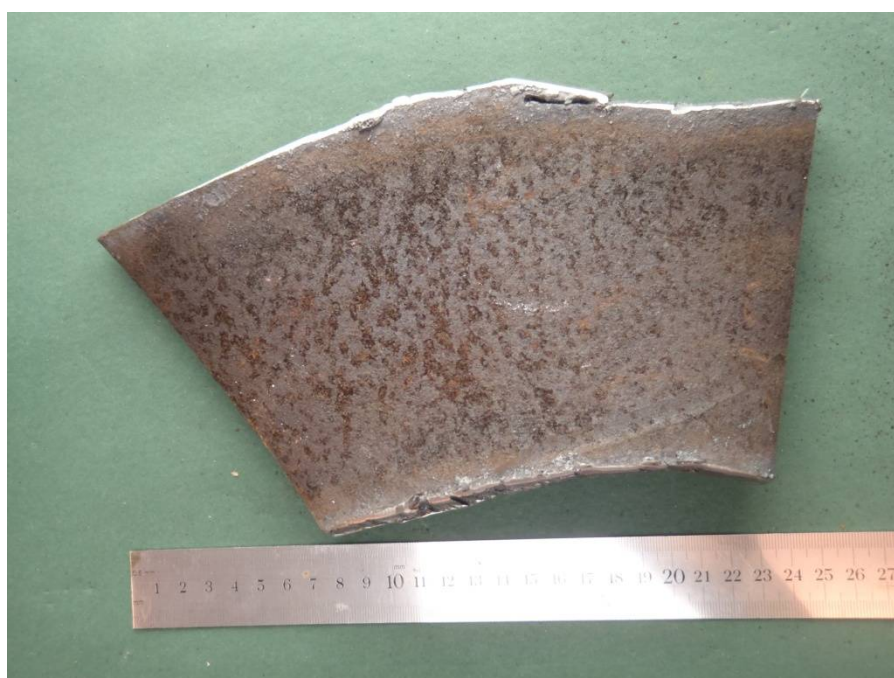
Figure 5 Sample ? as received.

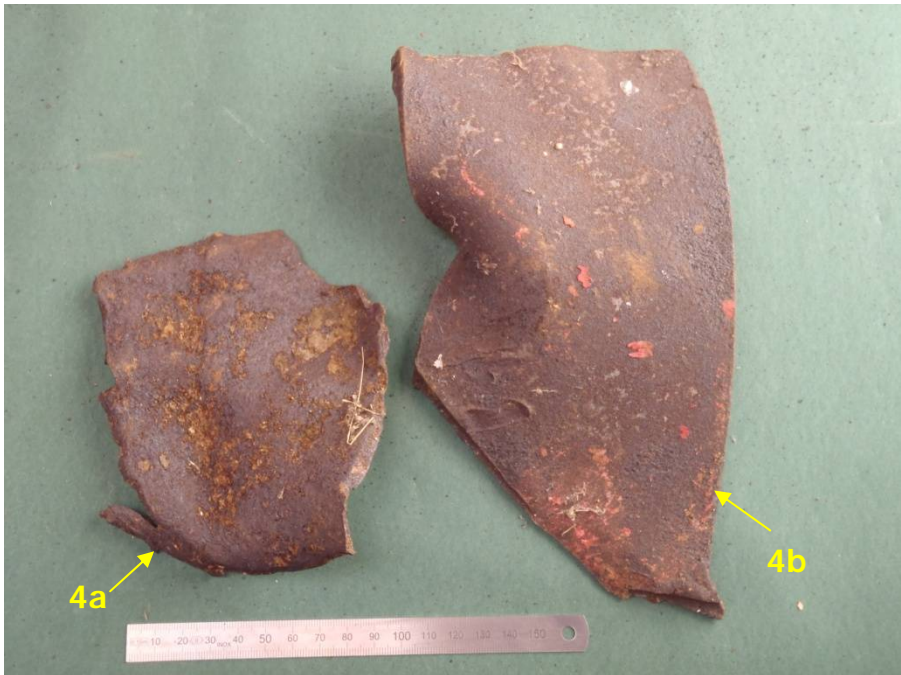
4b (large) Unknown	<p>Coating is left on < 5 % of the surface in small fragmented areas.</p> <p>The rest of the specimen is completely covered with rust. Small flakes of corrosion products can be removed from the surface. Tendency to pitting observed. The thickness of the rust layer is assessed to < 1 mm (Figure 6).</p>	Widespread micro pits. Localised corrosion in weld seam (figure 17).	Localised corrosion in weld seam: 0.8 1.1

Figure 6 Samples 4a and 4b as received.

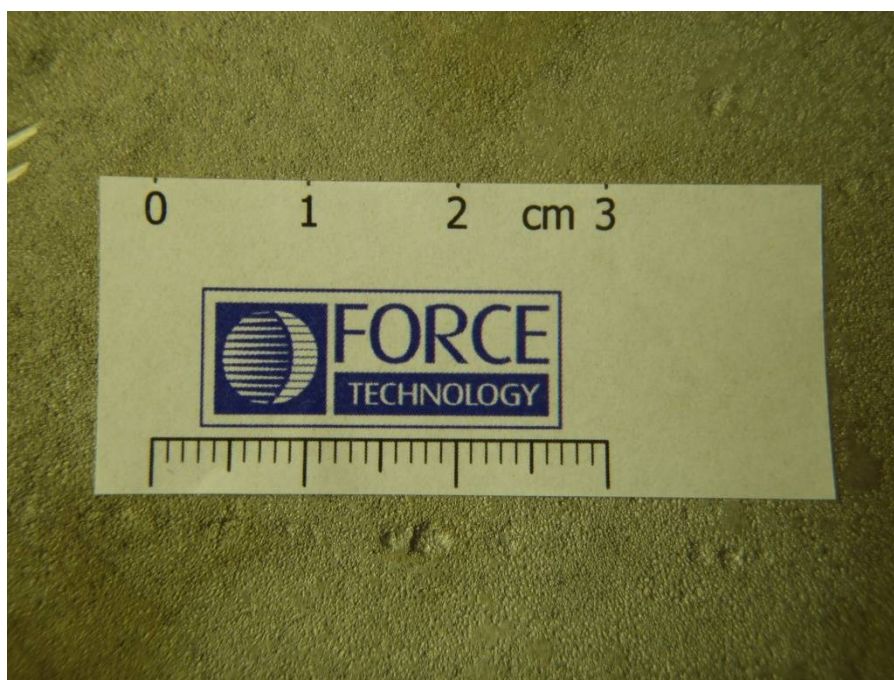
Figure 9 Pitting 0.6 mm deep in sample 1 after acid cleaning.

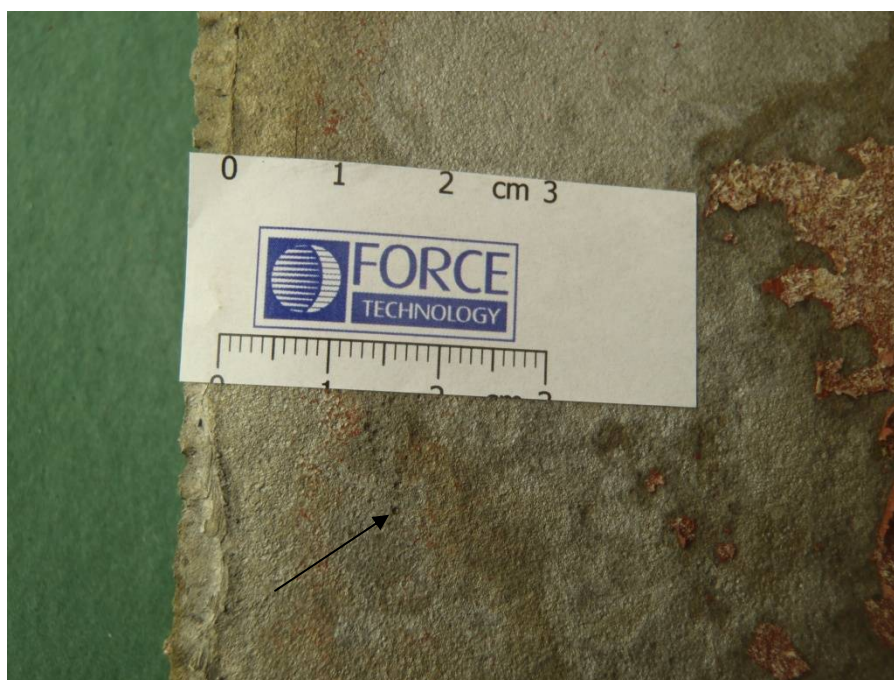
Figure 11 Pitting 0.2 mm deep in sample 2 after acid cleaning.

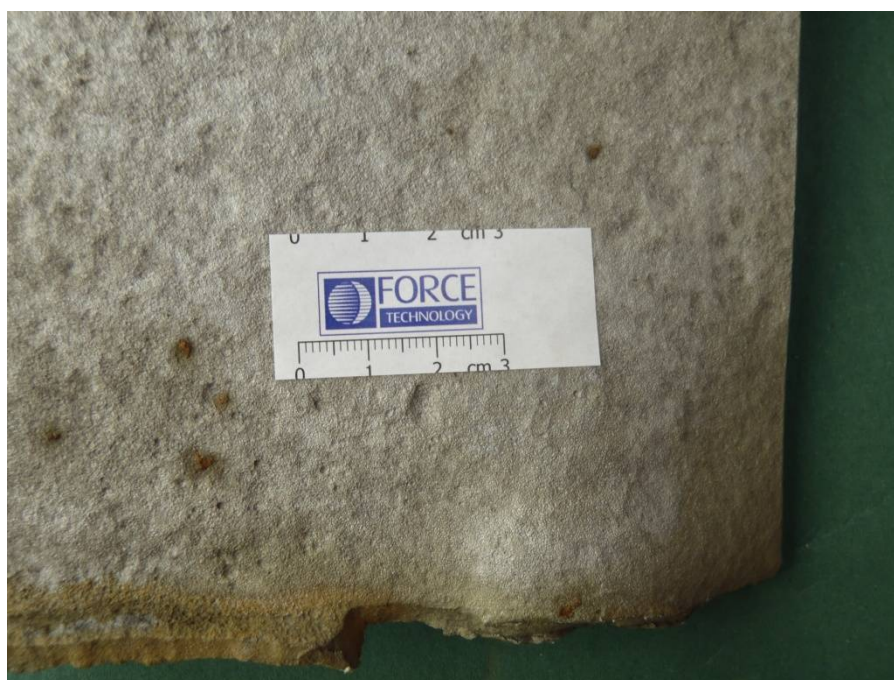
Figure 13 Pitting 1.1 mm deep in sample 3 after acid cleaning.

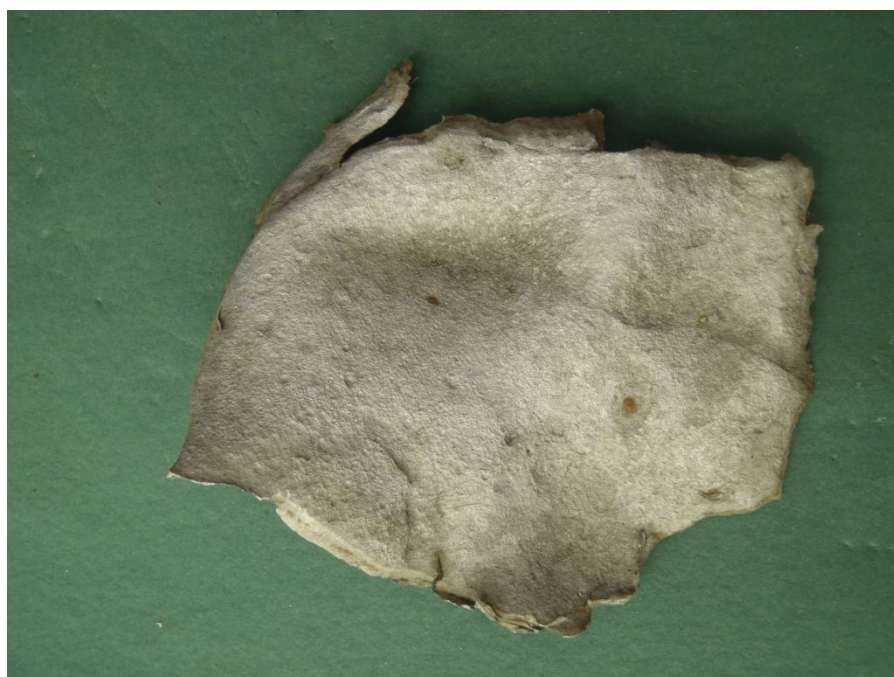
Figure 16 Sample 4a after acid cleaning.

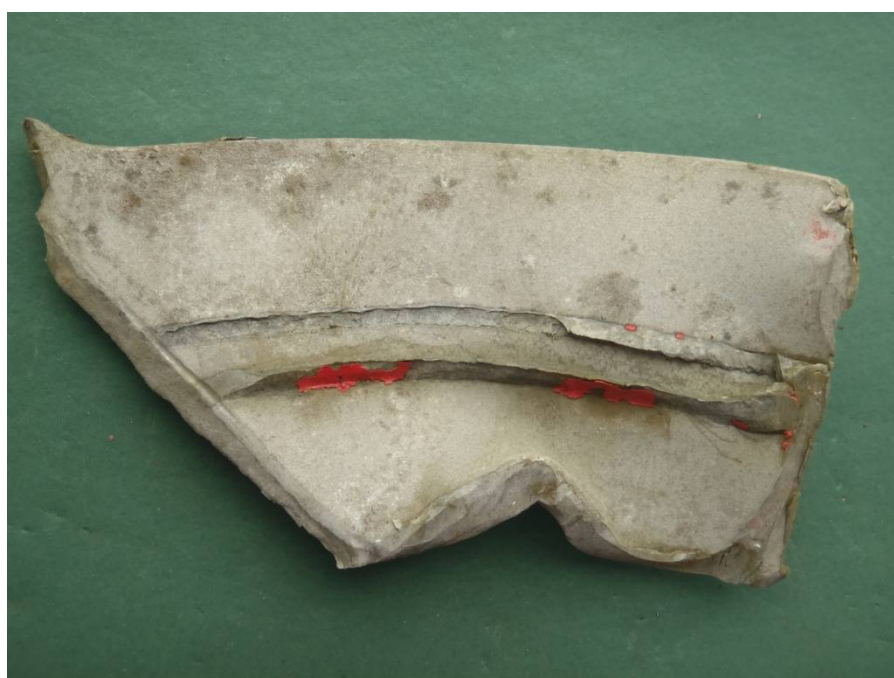
Figure 17 Sample 4b after acid cleaning.

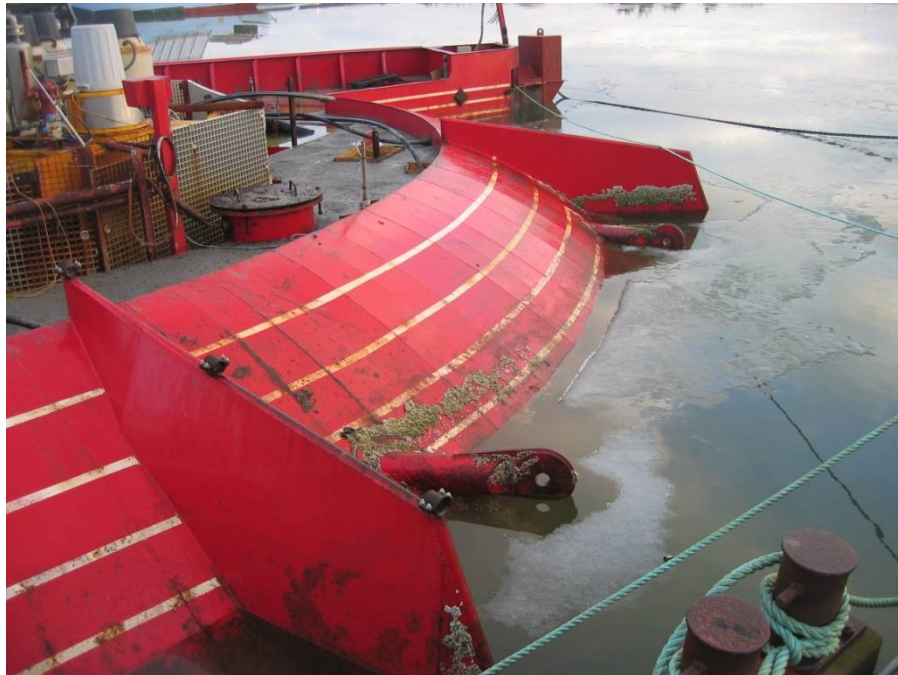
Figure 20 Photo of Wave Dragon 12-01-2006. Photo received from Wave Dragon.

Figures 18-21 show received photos of Wave Dragon. In Figures 20 and 21, partial breakdown of the coating system is noticed (after 3 years of deployment).

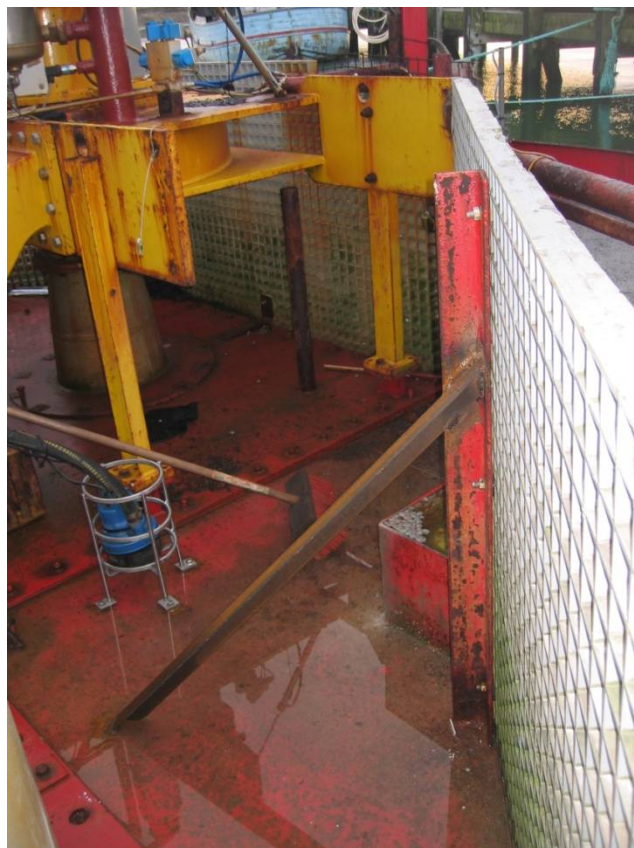
Figure 21 Photo of Wave Dragon 12-01-2006. Photo received from Wave Dragon.
