Final report

Project title	Corrosion management in biomass firing
Project identification (program abbrev. and file)	ForskEL - 2015-1-12289
Name of the programme which has funded the project	ForskEL
Project managing company/institution (name and address)	DTU Mechanical Engineering Niels Koppels Allé, bygning 404 2800 Kgs. Lyngby
Project partners	DTU Mechanical Engineering DONG Energy (Ørsted)
CVR (central business register)	30 06 09 46
Date for submission	09-09-2019

The project addressed corrosion in biomass fired power plants based on several years of collaboration between DTU and biomass fired heat and power plants in Denmark. The overall goal of the project was to develop and implement new tools for the management of corrosion problems in large-scale biomass firing based on improved understanding of corrosion mechanisms. This was obtained: a) In a ph.d project, which provided improved fundamental understanding of the influence of materials microstructure on the corrosion performance during long-term operation in biomass firing. And b) by collating and analyzing a large group of data from Danish biomass fired heat and power plants and developing quantitative models of corrosion

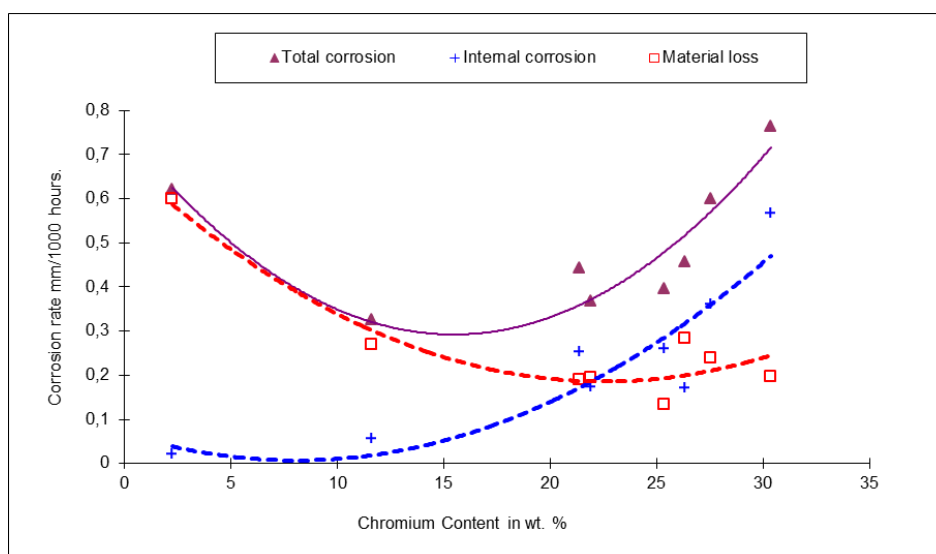
Figure 1: Corrosion rates for different materials exposed on a cooled probe.

Corrosion testing had been undertaken with a cooled corrosion probe inserted in the boiler of a straw-firing plant above the combustion zone [1]. The exposure time was 1392 hours where the probe temperature fluctuated around 450-580°C. Thus corrosion rates with respect to a specific temperature could not be given; however a ranking of materials with the fluctuating temperature and operating conditions was obtained. The specimens were measured for corrosion attack, where the materials loss was based on initial pre-exposure thickness measurements. The results from this test revealed that corrosion attack (\blacktriangle) could be divided into two components, material loss (\square) and internal attack (+) as shown in Figure 1. Lower material loss was observed for chromium rich alloys; however these alloys suffered from increased internal attack. The alloys with high iron content revealed very little internal attack, whilst alloys with higher chromium content were internally attacked at i) grain boundaries or ii) within the grain resulting in a porous structure or iii) both.

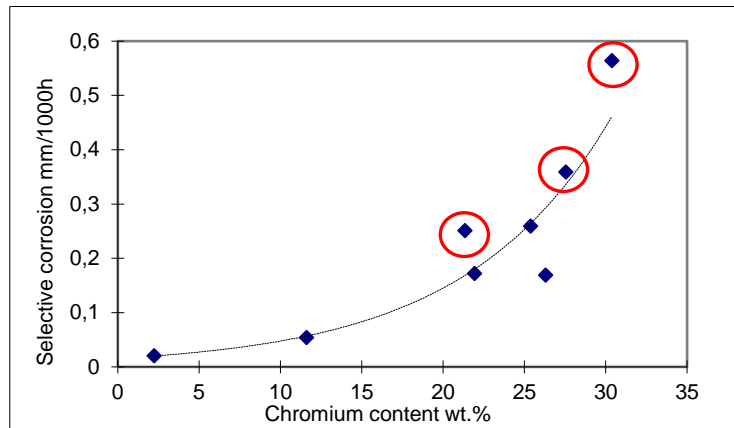
Figure 2: Internal attack of alloys shown in Figure 1, where the alloys with stable alpha precipitation are marked 5.

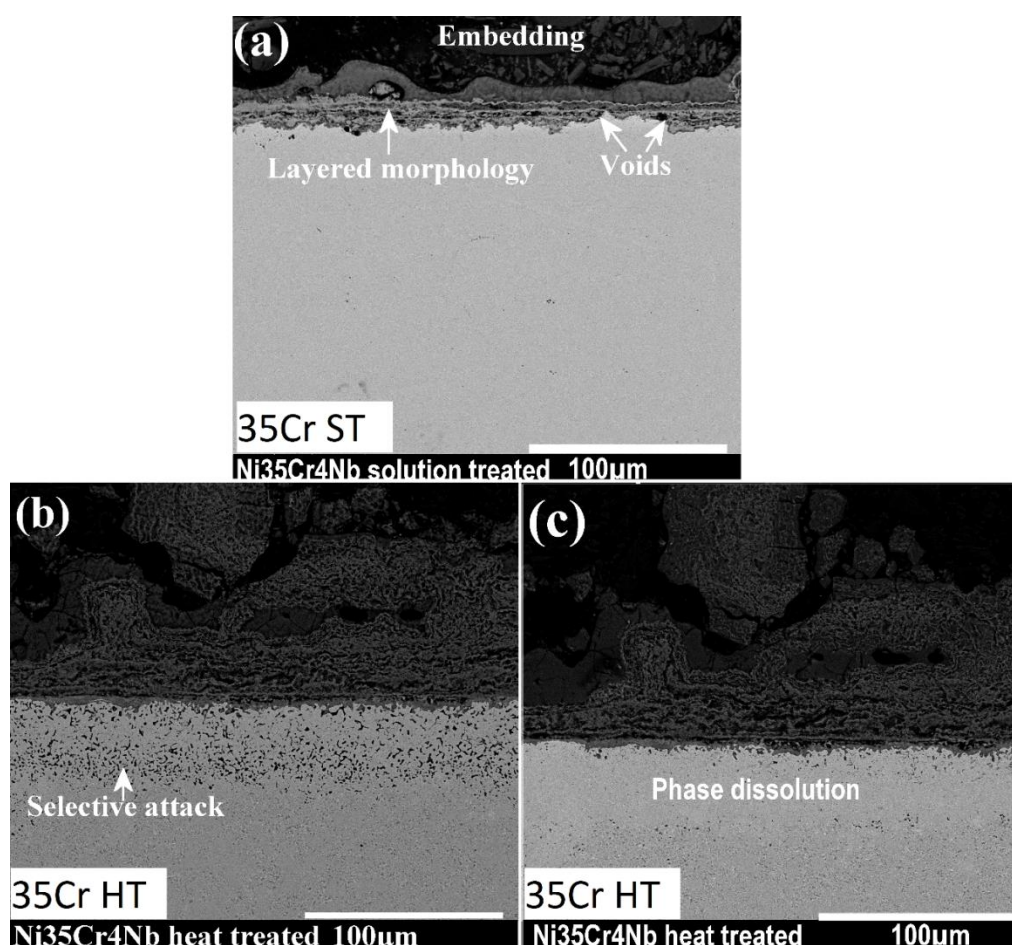
Figure 10: Morphology of attack of heat treated and solution treated Ni35%Cr alloys.

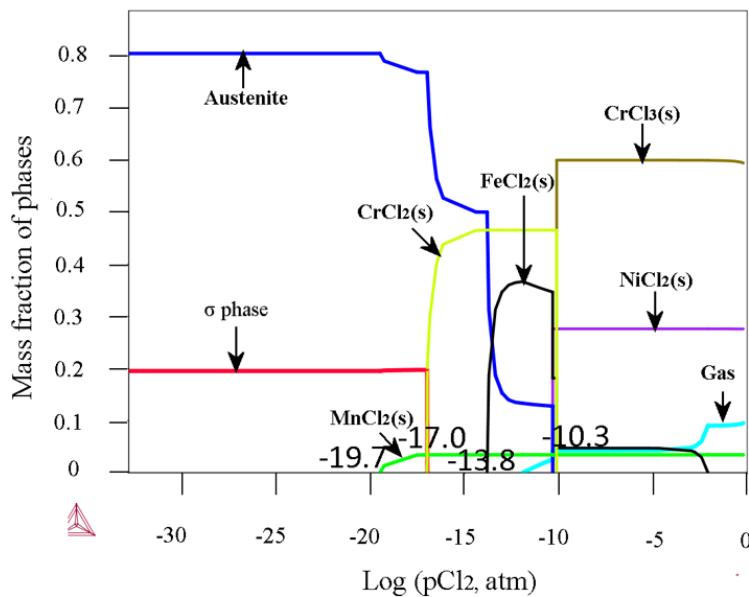
Calculations were also undertaken to understand the preferential attack observed for the specific sigma phase formed for the 347H steel. Figure 13 shows the stability of Cr rich sigma phase which has a lower stability than austenite in chlorine bearing environments.

Figure 13: Stability diagram of austenite and sigma phase in 347H steel.

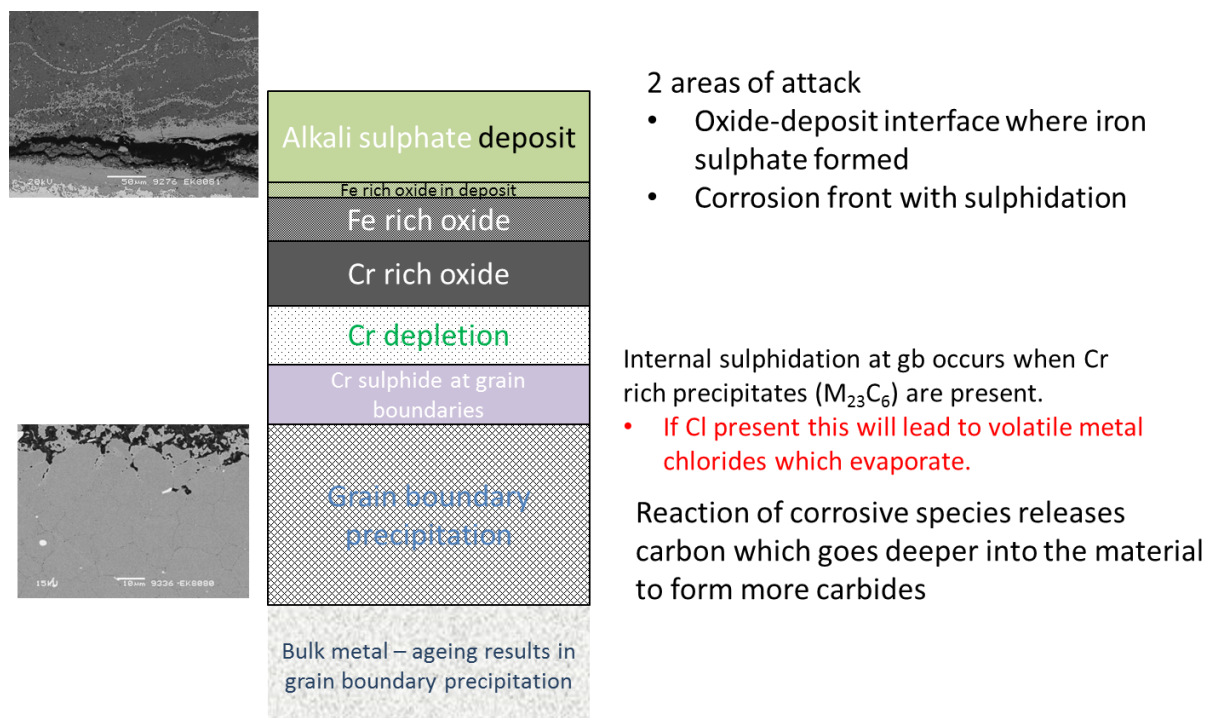
Figure 22 shows a schematic of the corrosion mechanism in a coal-firing or co-firing atmosphere. In addition to reactions on the surface resulting in iron oxides and alkali sulphates, preferential attack of carbides was observed resulting in grain boundary attack and chromium and manganese sulphides form at the corrosion front. Initially this could be Nb carbides which are in the steel releasing carbon to form Cr rich $M_{23}C_6$ carbides.

Figure 22: Schematic of corrosion in co-firing and coal boilers.

Similar reactions to those in Figure 22 occur in biomass environments, and as shown very clearly in the Ph.D. work, a preferential reaction of Cr rich precipitates, also Cr carbides, occurs when KCl is present. However these precipitates are not so noticeable in biomass firing, and were difficult to observe with increasing temperatures. It is therefore suggested that the Cl species especially at higher temperatures constantly attack the newly formed carbides resulting in the deep intergranular attack observed.

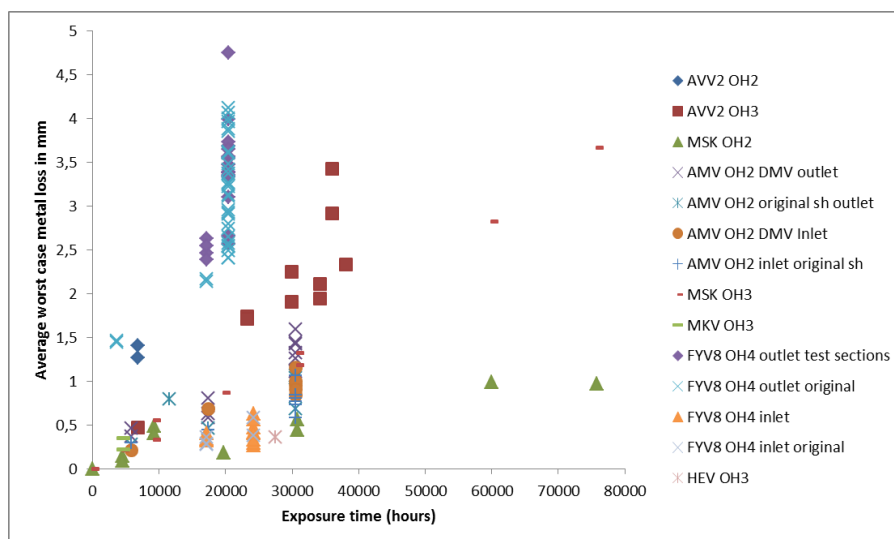
The overall performance of the steels is shown in Figure 23 by plotting metal loss against exposure time. However, since corrosion varies greatly with temperature or fuel type changes such a plot cannot be used for lifetime prediction, and data have to be refined to derive a model useful for lifetime prediction.

Figure 23: Comparison of results for TP347H/TP347HFG in Denmark.

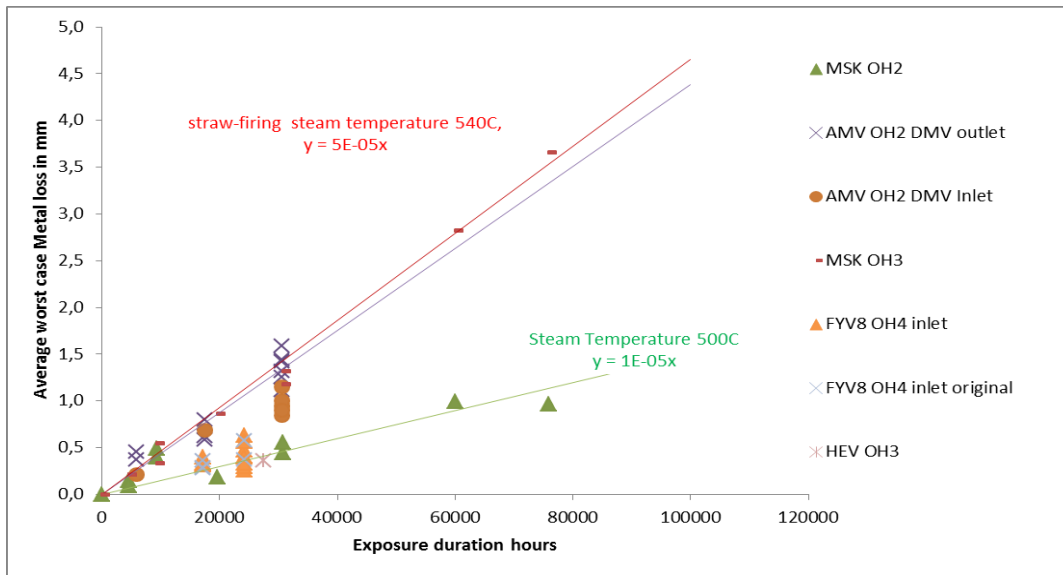
For the FYV8 and AVV2 bio-boilers, both fired with straw, there are large variations in the available metal loss measurements because of varying temperature during the operation time of the boilers. Thus, these data were removed in Figure 24.

The data from the longest exposure times were from Maribo-Sakskøbing (MSK). Here the outlet temperature had only little variation so a relation can be derived for this boiler for metal loss with respect to exposure time. At the lowest temperature (MSK OH2) with a steam temperature of 500°C data shows a trend of reducing corrosion rate with exposure time, indicating that some protection is maintained during corrosion. However, the tubes removed from superheater 3 where the steam temperature was 540°C indicate a linear increase in corrosion and no protection can be maintained. This intense corrosion caused by the effects of microstructure changes investigated in the Ph.D project, which become more prevailing at increasing temperature.

Figure 24: Same data as Figure 23 after removal of FYV8 outlet and AVV2bio data

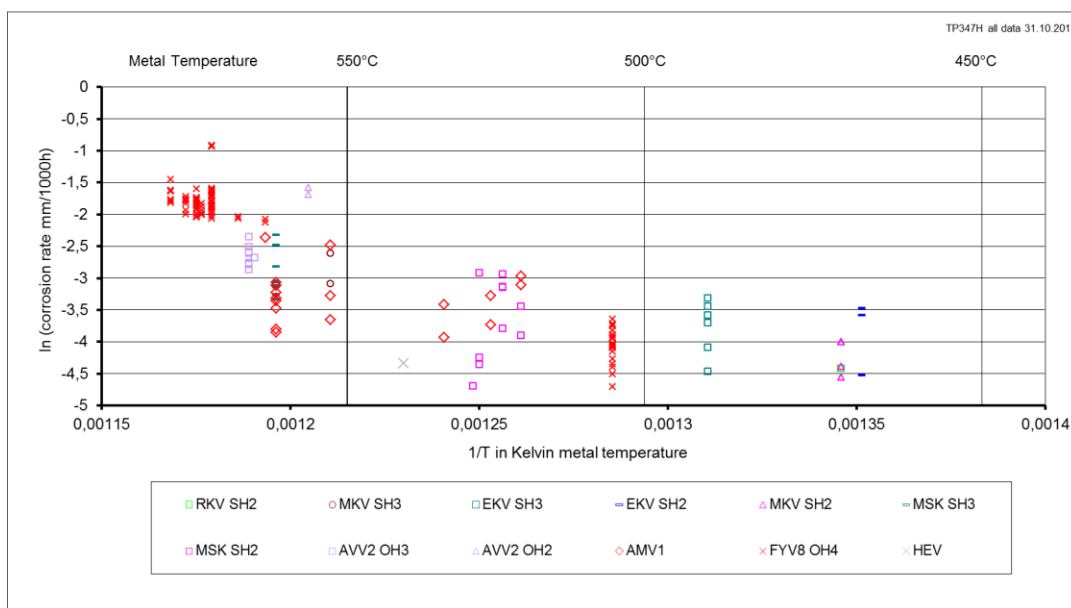
In some boilers such as Fynsværket, Avedøre 2 bioboiler and Amager 1 the measured temperatures showed great variation during operation. When using the peak temperatures as a parameter an Arrhenius type plot with an assumed linear corrosion rate is good to compare data from different exposure times and temperatures (if the temperatures are not too variable). The spread in the results is then somewhat reduced, figure 25.

Figure 25: Comparison of data using an Arrhenius plot (average worst case corrosion rate and peak temperature is used)

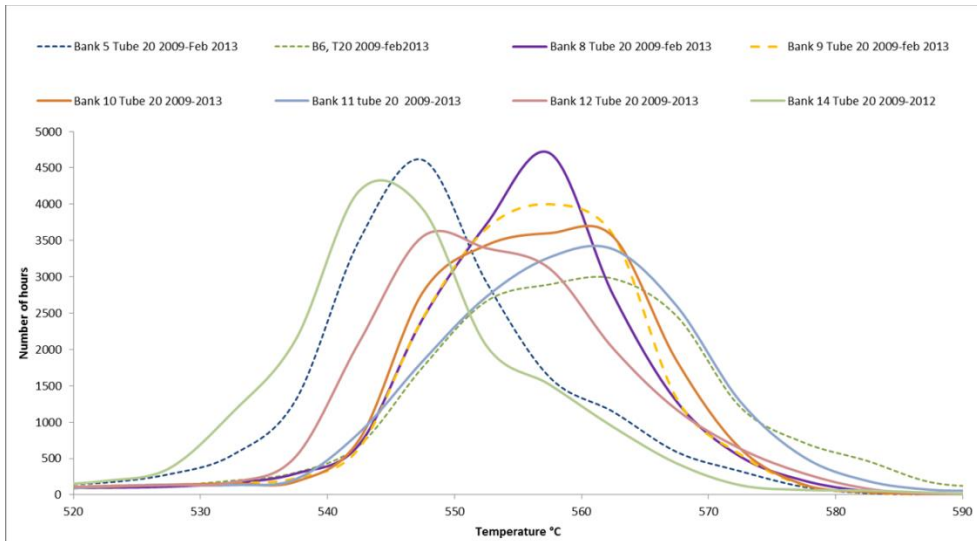
As previously shown [12], at temperatures above 540°C, the corrosion is extremely fast, therefore it is important to be able to weight the different temperatures experienced by the tube in order to assess how fluctuations in temperature affect corrosion rates. After the failure at FYV8 in 2013, many tubes of 347H/347HFG had been removed, where detailed temperature data had been collected (Figure 26). In the present project the corrosion rates of the components from FYV8 were re-assessed

Figure 26: Temperature profiles for the outlet test sections removed from FYV8 in 2013.

- Initially, arithmetic mean temperatures were used, thereafter metal temperatures were calculated from the temperature profiles in figure 26 using the equation:

A range of alloys were also tested at FYV8, where there were four 347H/347HFG variants and a new candidate alloy Tempalloy A1. They were exposed in different banks with the different temperature profiles shown in Figure 26.

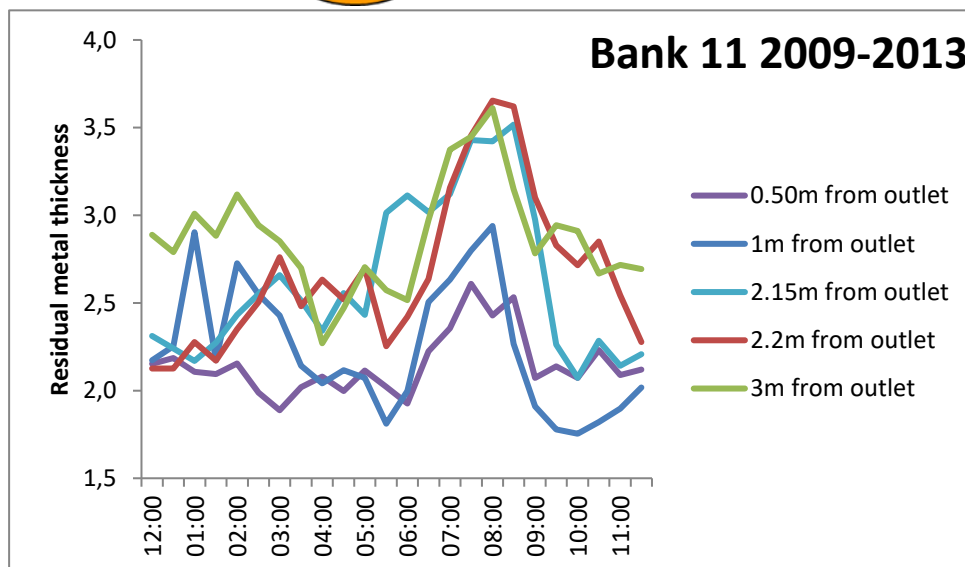
Usually the metal loss rates is measured as average worst case (AWC), which is most often the tube thickness loss in the flue gas direction and is what is needed to assess failure. However, corrosion rates for FYV8 boiler close to the outlet vary greatly from one side of the tube to the other (Figure 27). Since the steam temperature measured is relevant for the whole tube circumference, and the extra surface metal temperature comes from the heat flux from the flue gas, then the average best case metal loss (ABC) was used to give a corrosion rate as this would correlate better to the steam temperature measured in the penthouse. Depending on the distance from the outlet, the temperature at the place of investigation was estimated.

Figure 27: Variation in residual metal thickness around the tube. (12:00) is heading

the flue gas direction.

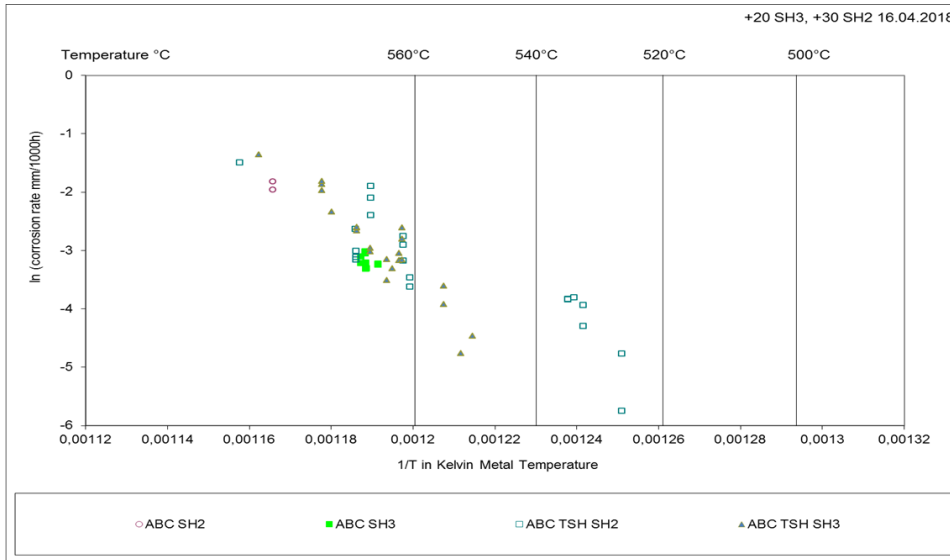
With further assessment of increased flux over the combustion zone individual temperature additions of SH2 +25, TSH2 +30, TSH3 +25 and SH3 +20 degrees were used, however such an assessment has to be based on knowledge of heat flux patterns within the boiler. Assessment with respect to precise location from the outlet is not yet incorporated into this analysis, however a clear trend can now be observed.

Figure 30: Revised Arrhenius plot with specific assessments associated with location of tubes.

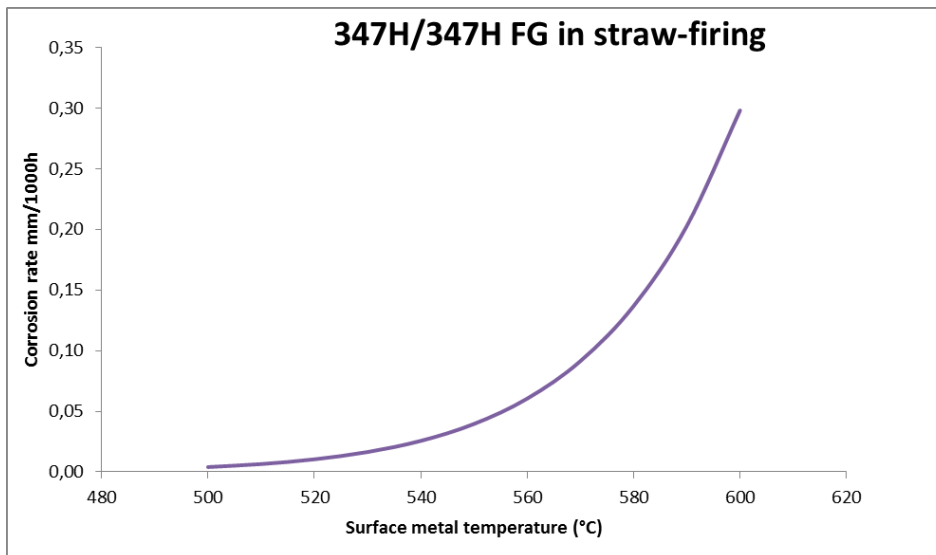
$$K_p \text{ (mm/1000h)} = 8,84 \cdot 10^{12} \exp(-29004/T_{\text{metal}})$$

The model predicts a linear corrosion rate in mm/1000 h based on the surface *metal* temperature (in degrees K) at the location of interest, see figure 31. The model is useful both for the estimation of local surface temperature at a point of inspection and for estimation of corrosion rate in design or lifetime prediction for superheaters.

Figure 31: Graph showing the derived basic curve for the corrosion rate of steels 347H/347HFG with respect to temperature in straw firing.

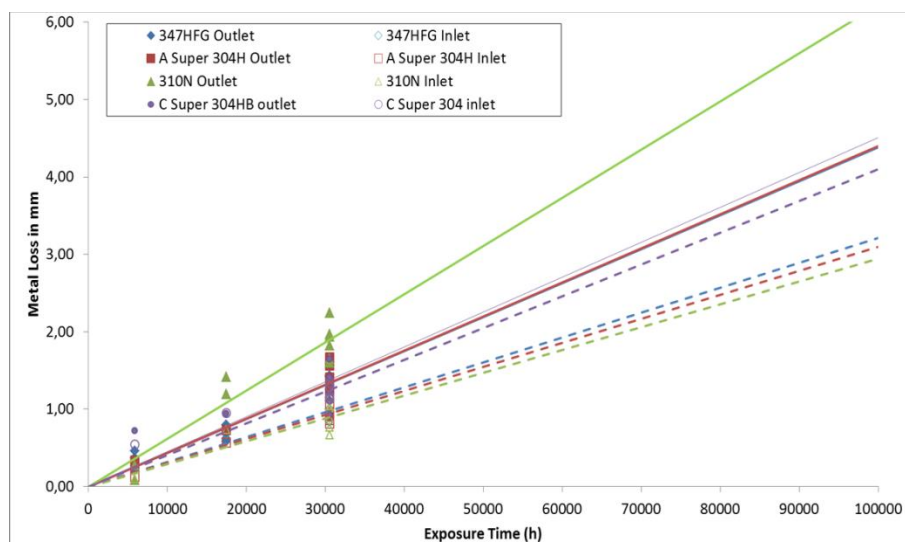
The high corrosion rate of the 310N steel has a great effect with respect to lifetime prediction (Figure 33) and an Arrhenius plot would have a steeper gradient.

Figure 33: Extrapolated data for steels exposed at Amager 1 test sections.

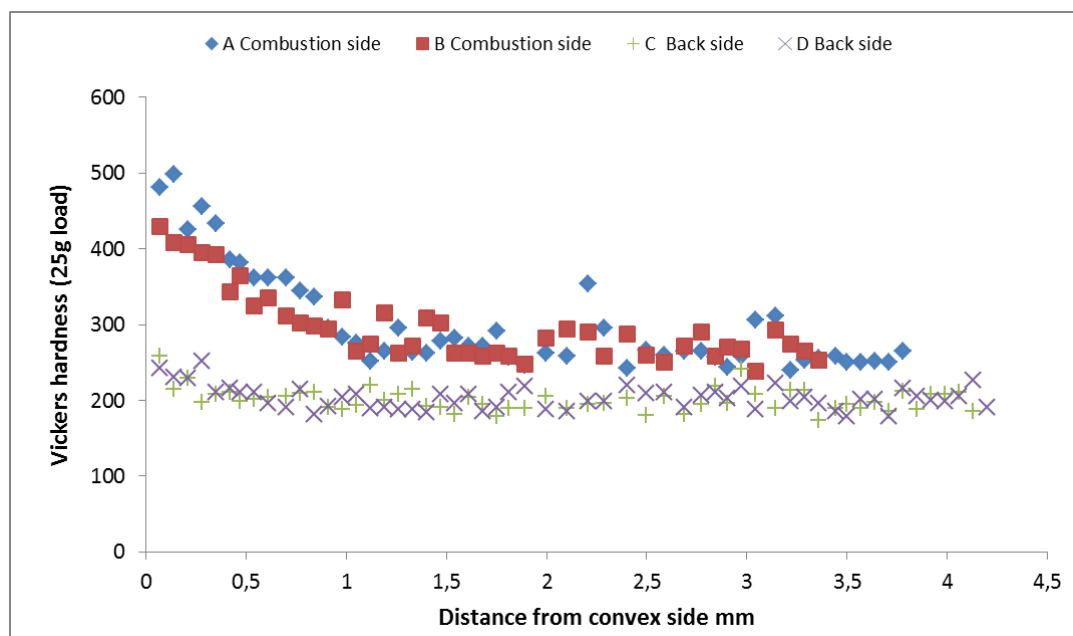
At Maribo Saksøbing the grate had an estimated surface metal temperature of 350°C and therefore much lower than superheaters previously described, and corrosion attack was slower due to the lower temperature, however the exposure time had been over 93000 hours. Measurement of hardness profiles across the tube wall indicated that the grate tube had a higher hardness at the side closest to the combustion zone (Figure 37). The microstructure was also different in that needle shaped precipitates were present close to the combustion zone and their presence gradually decreased closer to the steamside (Figure 38). In addition, the usual surface hematite and inner magnetite was not always present. Instead the presence of FeOOH (goethite and lepidocrocite) was detected.

Figure 37: Hardness measurements comparing the combustion side and the backside of the tube.

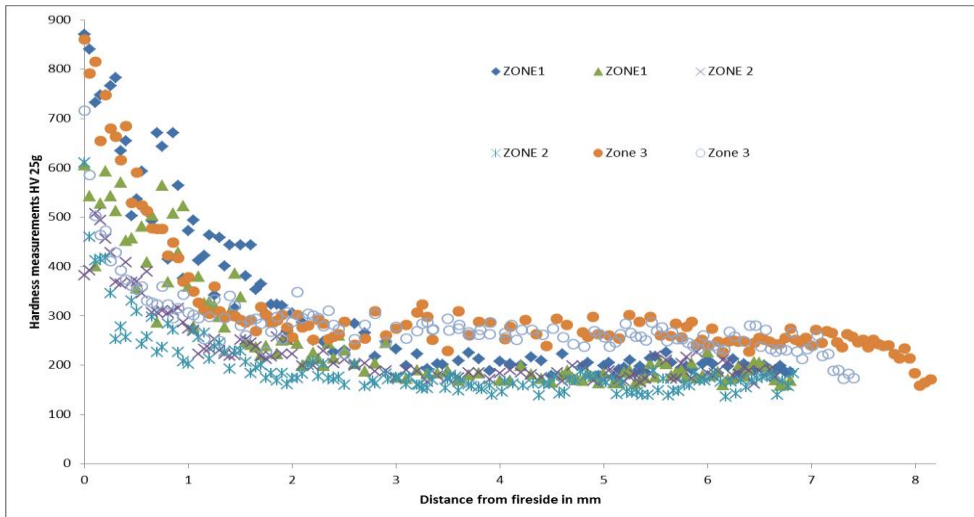
Analysis of the 13CrMo44 grate tubes from the AVV2 bioboiler revealed higher hardness (than for the 15Mo3 and 16Mo3 tubes) (Figure 40). Three sections from different zones on the grate were investigated to see if location on the grate influenced the profile. All zones had different measures of hardness and these also varied around the tube. Even two tubes adjacent each other had different hardness profiles. In comparison, the fins which were 15Mo3 had hardness values similar to 15Mo3 previously measured from the other boilers.

Figure 40: Hardness profile through 13CrMo44 grate tubes from Avedøre bioboiler

The higher hardness compared to that observed for 15Mo3 both in the fins of the grate, and also in other 15Mo3 grate tubes must be due to the increased amount of Cr and Mo in the steel which both have a higher affinity for nitrogen than iron. The presence of Cr may lead to Cr nitrides at the grain boundaries resulting in a greater embrittlement, however this was not proven.
